SUBJECT: 11th Street Jail Demolition – In-Principle

Reference: Seismic Evaluation Report
County of Riverside Probation and Jail Facilities
Riverside, California

SEISMIC EVALUATION

COUNTY OF RIVERSIDE PROBATION AND JAIL FACILITIES Riverside, California L06-48

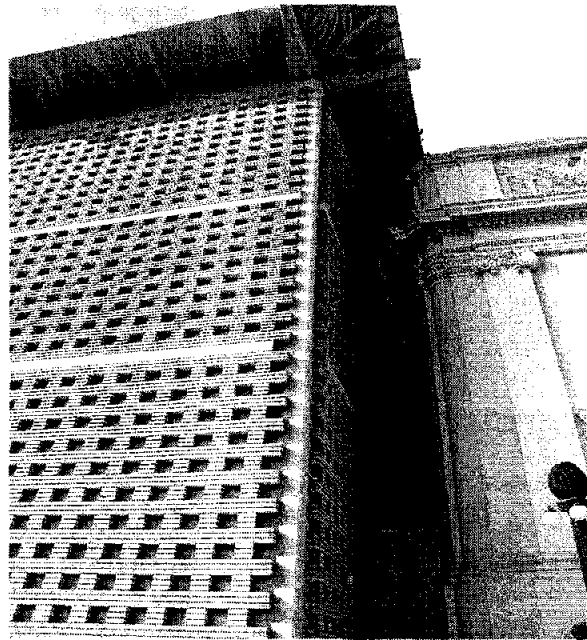
1. Cracking in perimeter cantilever concrete slab at top of parapet walls are prominent from view. Please refer to Pictures 2 through 7.
2. Stress and shrinkage cracking at exterior concrete shear wall of first floor. Please refer to Pictures 10 through 13. Similar cracking might have occurred on other floors which are not visible due to presence of veneer.
3. Damages on wall finishes due to water leakage in plumbing pipes were found on many interior partitions and ceilings. Please refer to Pictures 16 through 21. In one location, evidence of damage to existing concrete slab was observed. Please

Picture 2 – North-East Elevation at
Adjacent Building

1. Cracking in existing collar slab over perimeter parapet may not present immediate structural problem. However, the cracking should be sealed to prevent further damages to the reinforcing steel which may cause spalling to covering concrete.

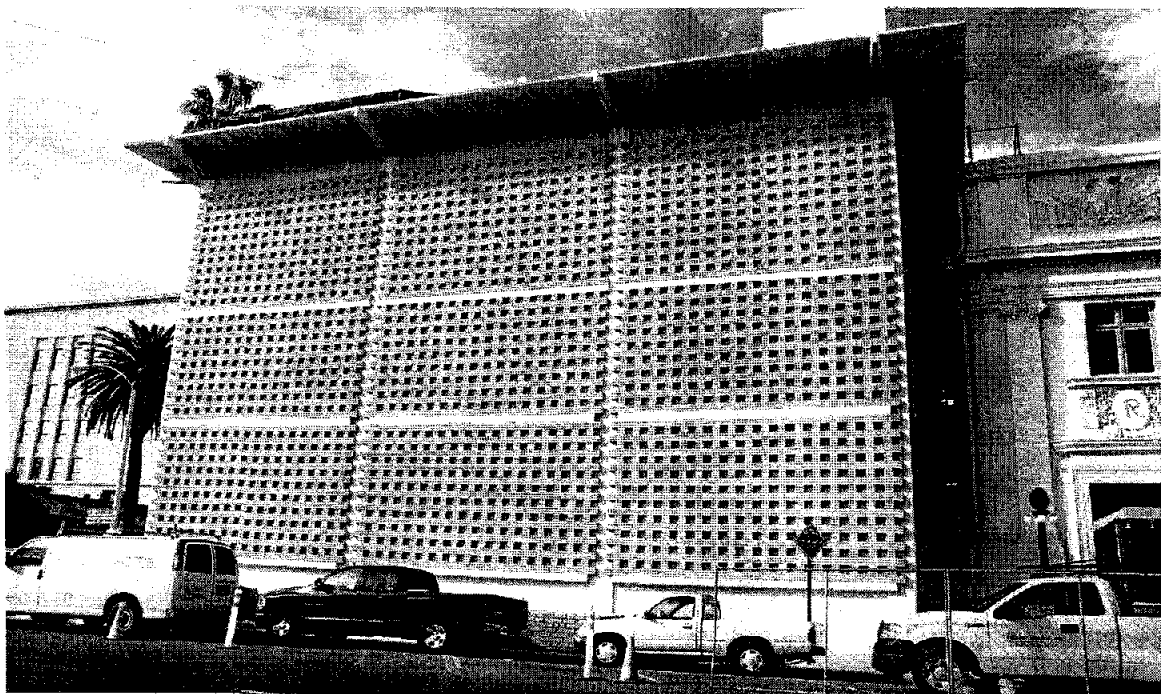
Picture 3 – East Elevation

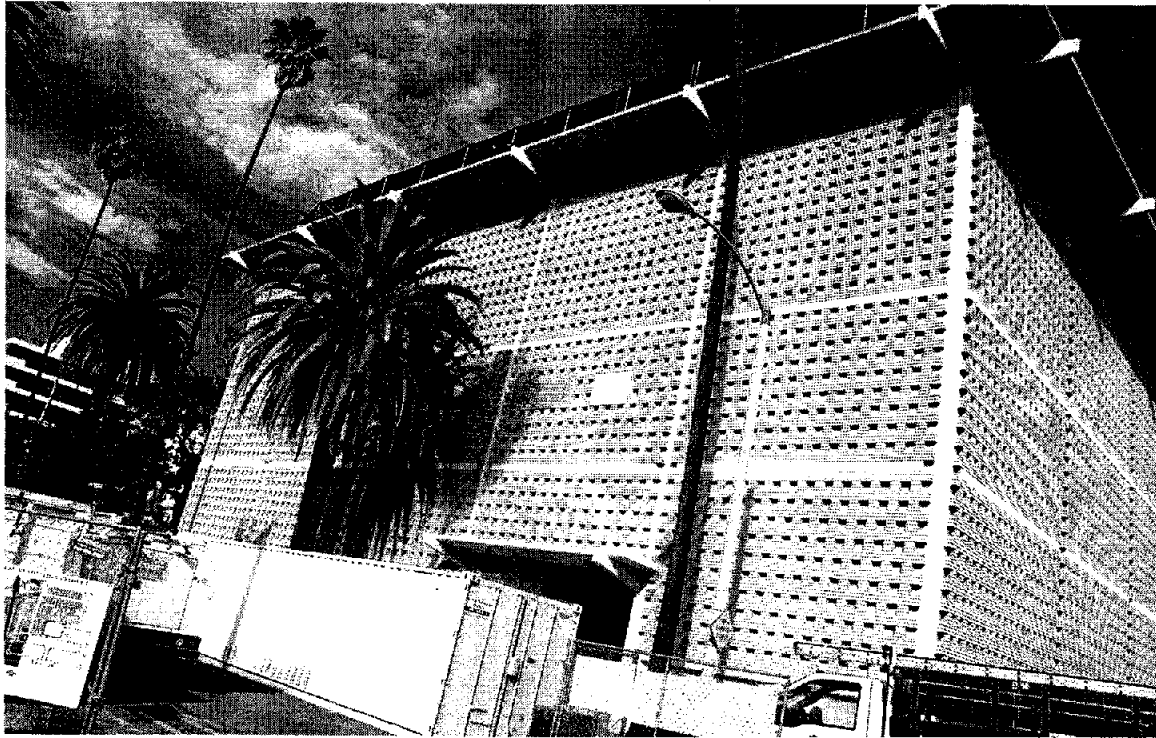
Picture 4 – South Elevation

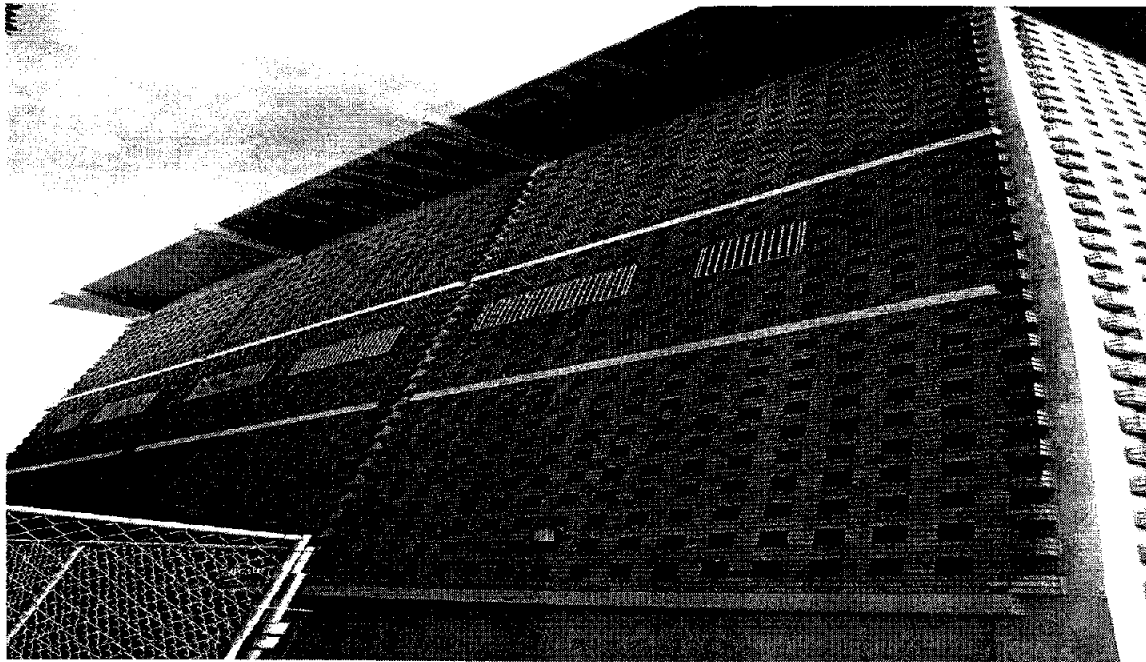
Picture 5 – West Elevation

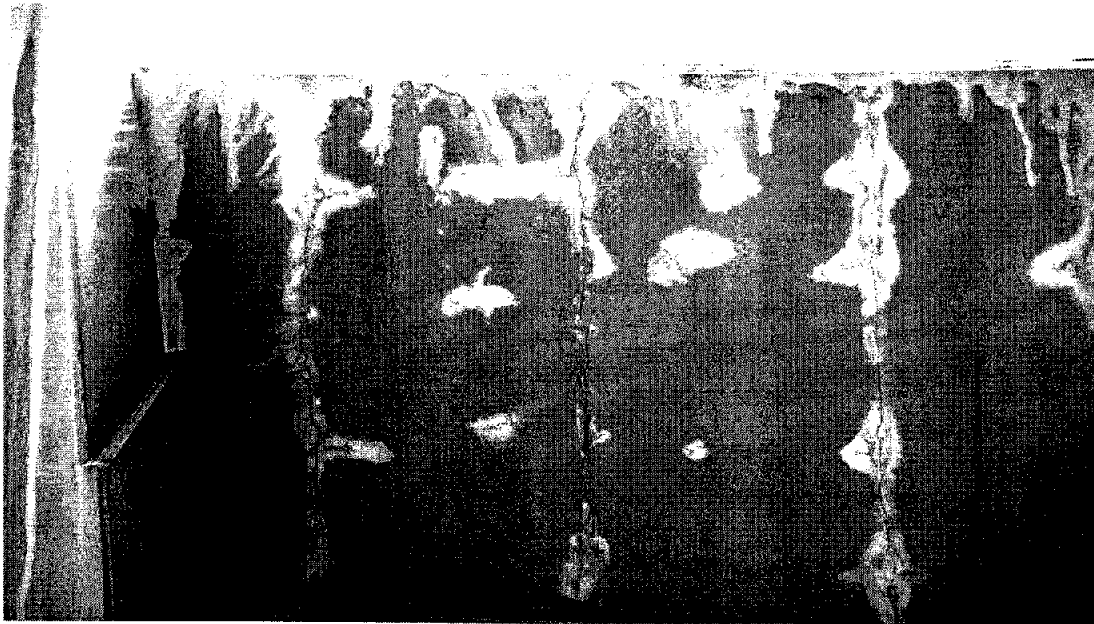
Picture 6- Cracking on perimeter cantilever slab

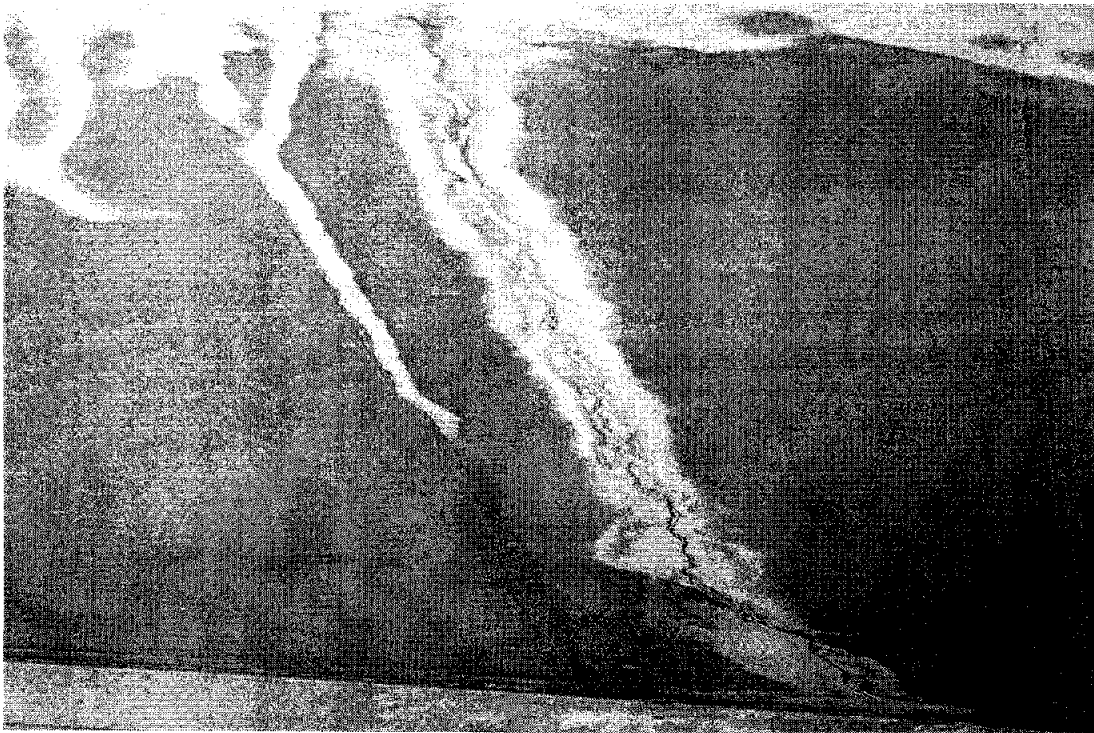
Picture 7 – Cracking on perimeter cantilever slab

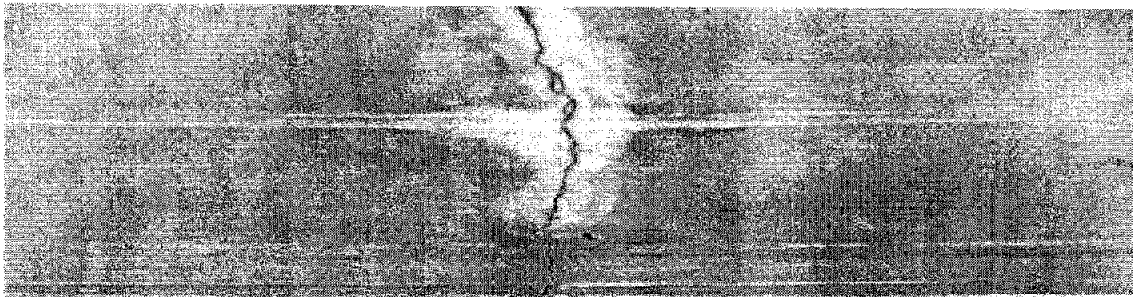
Picture 8 – Cracking on perimeter cantilever slab and wall

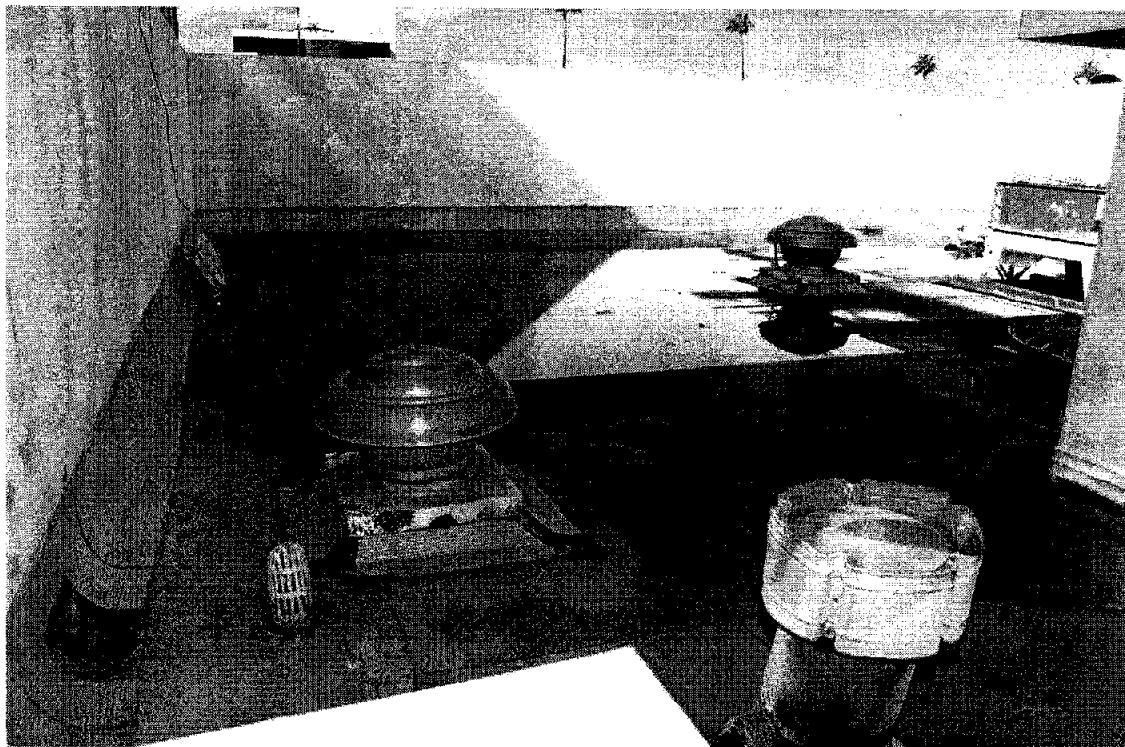
4. Insufficient building separation to adjacent building. Please refer to Pictures 14 and 15. No real separation was found.
5. The roof is ponded with rain water a week after the first rainfall of the season. It appeared that the roof is improperly sloped and maybe insufficient roof drains. Please refer to Picture 9.

Picture 9 – Water ponding on roof slab

2. Cracking on existing concrete shear walls wider than 0.01 inch shall be repaired with epoxy injection to restore the strength of the existing shear walls.
3. It appeared that the old existing plumbing system needs an overhaul. Water damages from leaks of existing piping are visible at various walls on the first and second floors. Complete replacement of the existing system maybe in order. A plumbing engineer shall be consulted with this problem.
4. To minimize effect of building ponding due to seismic deflection, the building shall be physically separated with a minimum of 2-inch gap between adjacent buildings at each connecting tunnels. Seismic joint shall also be installed around all sides of each tunnel at the separation joints.
5. Insufficient roof slope and drainage system shall be addressed by the Architect. Ponding of water is part of the water leakage problem of this building.

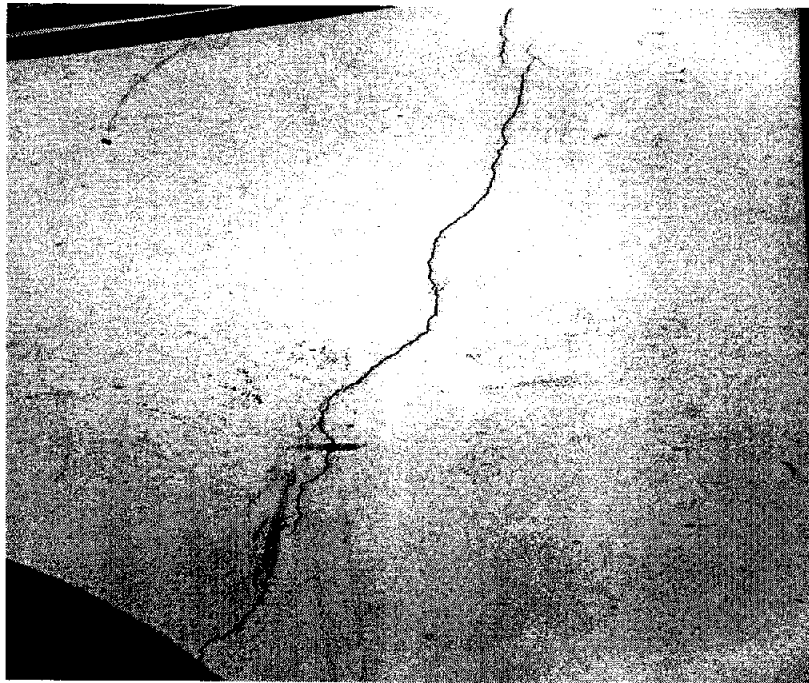
Picture 10 – Cracking on first floor perimeter wall

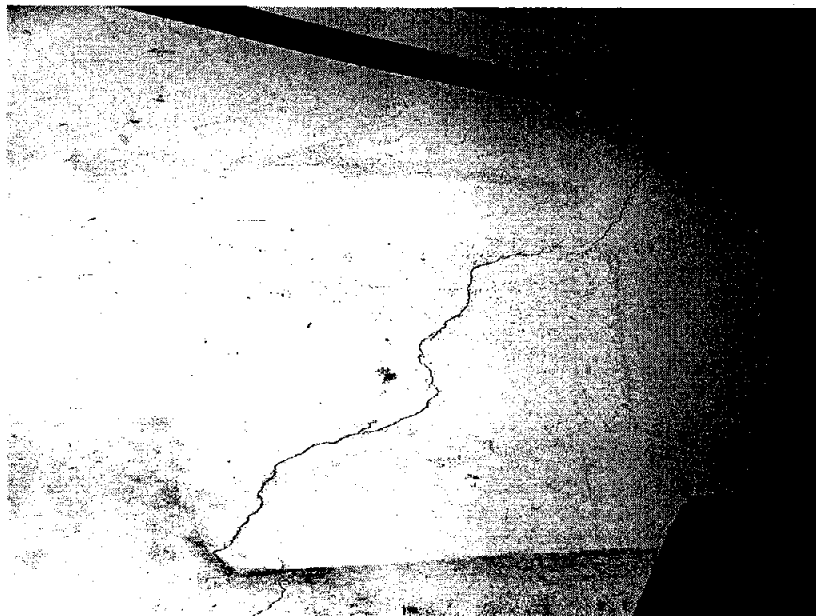
Picture 11 – Cracking on first floor perimeter wall

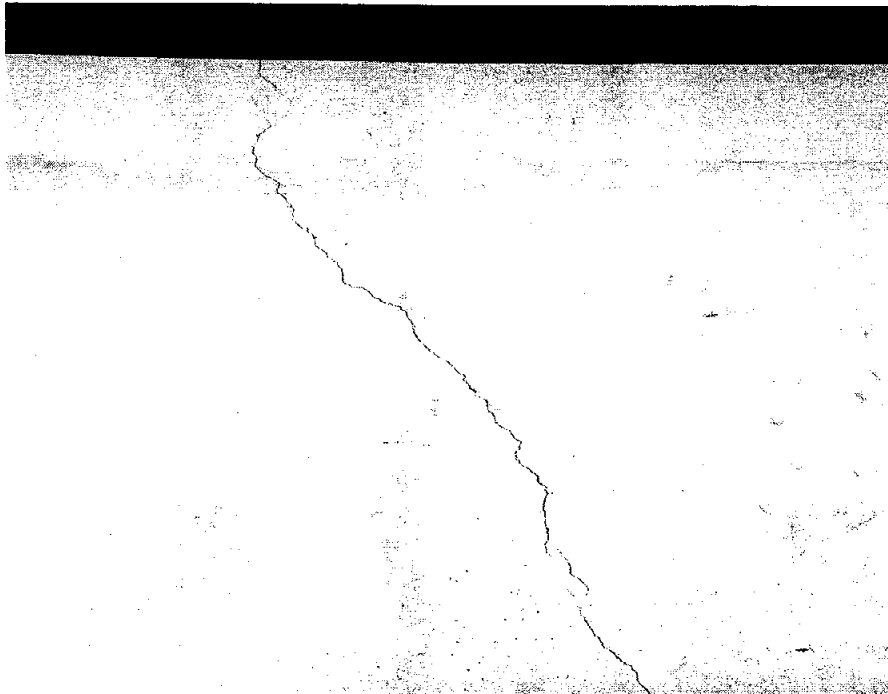
Picture 12 – Cracking on first floor perimeter wall

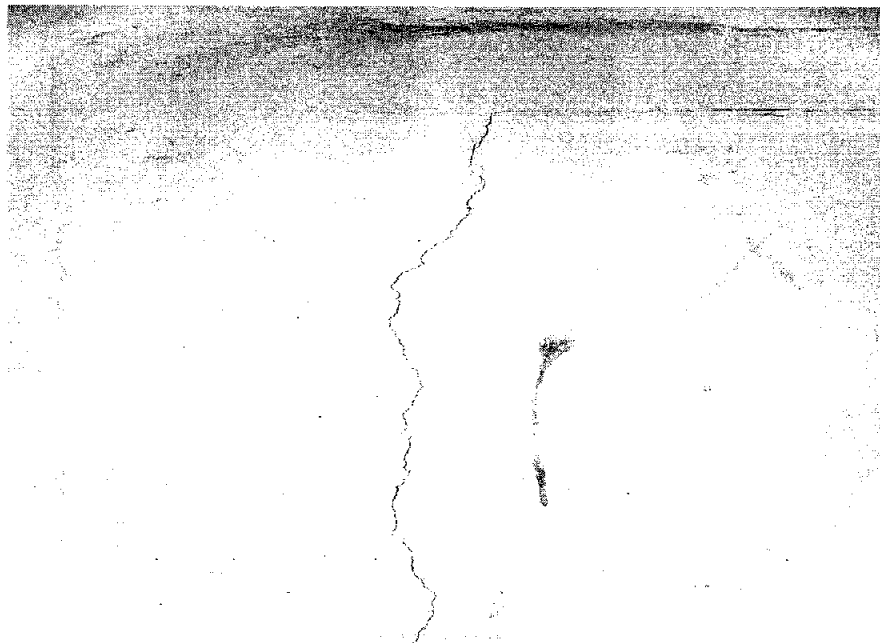
Picture 13 – cracking on first floor perimeter wall

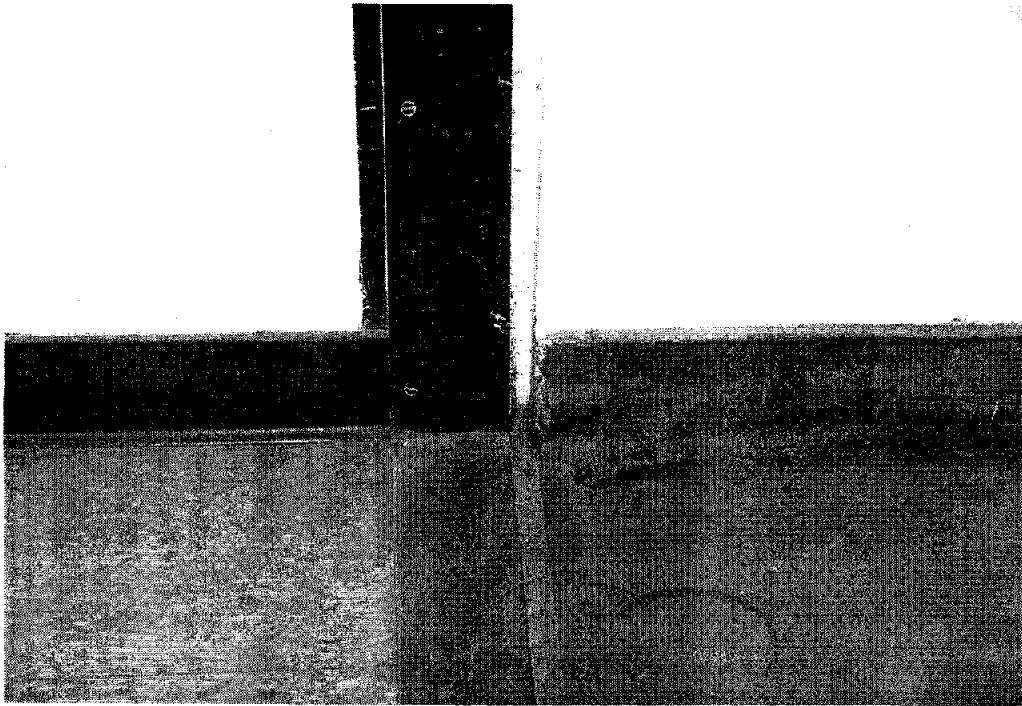
Picture 14 – Expansion joint between buildings at second floor

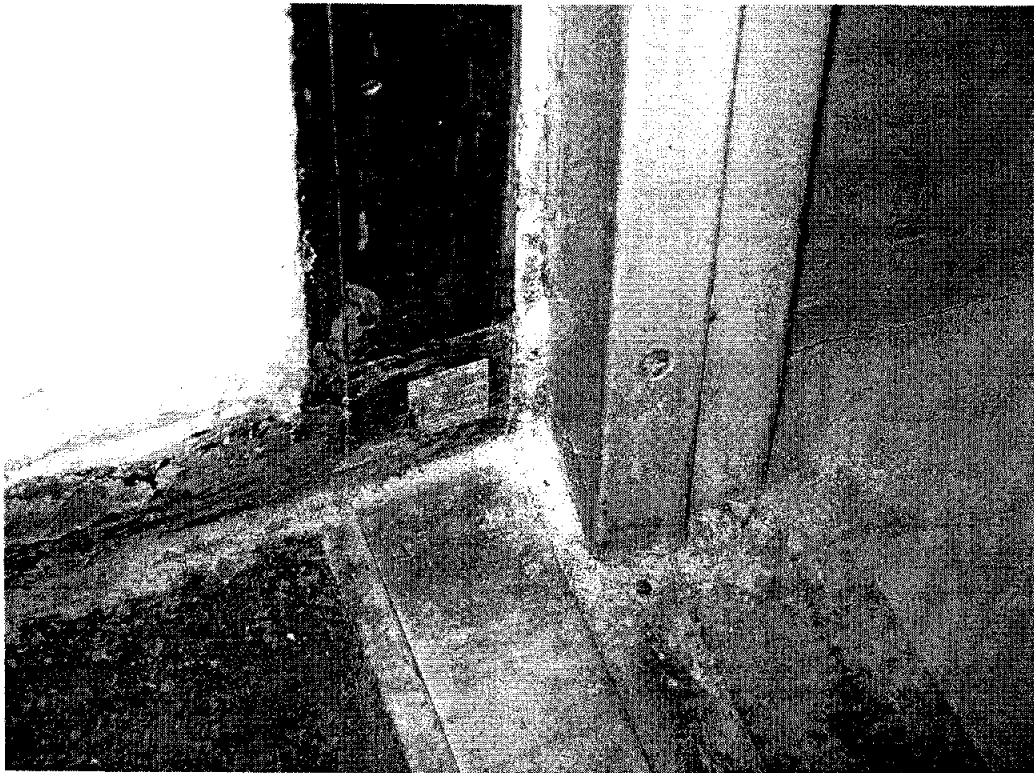
Picture 15 – Expansion joint between buildings at third floor

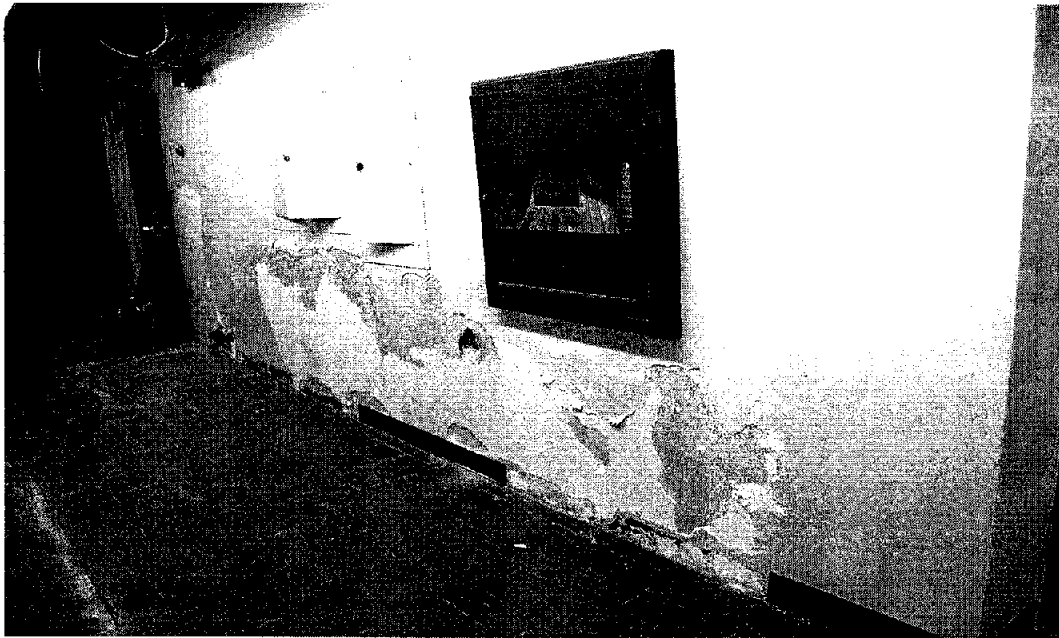
Picture 16 – Water-damaged interior partition

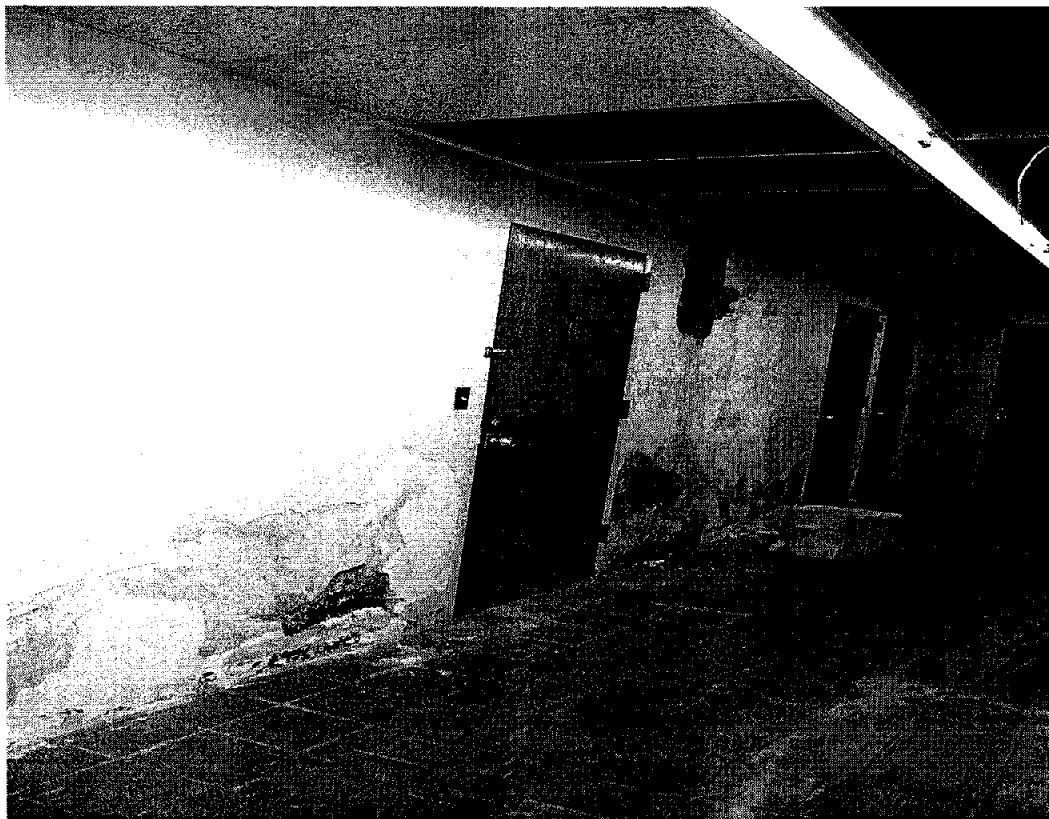
Picture 17 – Water-damaged interior partition

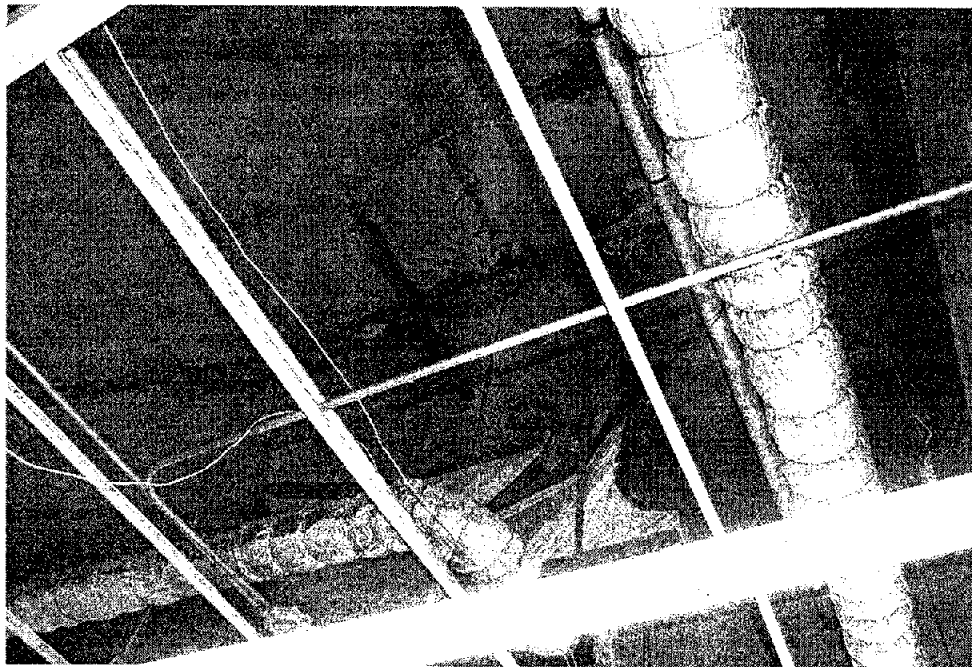
refer to Picture 18, where rust stain of reinforcing steel on concrete slab is visible.

Picture 18 – Water-damaged second floor slab

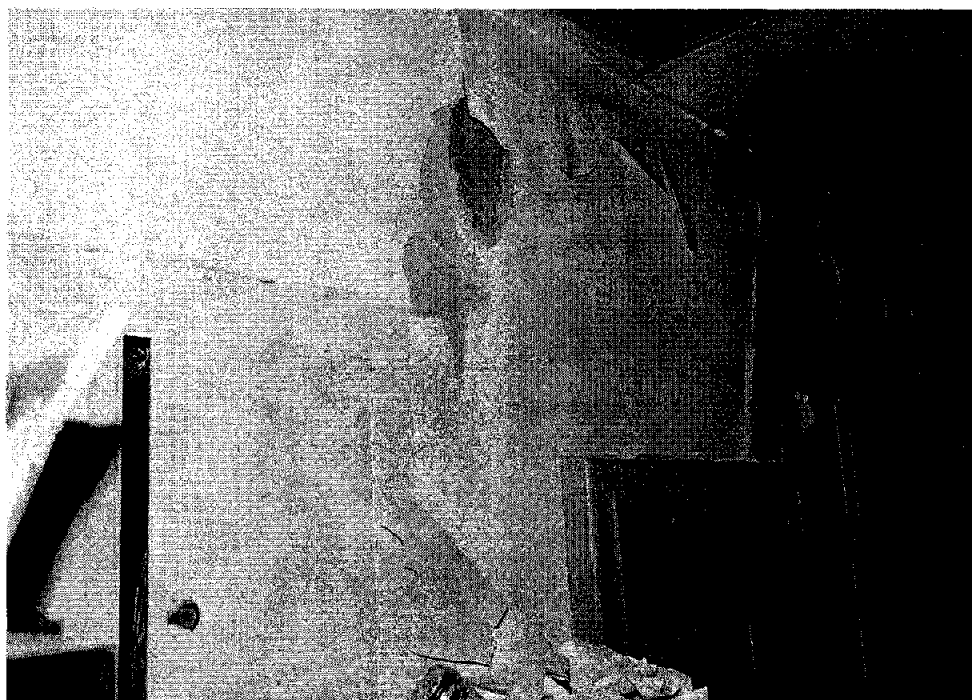
Picture 19 – Water-damaged interior partition

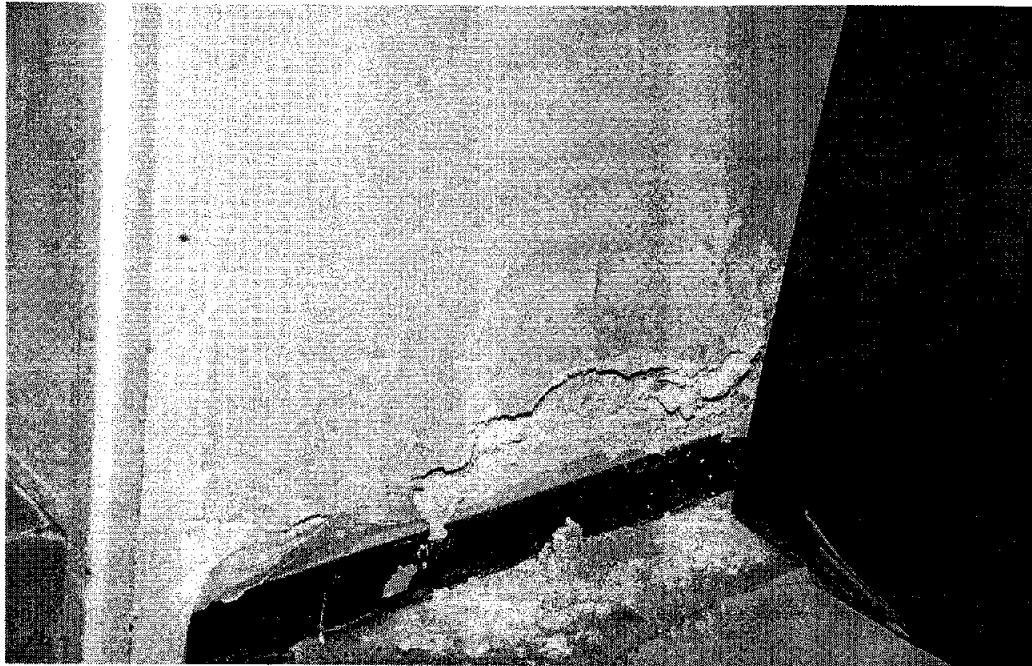
Picture 20 – Water-damaged interior partition
