**SUBMITTAL TO THE BOARD OF SUPERVISORS
COUNTY OF RIVERSIDE, STATE OF CALIFORNIA**

FROM: Economic Development Agency

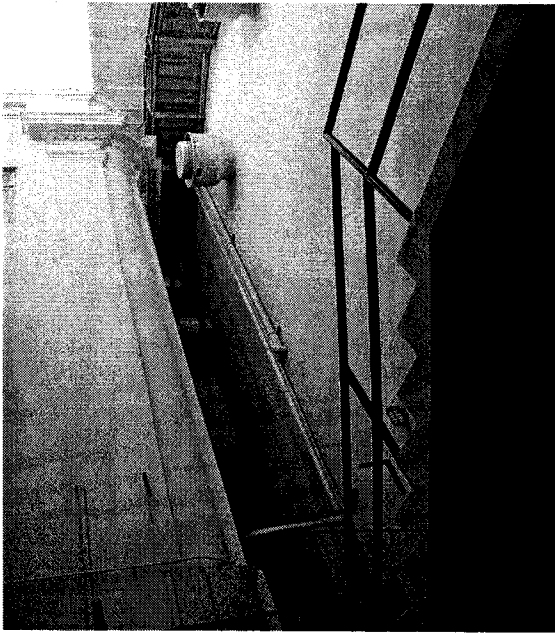
Picture 1 – North-West Elevation at
Adjacent Building

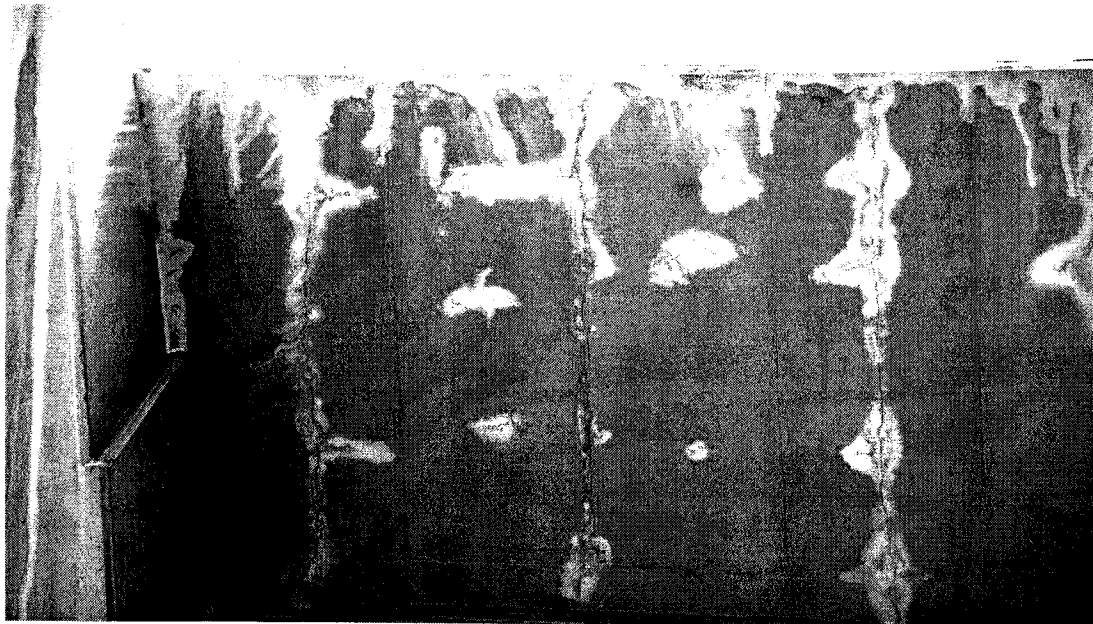
Picture 6- Cracking on perimeter cantilever slab

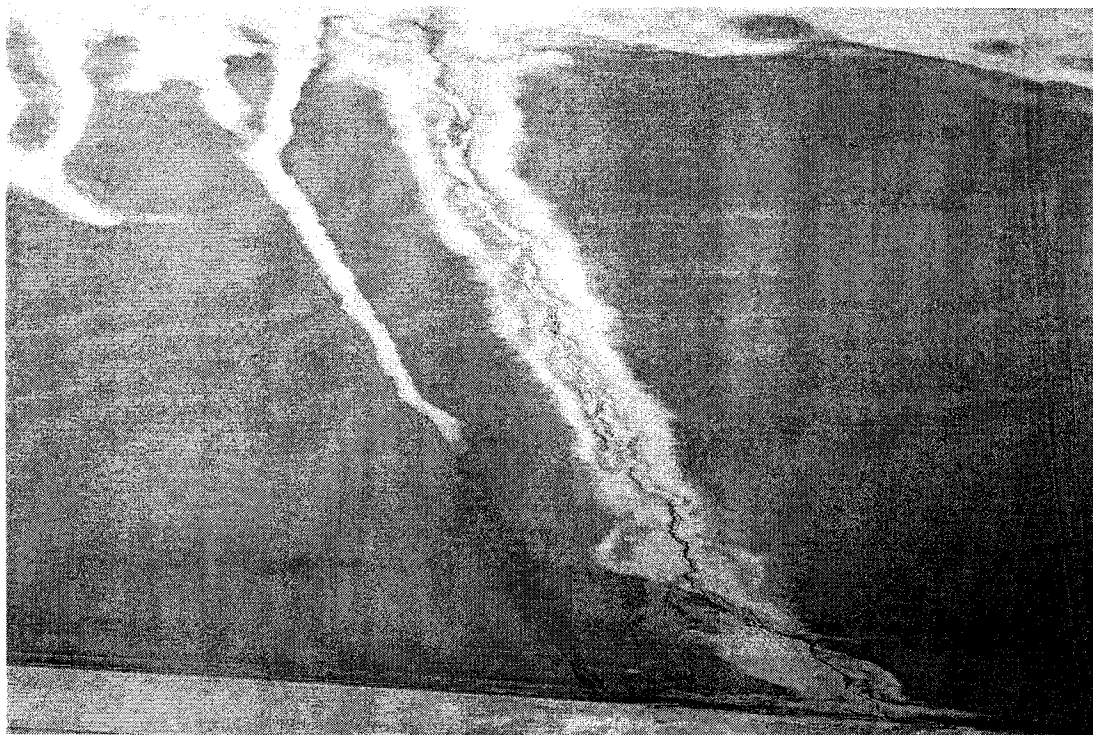
Picture 7 – Cracking on perimeter cantilever slab

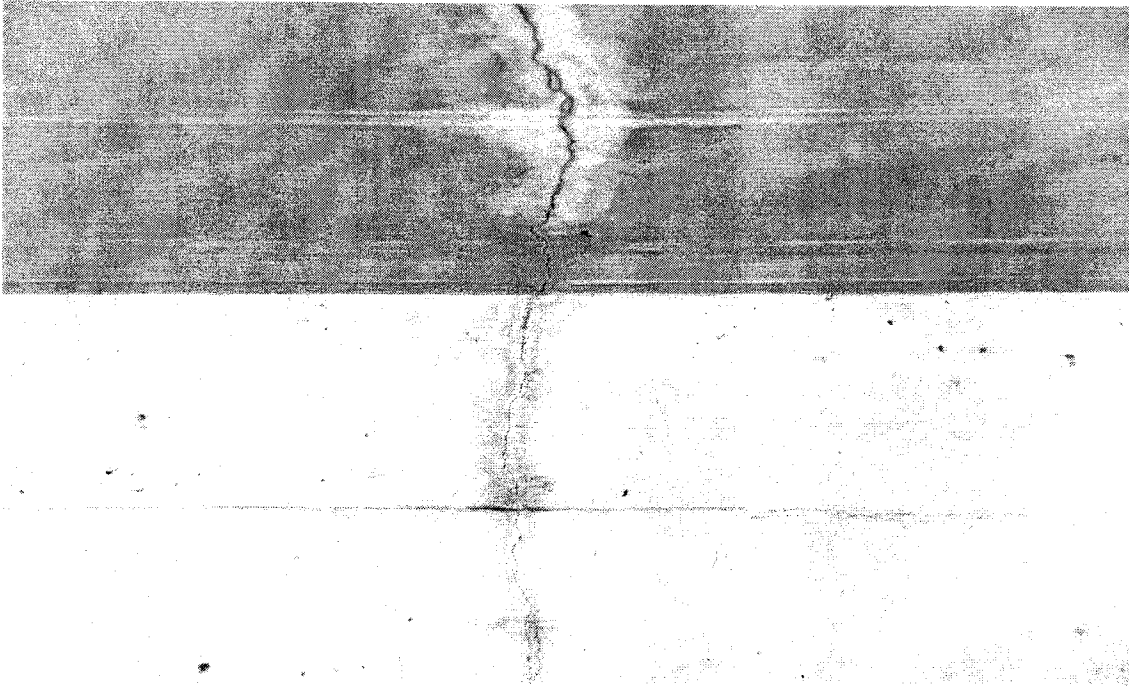
Picture 8 – Cracking on perimeter cantilever slab and wall

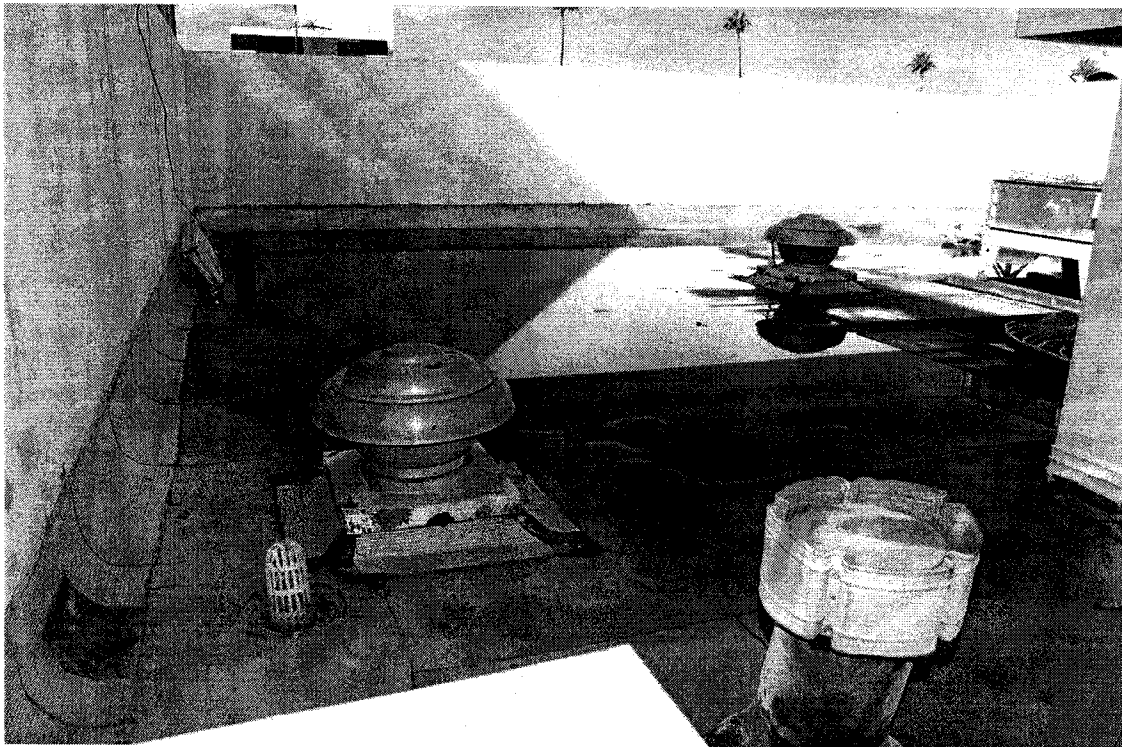
Picture 9 – Water ponding on roof slab

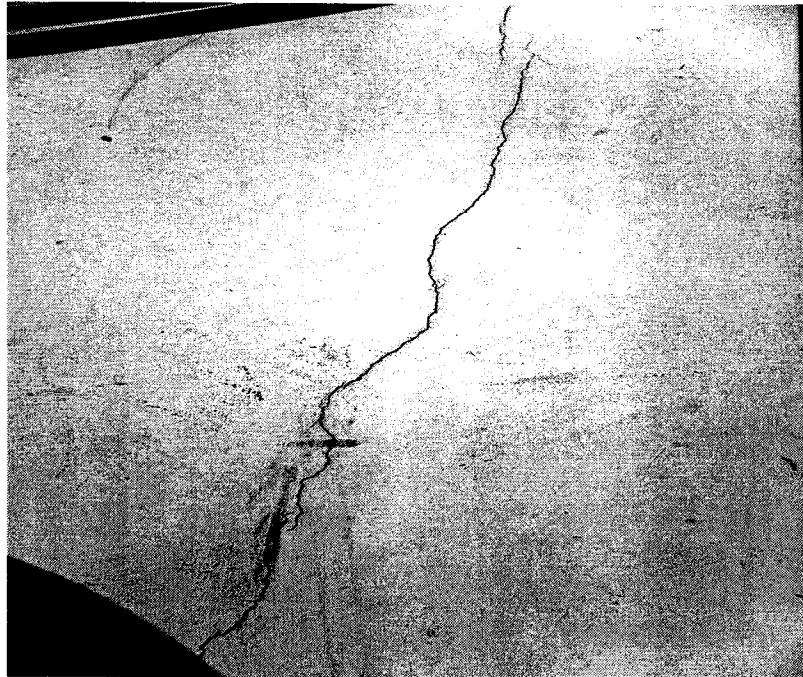
Picture 10 – Cracking on first floor perimeter wall

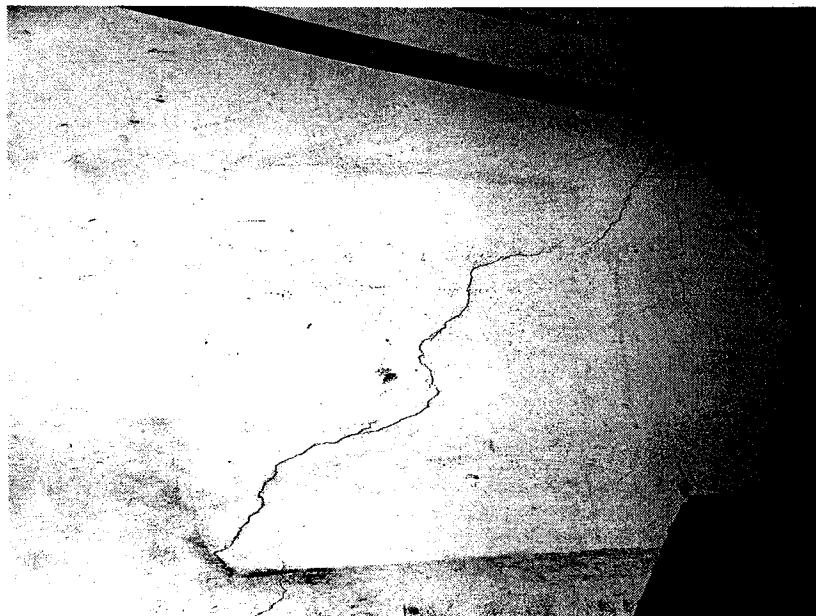
Picture 11 – Cracking on first floor perimeter wall

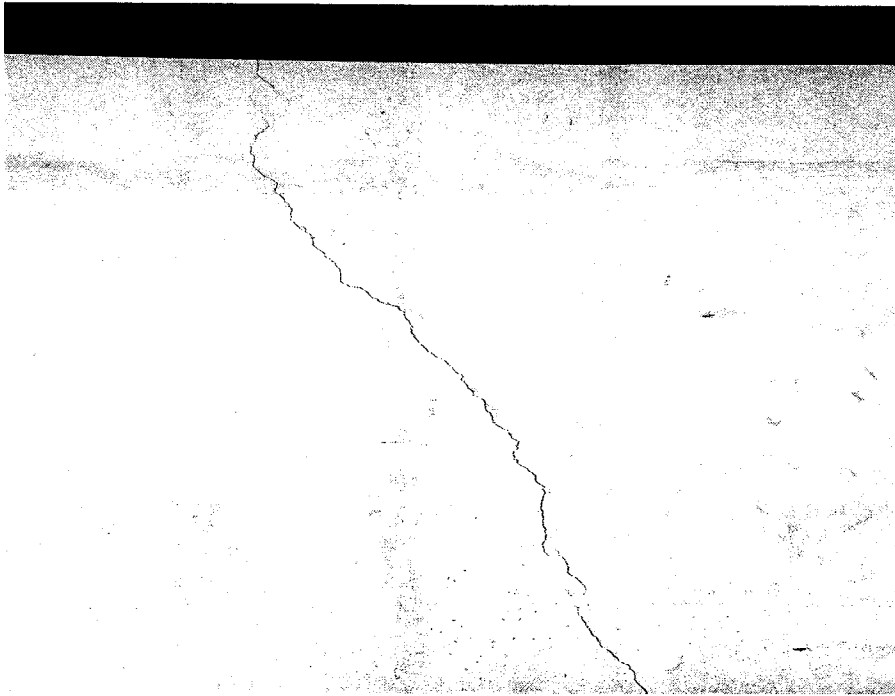
Picture 12 – Cracking on first floor perimeter wall

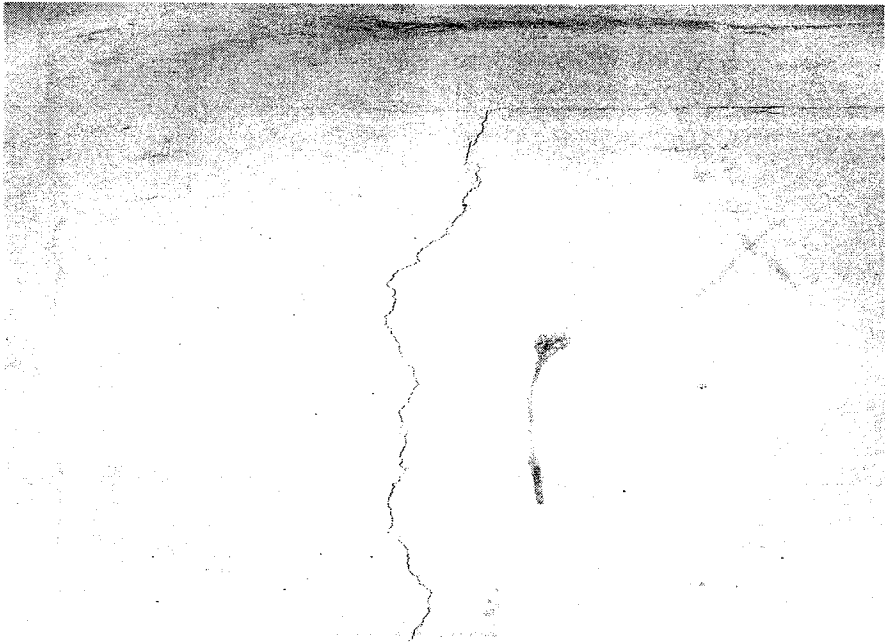
Picture 13 – cracking on first floor perimeter wall

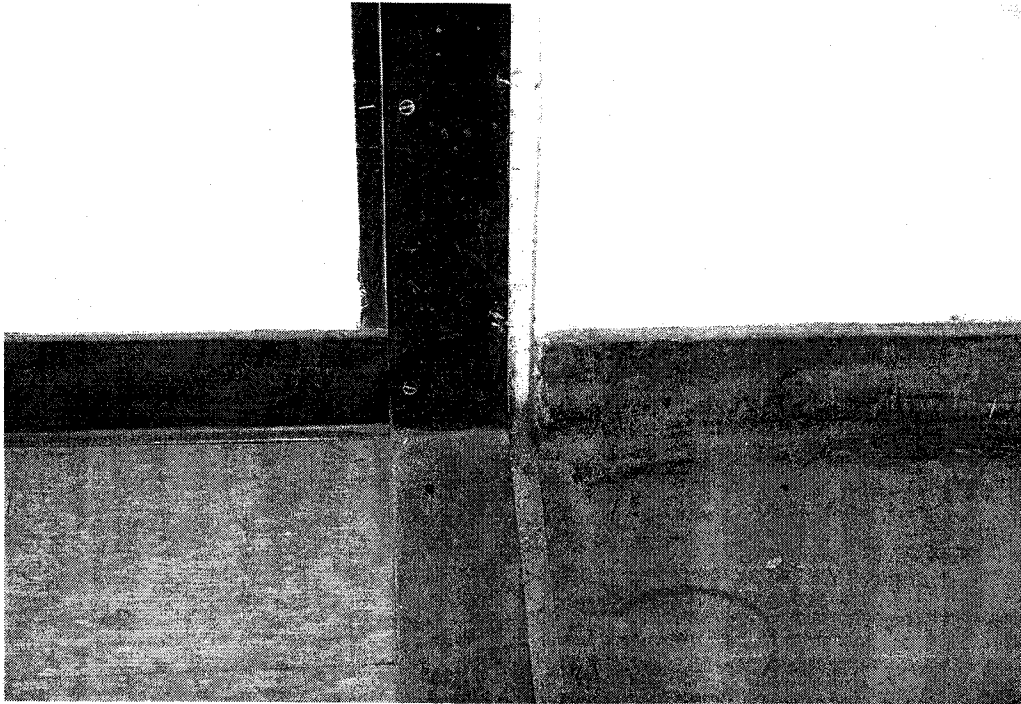
Picture 14 – Expansion joint between buildings at second floor

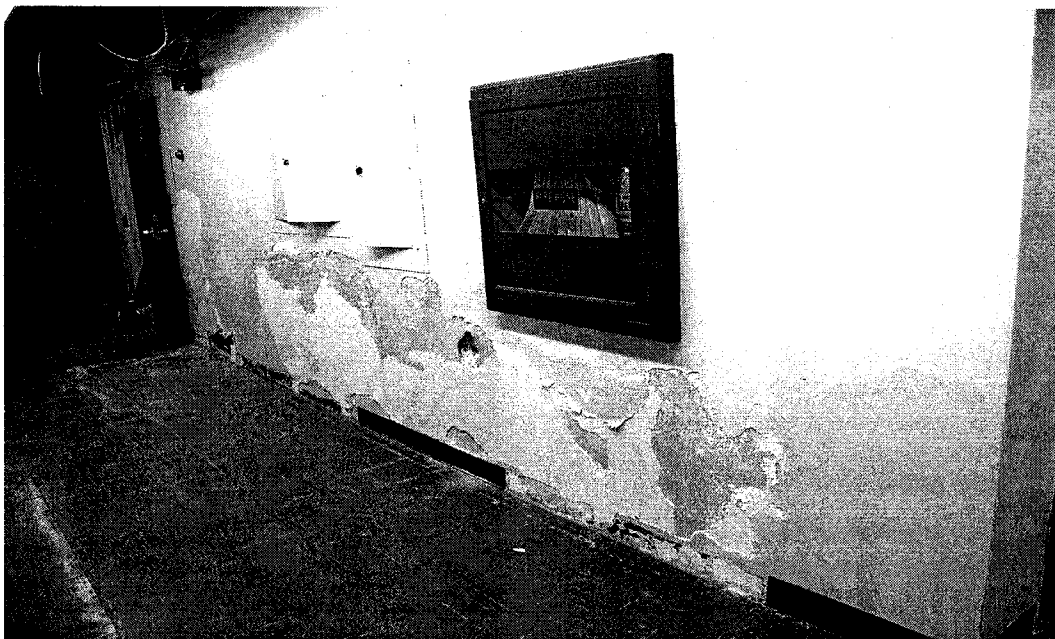
Picture 16 – Water-damaged interior partition

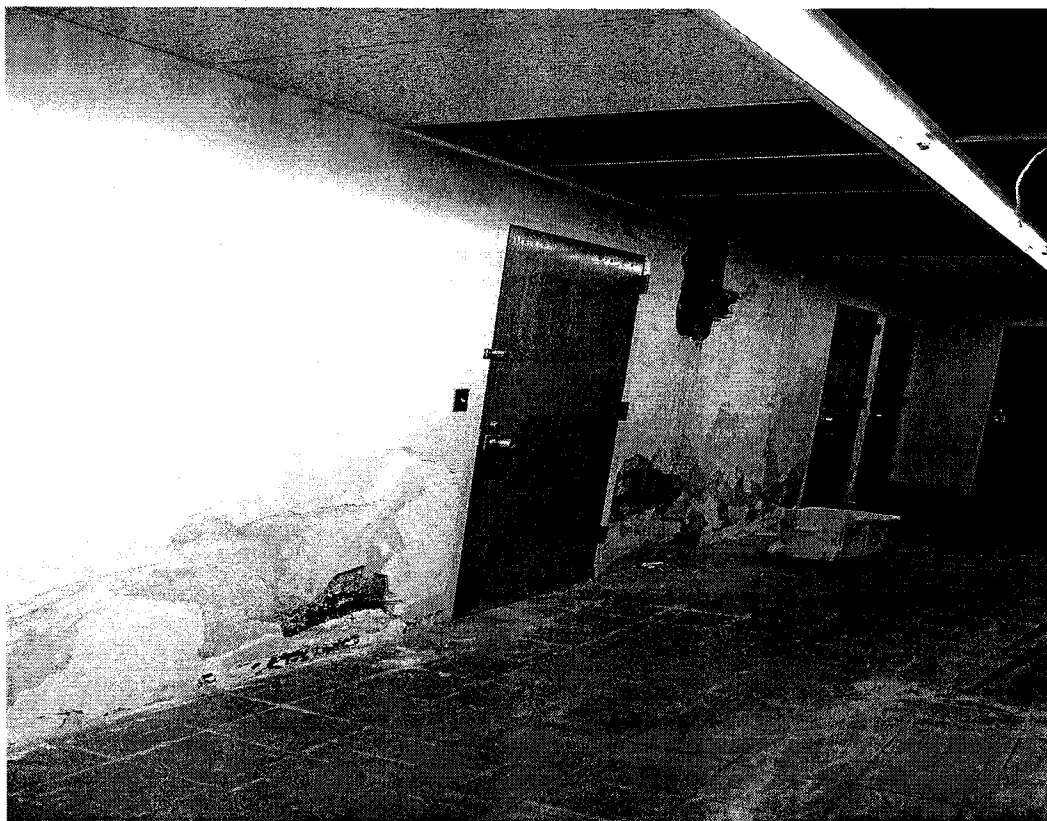
Picture 17 – Water-damaged interior partition

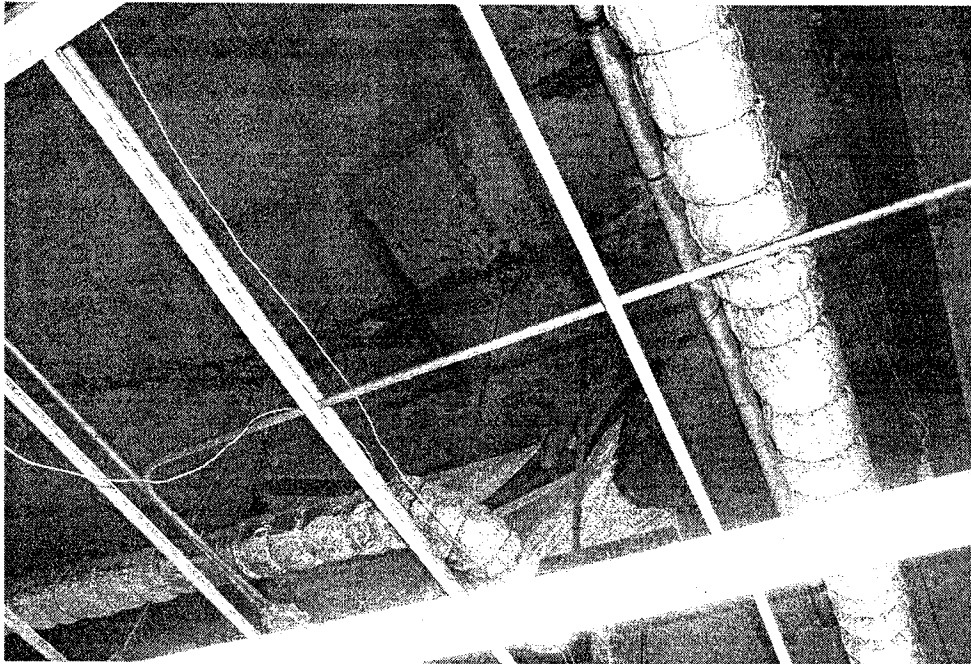
Picture 18 – Water-damaged second floor slab

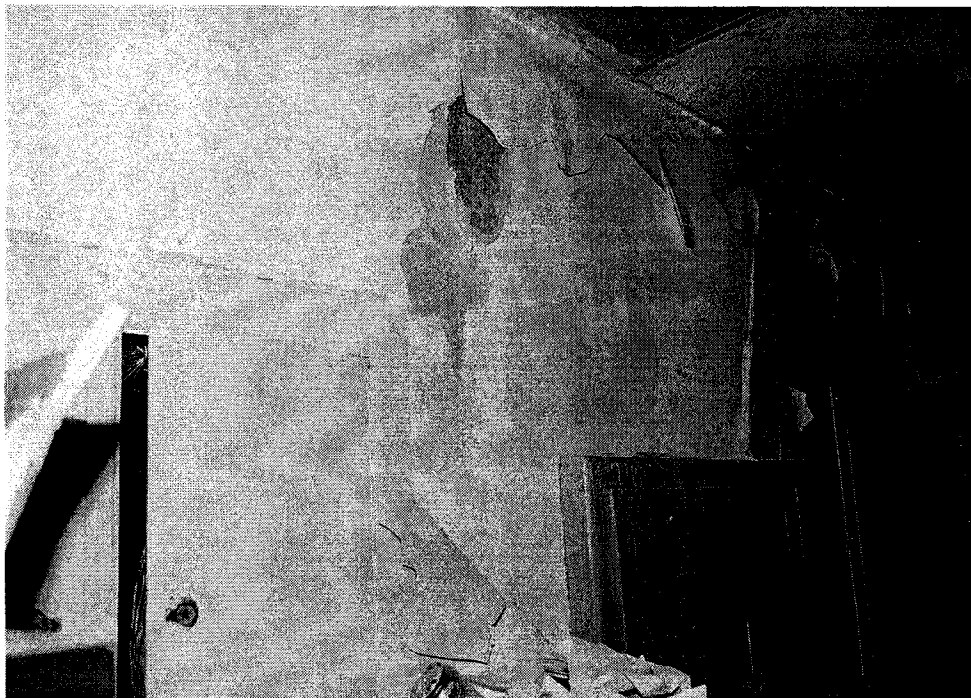
Picture 19 – Water-damaged interior partition

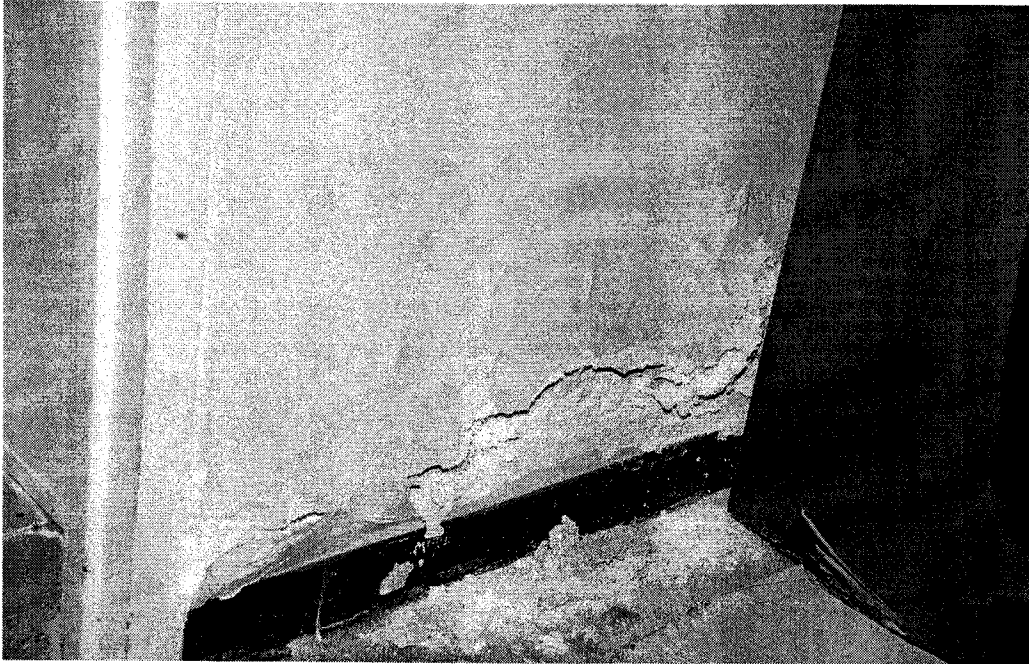
Picture 20 – Water-damaged interior partition

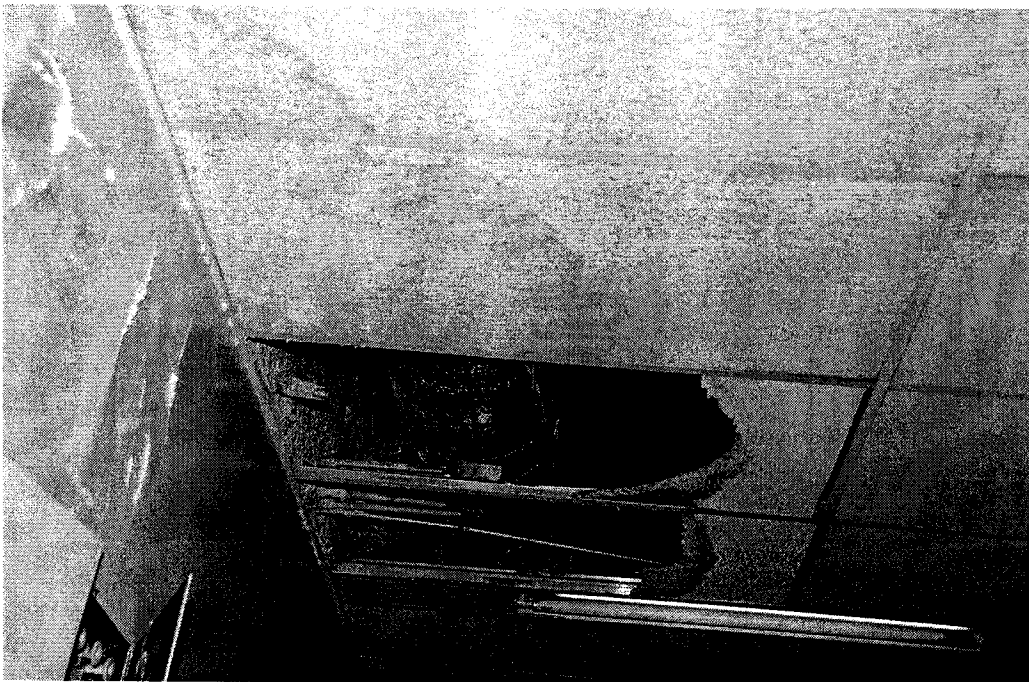
Picture 21 – Water-damaged ceiling and wall

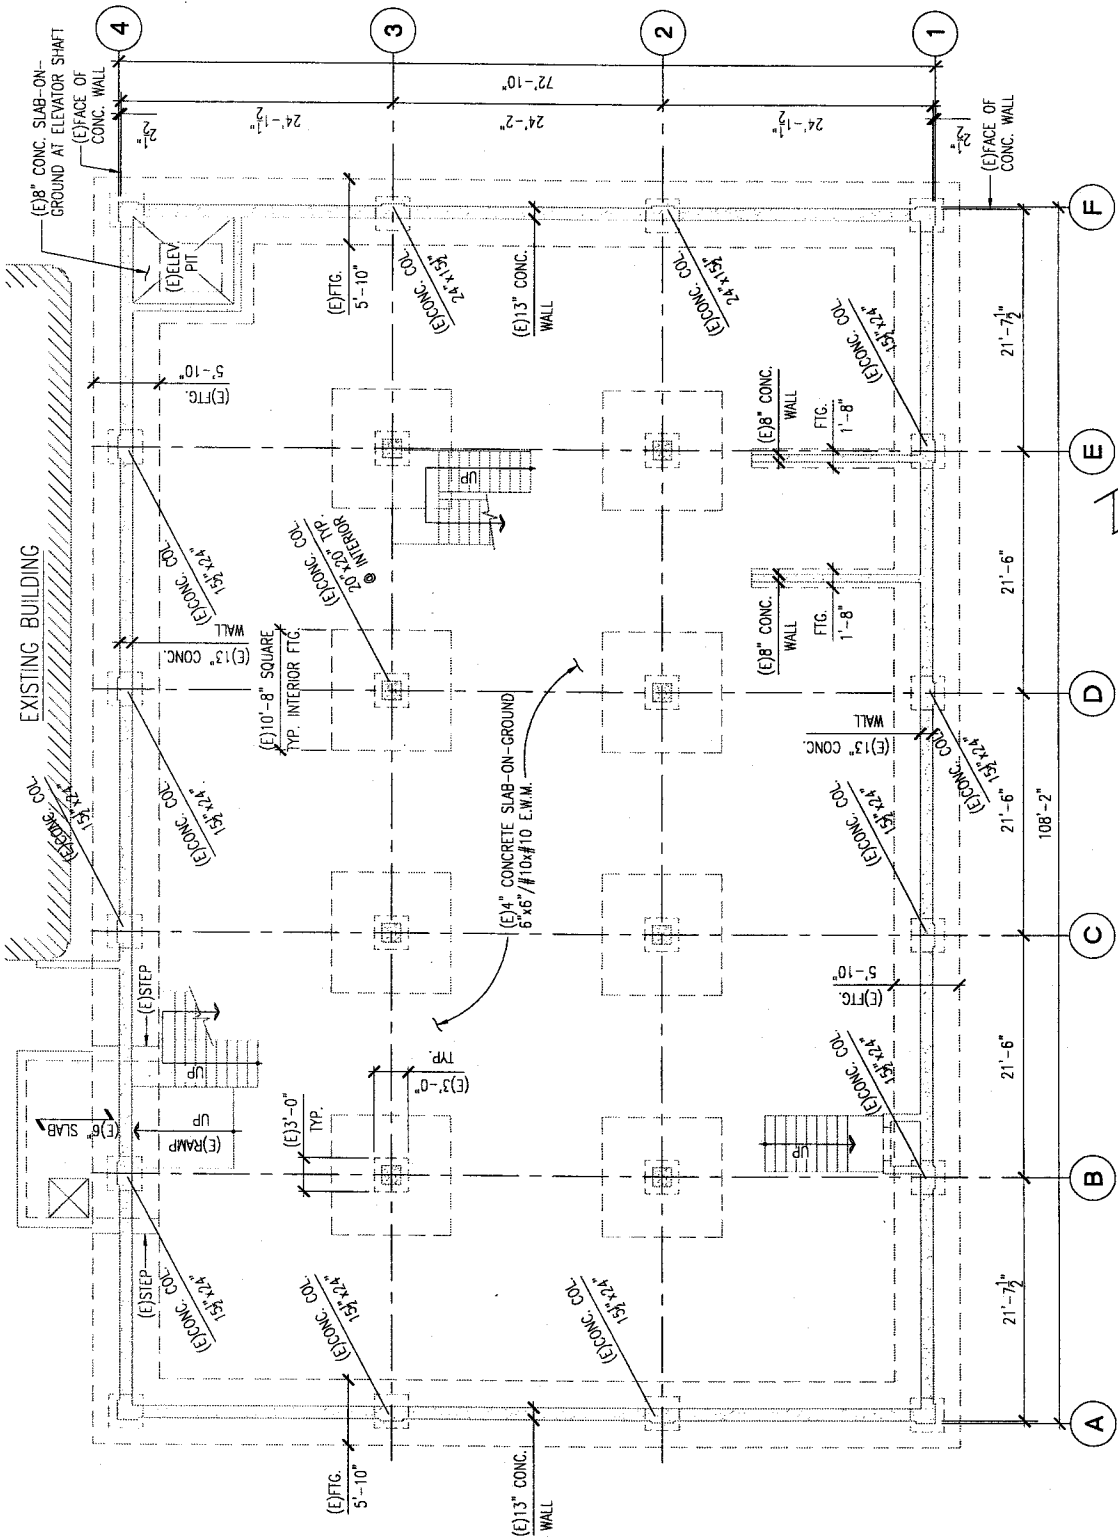
PROBATION AND JAIL FACILITIES
 FOUNDATION PLAN

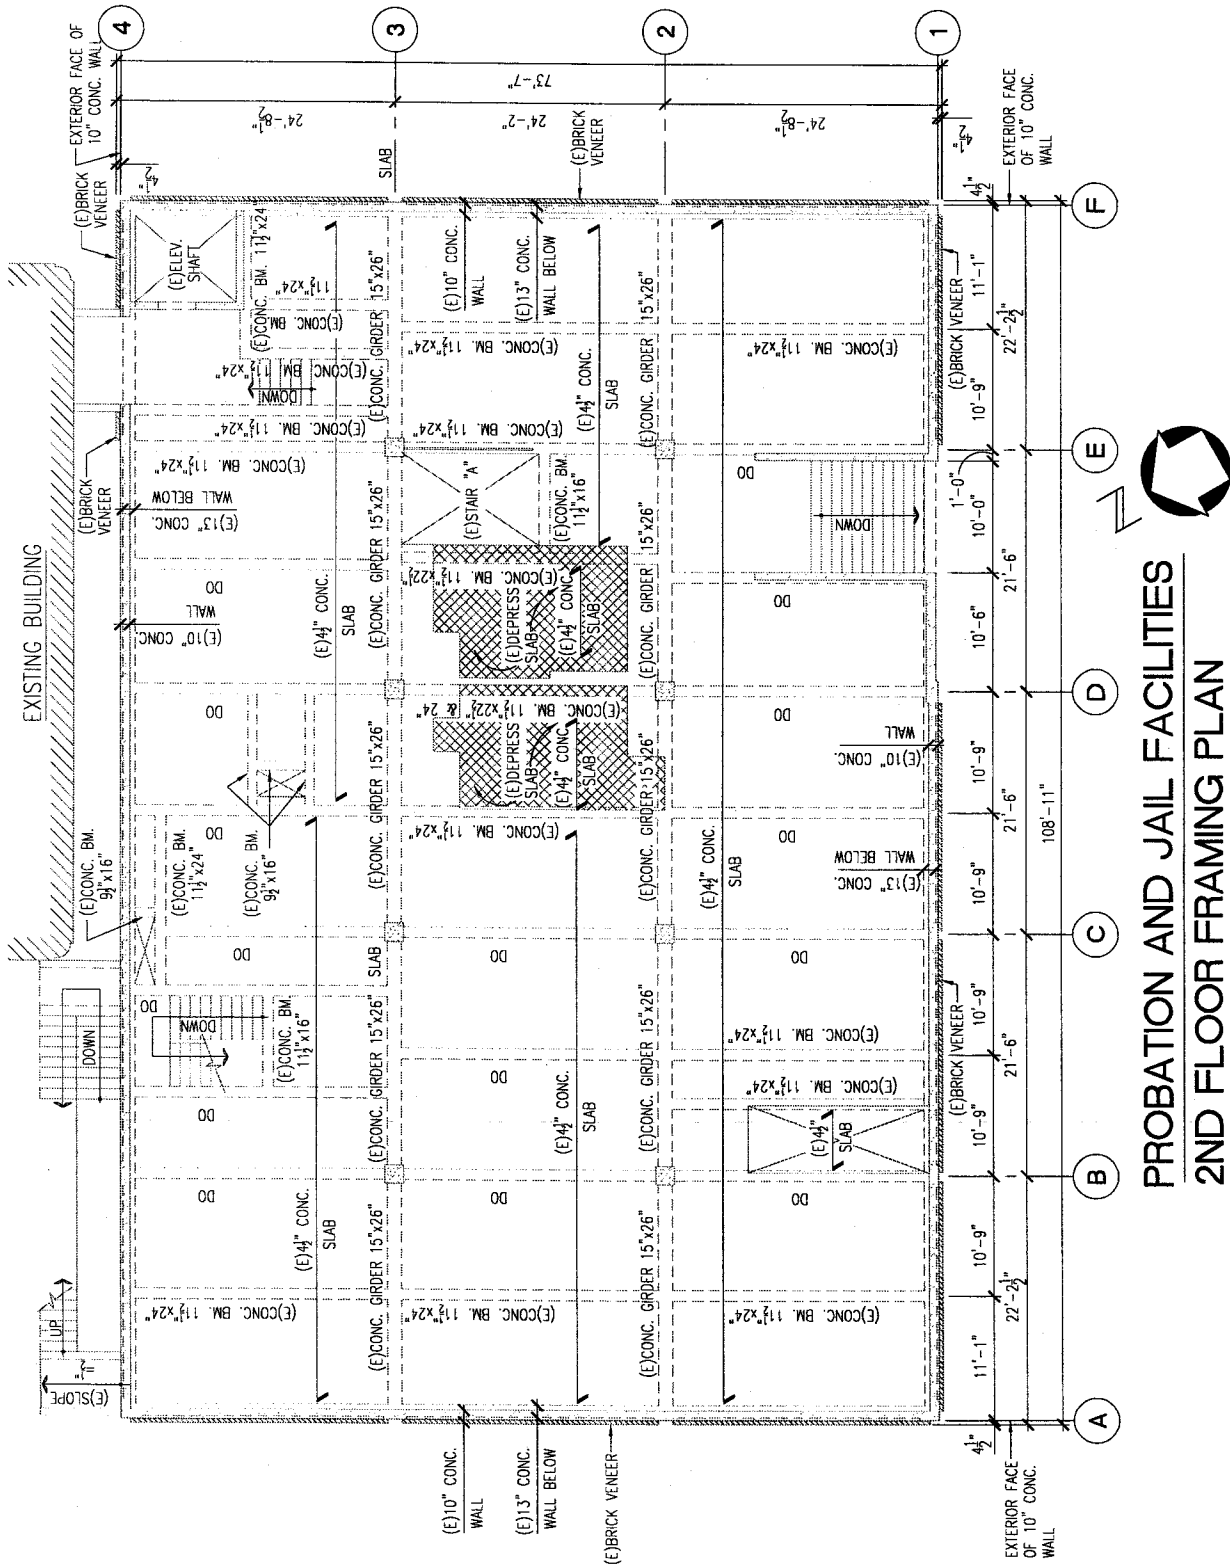
PROBATION AND JAIL FACILITIES
2ND FLOOR FRAMING PLAN
FIGURE 2
