AQMD ASBESTOS, LIMITED LEAD PAINT & UNIVERSAL WASTE SURVEY

For Riverside County Economic Development Agency
Site: Mental Health Facility
Located at 9890 County Farm Road Riverside, CA
Reference # SR33056

Date of Report: May 7, 2015

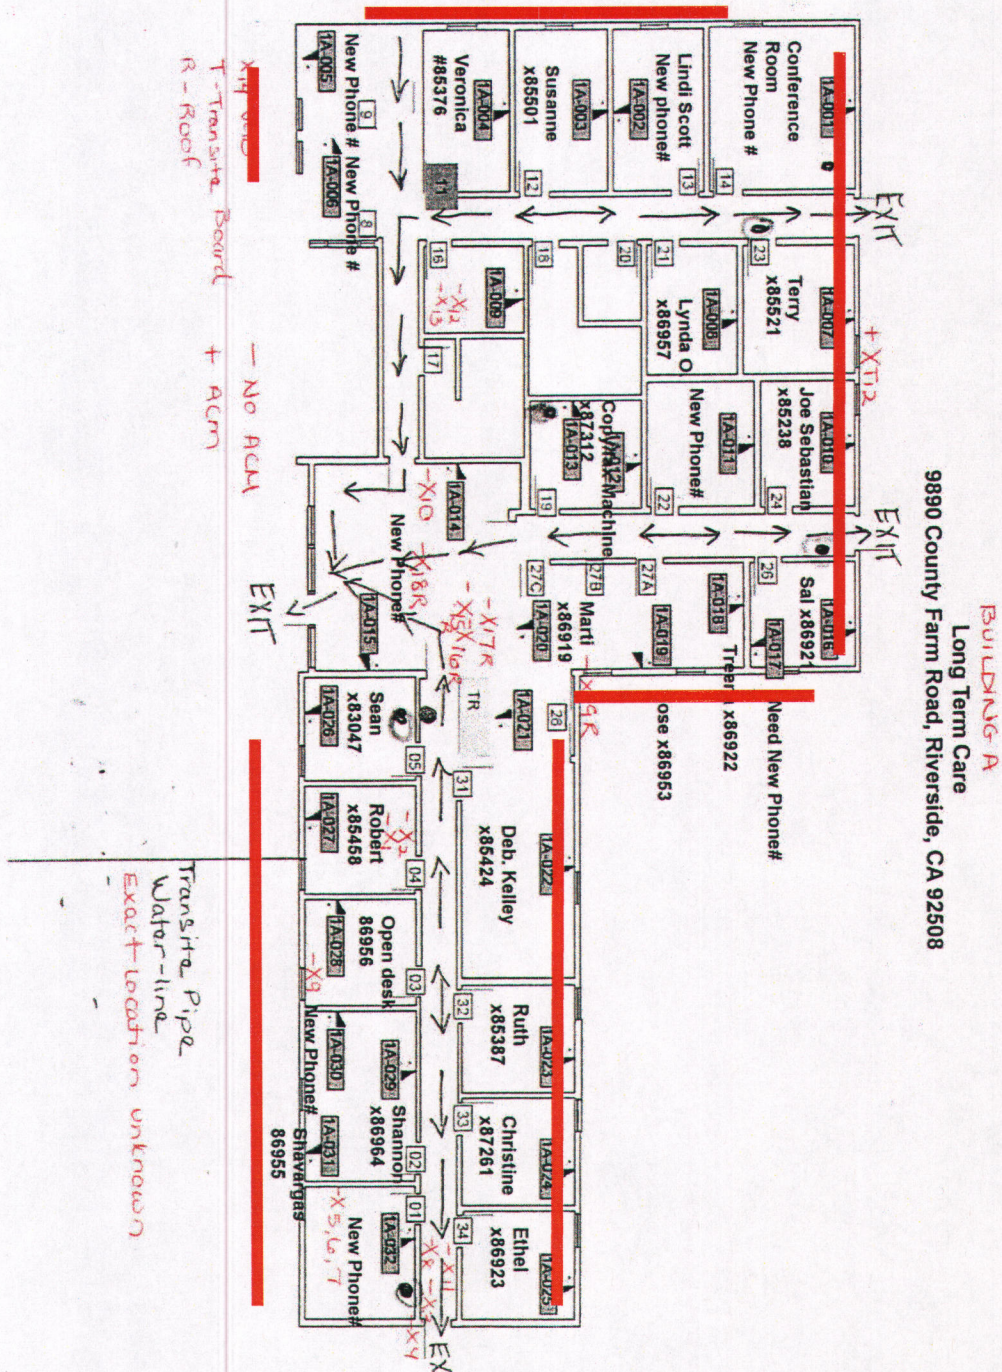
Illustrated are the location, type and square footage of the ACBM locations for future abatement on Building A

- Remove approximately 72 sq. ft. of ACM transite panels below windows,
- Remove approximately 500 sq. ft. of buried ACM transite pipes.

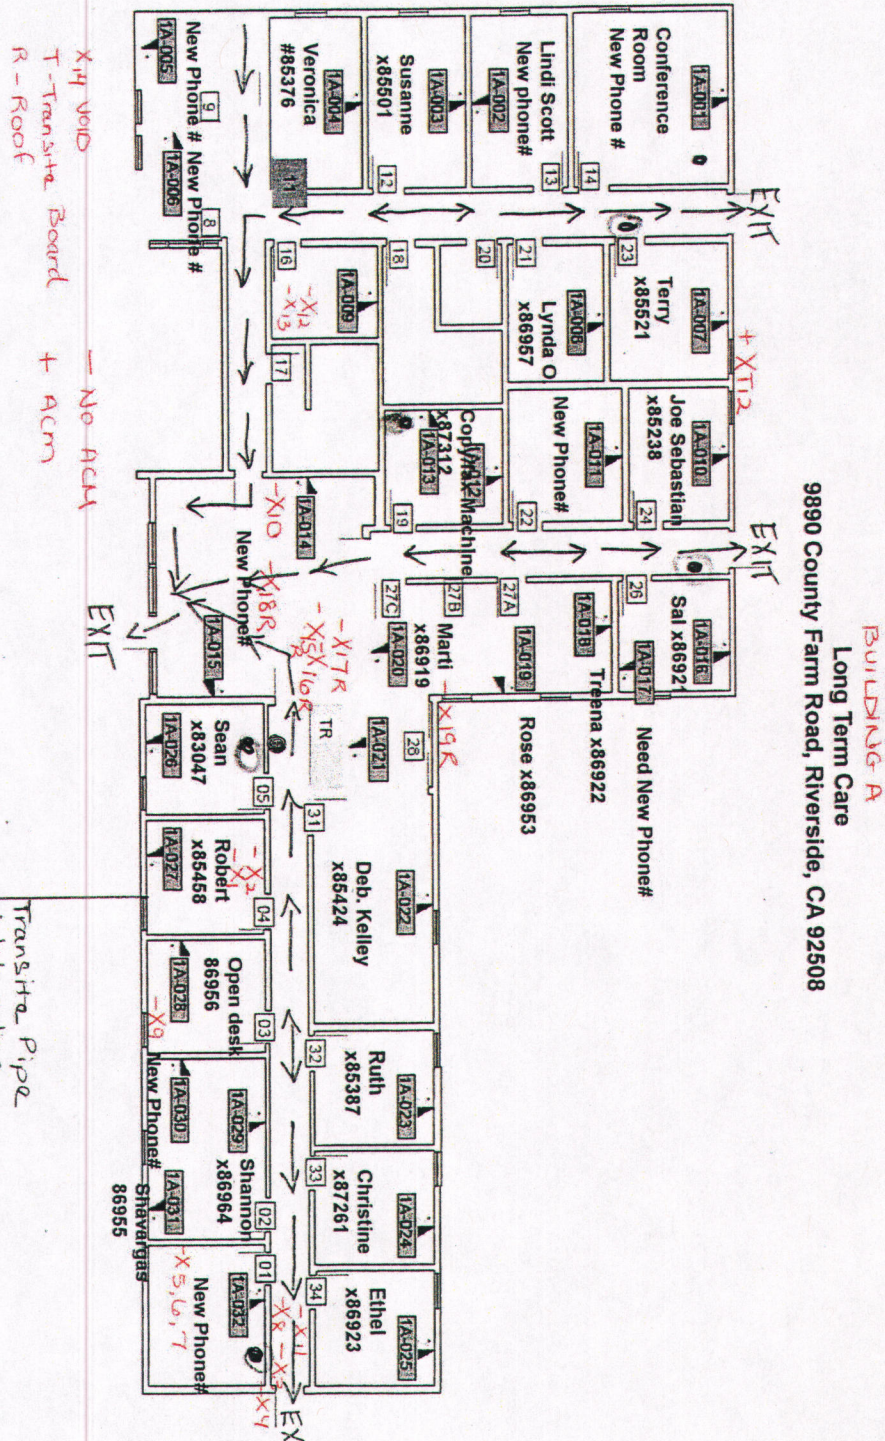
Diagram 1.1 - Asbestos Sampling Points, Building A

An "X" illustrates the locations of samples taken, R indicates a roof sample, + indicates positive ACM sample and - indicates a negative ACM sample

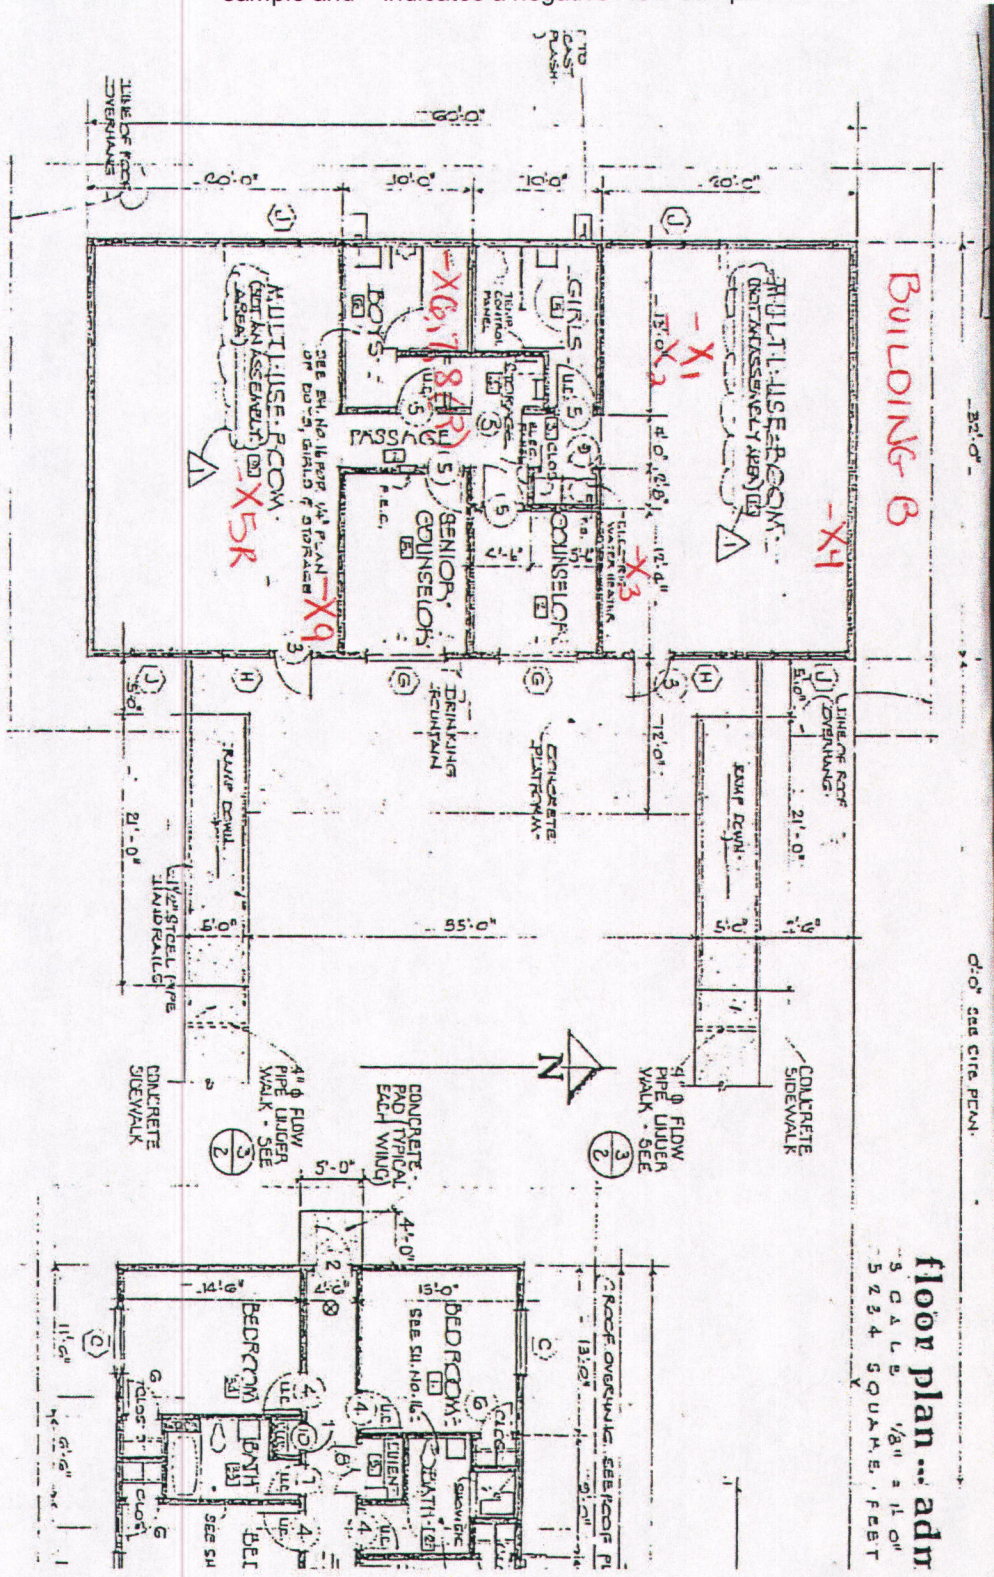
Diagram 1.2 - Asbestos Sampling Points, Building B

An "X" illustrates the locations of samples taken, R indicates a roof sample, + indicates positive ACM sample and - indicates a negative ACM sample

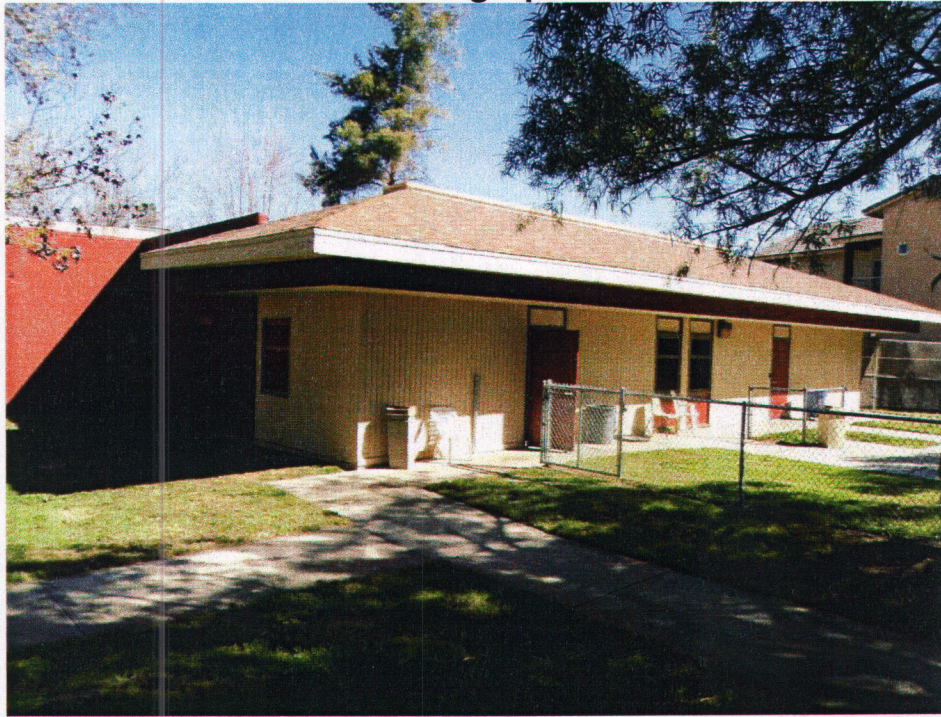
Photograph 1- Illustrates ACM transite panels below windows in Building A.

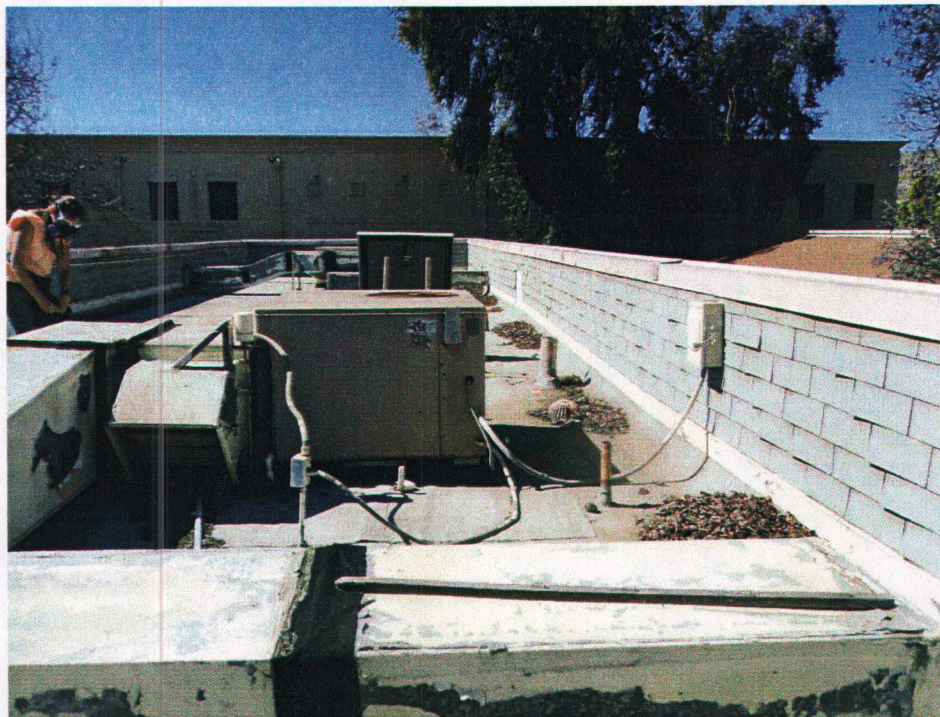
Photograph 2 - Illustrates the roof and roof penetrations on building C.
