JURISDICTIONAL DELINEATION REPORT

CLINTON KEITH ROAD EXTENSION PROJECT

RIVERSIDE COUNTY, CALIFORNIA

March 2014

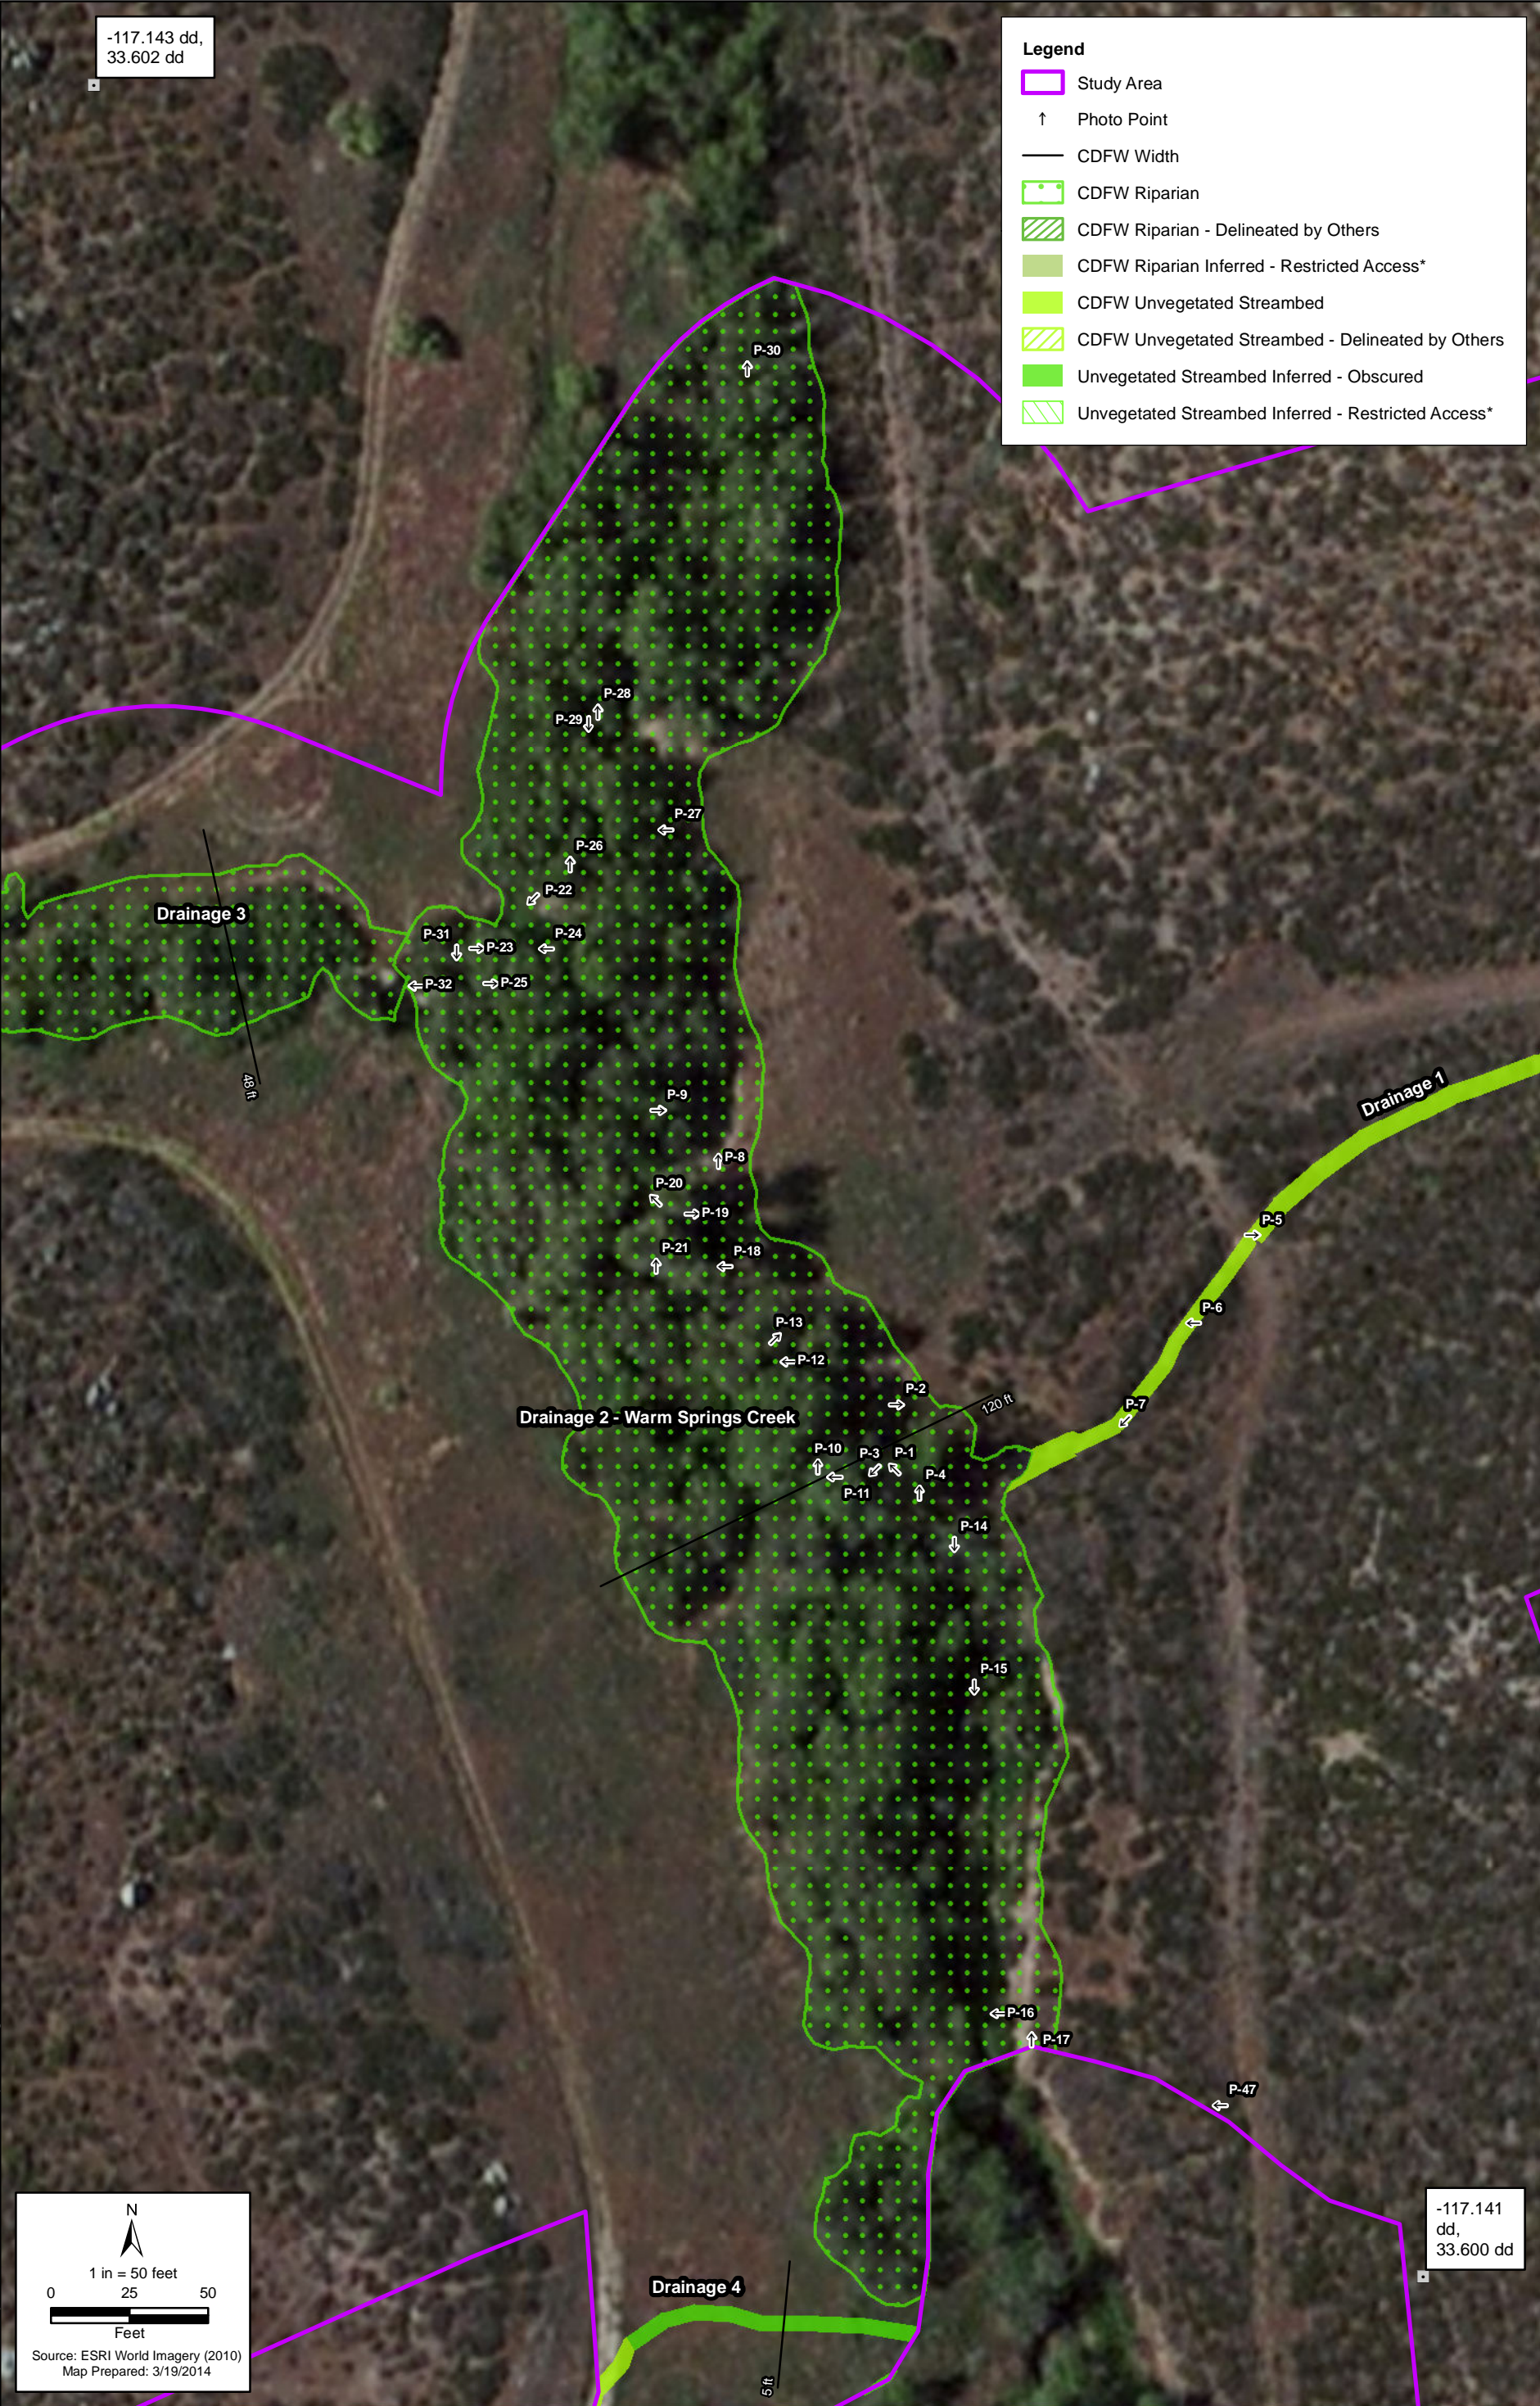
Figure 8b - Inset Sheet 1
CDFW Jurisdictional Delineation Results Map
Clinton Keith Road Extension Project

Drainage 3
48 ft

Drainage 2 - Warm Springs Creek
120 ft

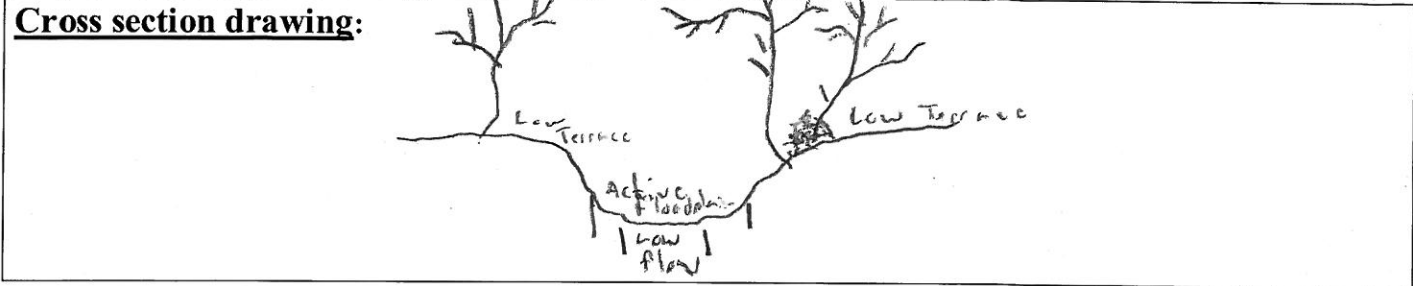
Project ID: Clinton Keith Road Ext. Cross section ID: OHWM-34 Date: 1/10/14 Time: 10:30

OHWM
