AQMD ASBESTOS, LIMITED LEAD PAINT & UNIVERSAL WASTE SURVEY

For Riverside County Economic Development Agency
Site: Mental Health Facility
Located at 9890 County Farm Road Riverside, CA
Reference # SR33056

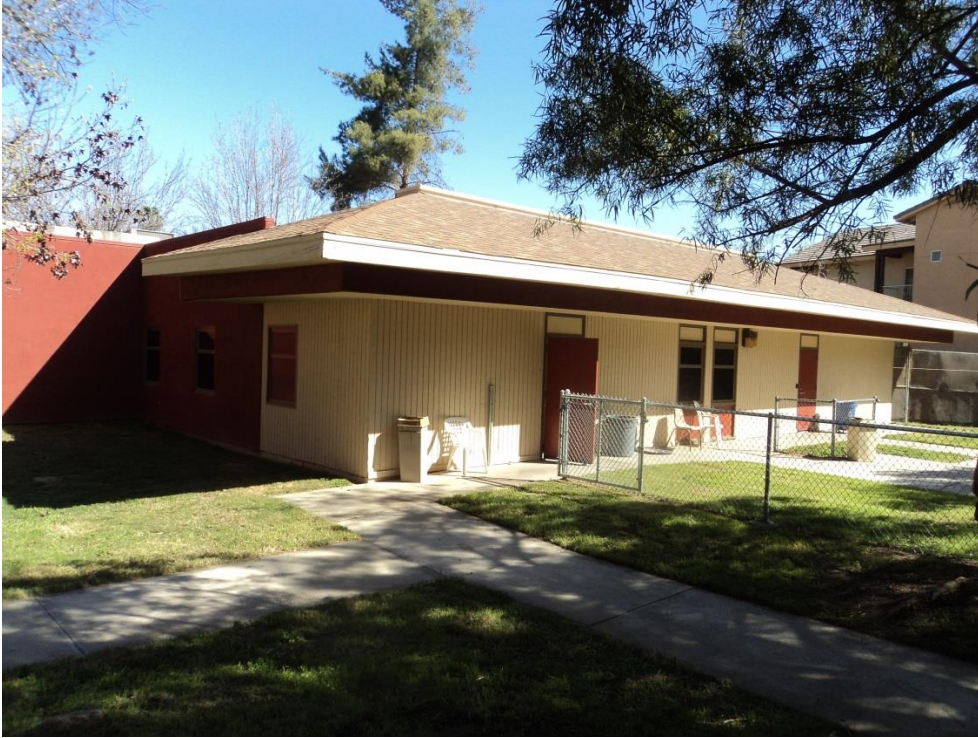
Photograph 1- Illustrates ACM transite panels below windows in Building A.

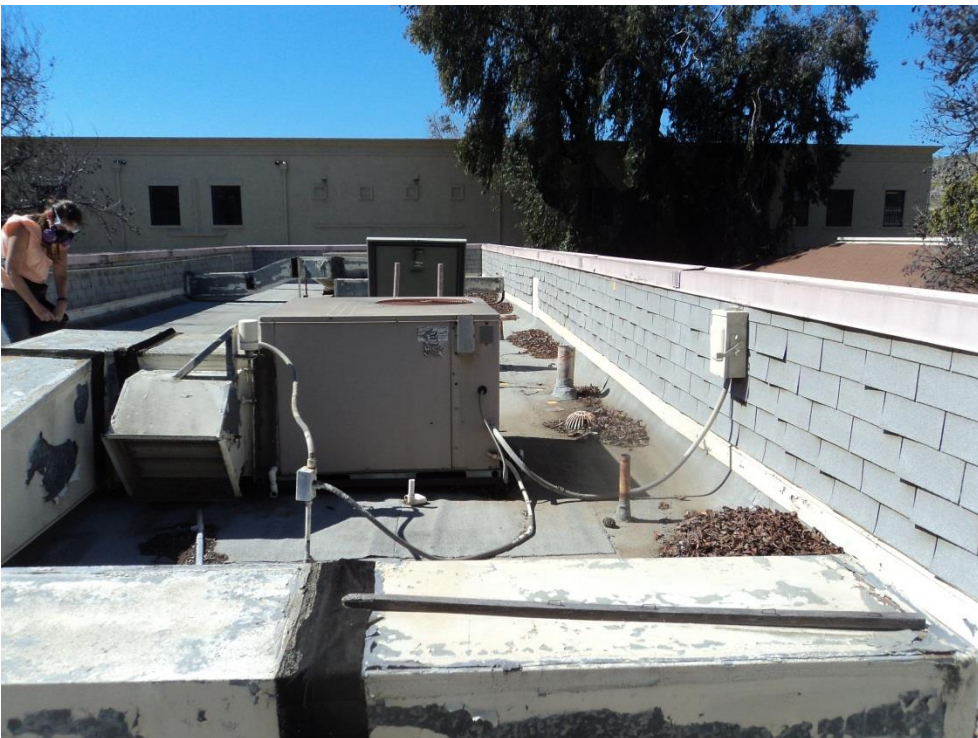
Photograph 2 - Illustrates the roof and roof penetrations on building C.
