NORTH NORCO CHANNEL STAGE 11 PROJECT NO. 2-0-00140-11

# Jurisdictional Waters Delineation Report for the North Norco Channel Stage 11 Project No. 2-0-00140-11, Riverside County, California

## *Photo Documentation*

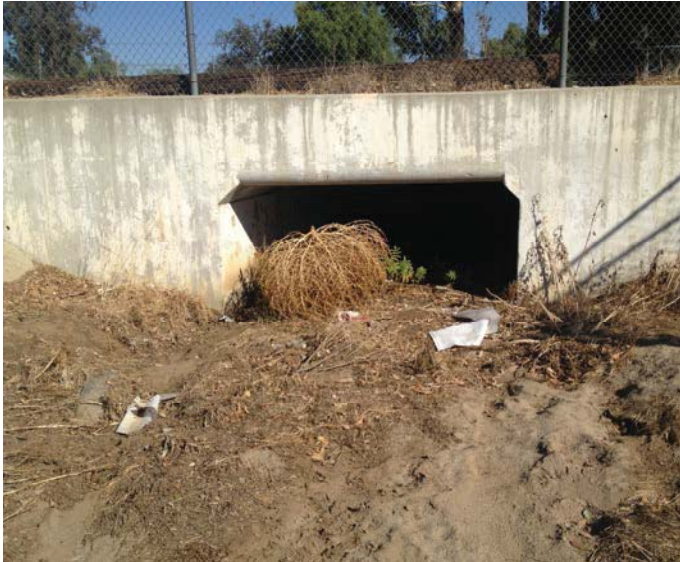
Location 1: Facing north, upstream towards Seventh Street. Bed 8ft. Bank 28ft.

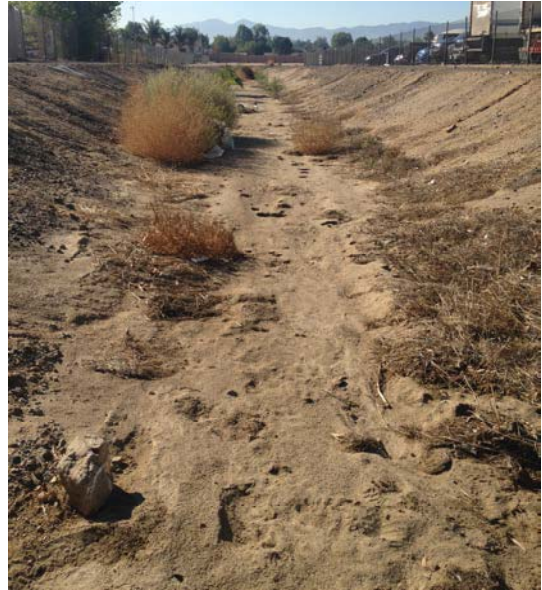
Location 1: Facing south, downstream. Bed 8ft. Bank 28ft.

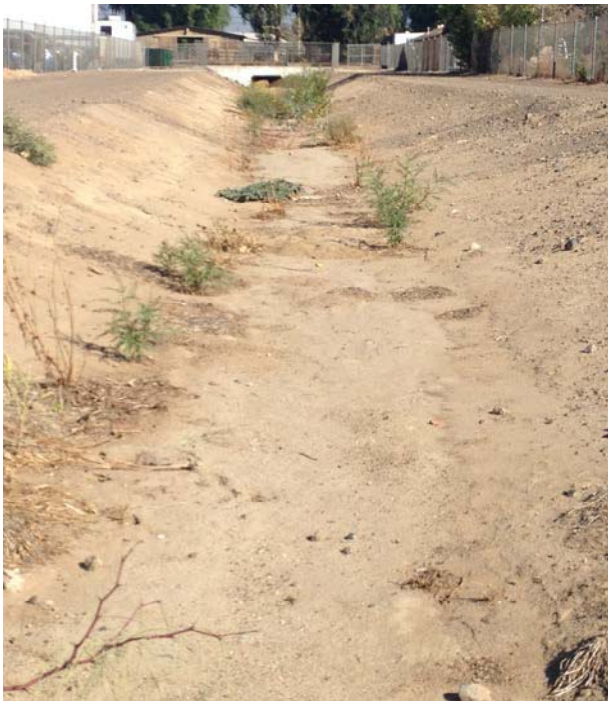
Location 2: Facing north, upstream towards Seventh Street. Bed 9ft. Bank 25ft.

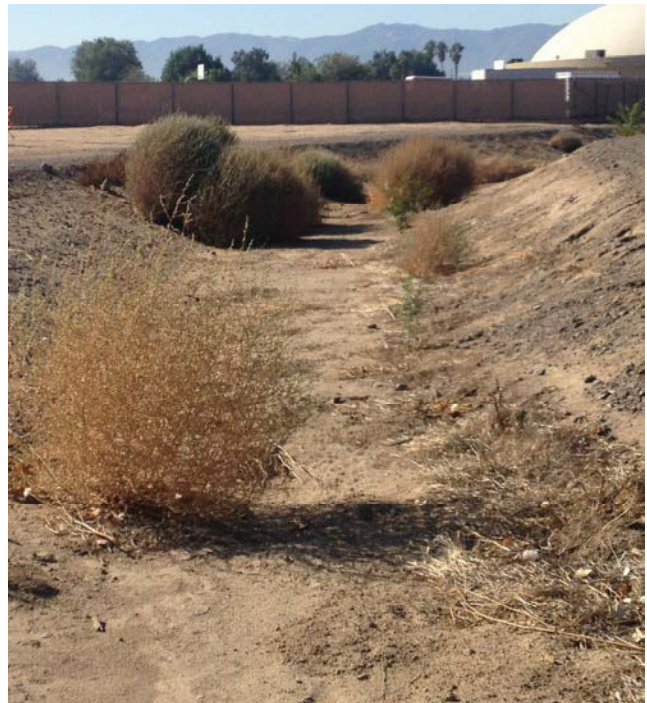
Location 2: Facing south, downstream. Bed 9ft. Bank 25ft.

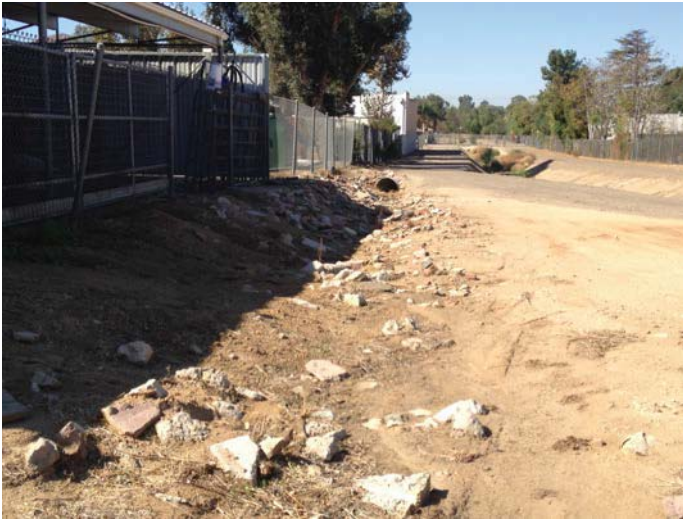
**Location 12: Swale facing west, downstream. Earthen ditch for nuisance flows. Broken bricks and concrete have been placed in the ditch.**

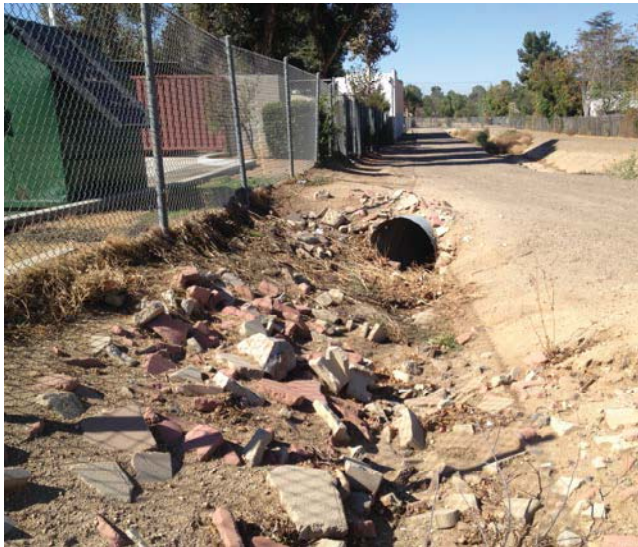
**Location 13: Swale, facing west. Earthen ditch created apparently to drain nuisance flow into the channel. RCP crosses under access road and outlets into channel.**

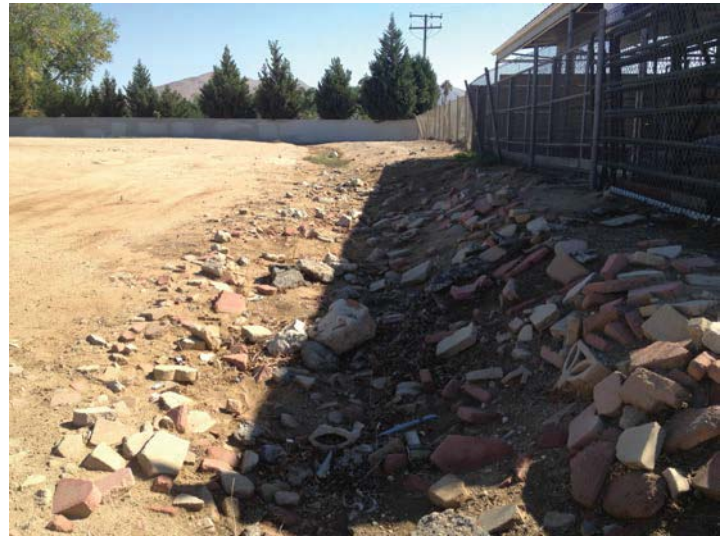
**Location 13: Swale, facing east. Earthen ditch created apparently to drain nuisance flow into the channel. Broken bricks and concrete have been placed in the channel presumably to reduce erosion.**

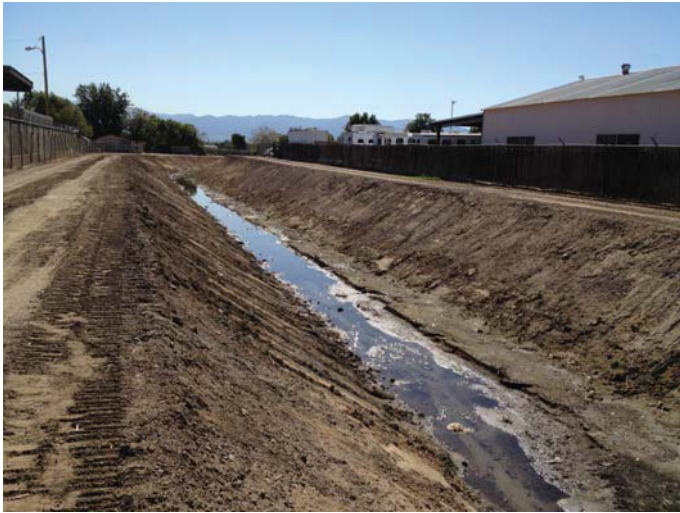
**Location 19: Flowing Water – facing south, downstream. Standing water is from inlet conveying nuisance flows into the channel.**

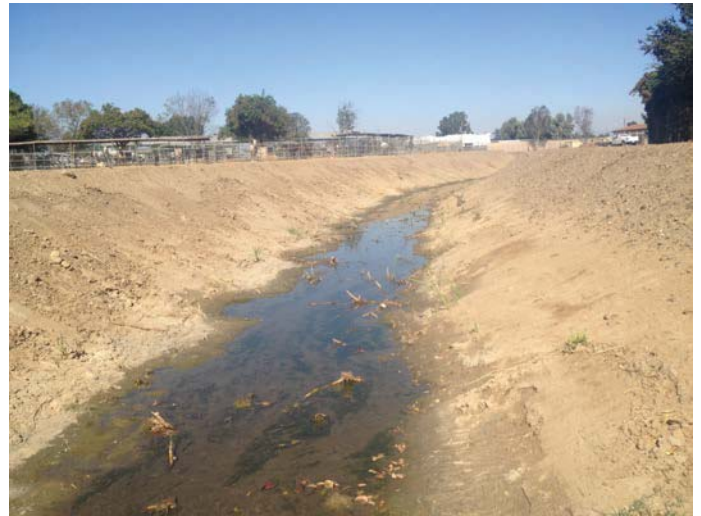
**Location 20: Facing northeast, upstream. Bed 9ft. Bank 26ft. Standing water is from nuisance flows.**

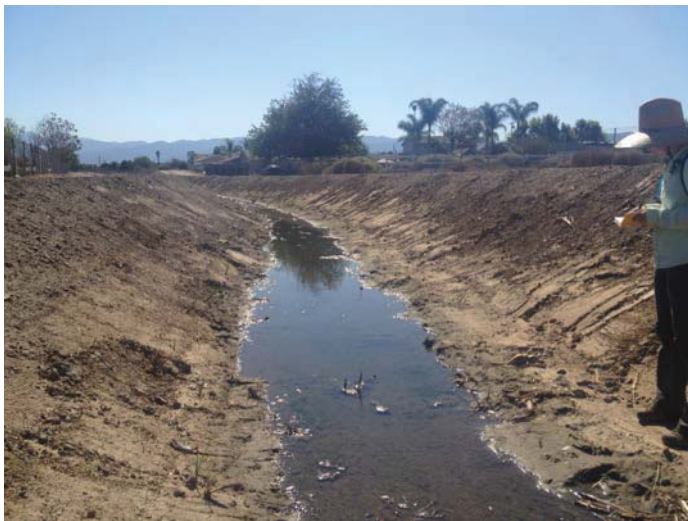
**Location 20: Facing southwest, downstream. Bed 9ft. Bank 26ft. Evidence of recent maintenance activities (scrape marks along channel slopes)**

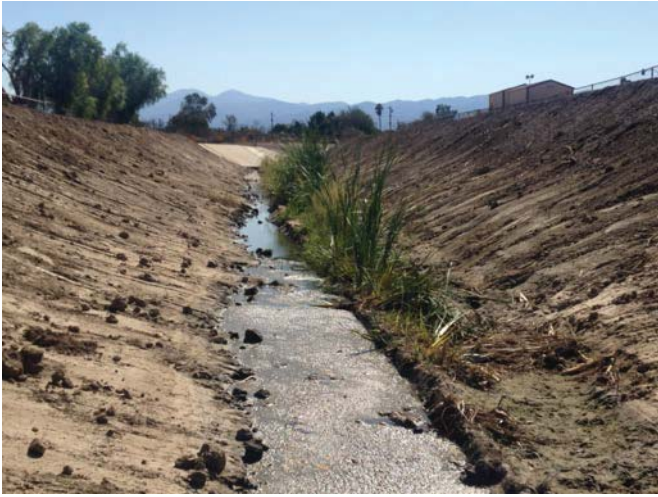
**Location 21: Facing south, downstream. Bed 13ft. Bank 37ft. Wetland vegetation along toe of slope.**

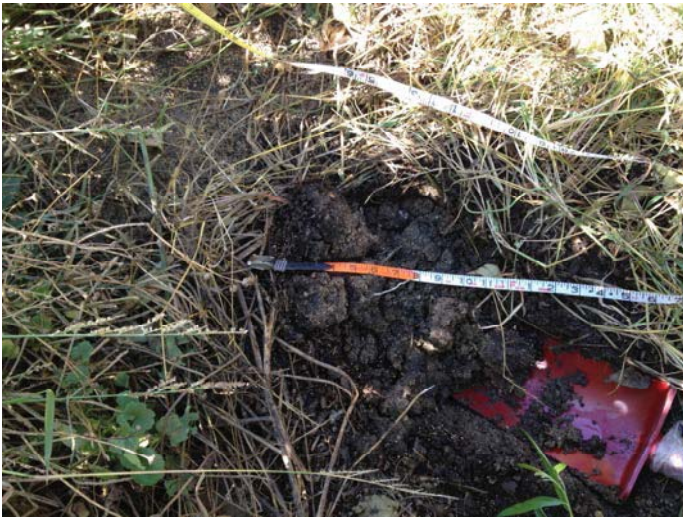
**Sample Point 1: Soil pit soil.**

Depth (inches)	Matrix		Redox Features				Texture <sup>3</sup>	Remarks
	Color (moist)	%	Color (moist)	%	Type <sup>1</sup>	Loc <sup>2</sup>		
0-1	7.5 YR 3/2	100	-	-			sand	
1-12	10 YR 4/3	100	-	-			sand
