**SUBMITTAL TO THE BOARD OF SUPERVISORS  
 COUNTY OF RIVERSIDE, STATE OF CALIFORNIA**

**SUBJECT:** Agreement by and between the County of Riverside, Valley Wide Recreation and Park District, and Hemet Unified School District for the construction of a Multi-Purpose Community Park Site in the Community of Valle Vista; CEQA Exempt; District 3 [\$380,000; 3<sup>rd</sup> District Development Agreement Public Facilities Fund - \$130,000 and Gas Tax - \$250,000].

**PRELIMINARY GEOTECHNICAL INVESTIGATION  
VALLE VISTA JOINT USE PROJECT**

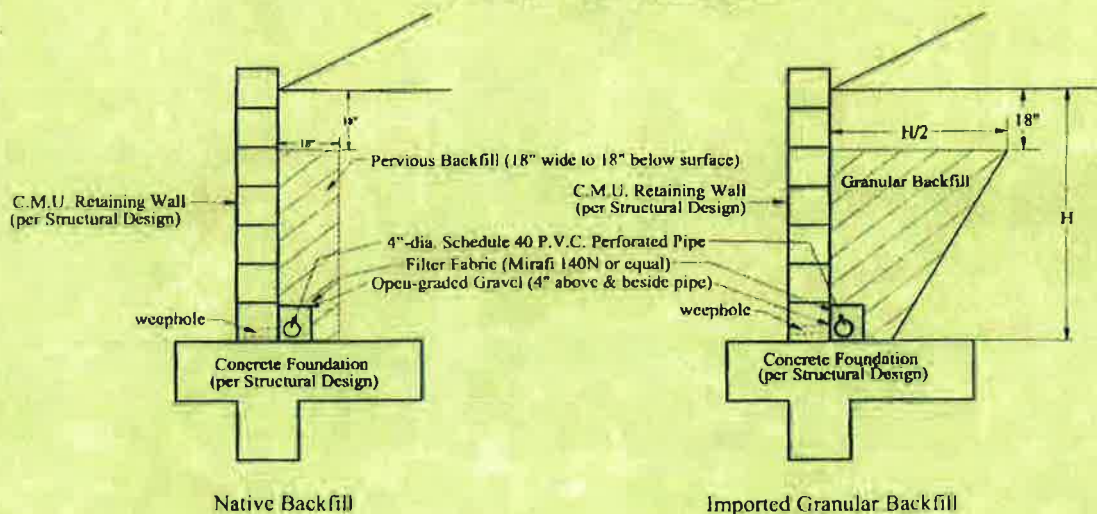
RETAINING WALL - TYPICAL PROFILE

Any applicable construction and seismic surcharges should be added to the above pressures. At least 12 inches of granular material should be used in the backfill behind the walls and water pressure should not be permitted to build up behind retaining walls. The upper 12 to 18 inches of the backfill should consist of impervious soil. A subdrain should be constructed along the base of the backfill.

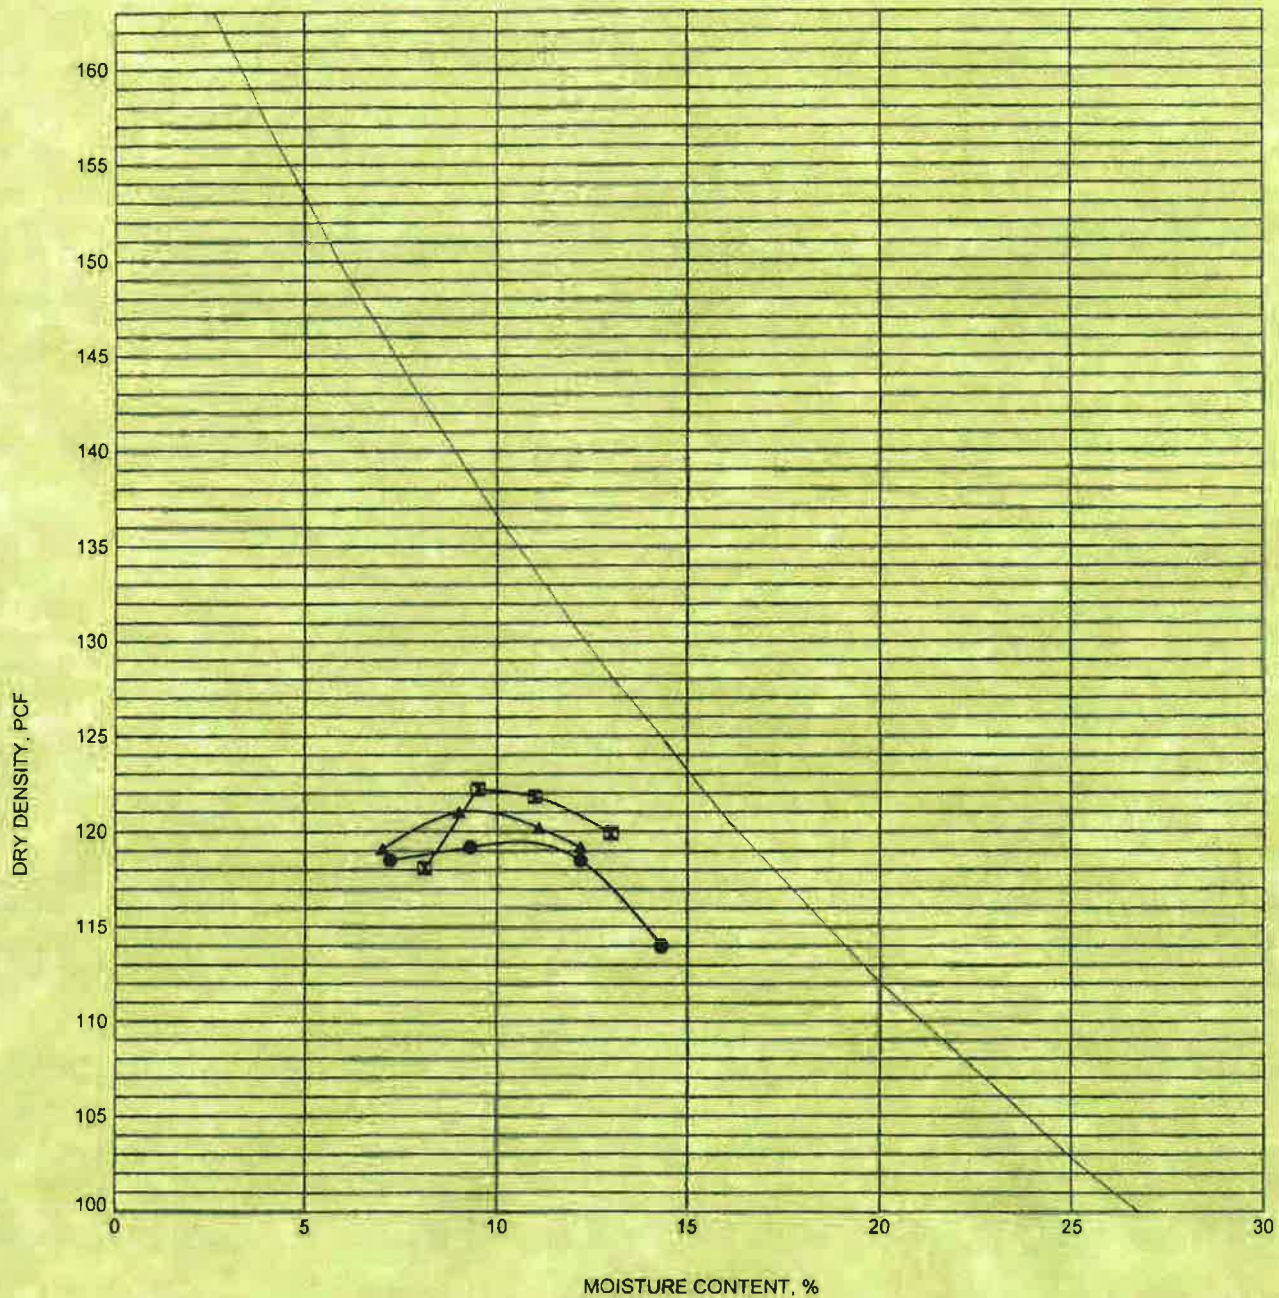
FIGURE NO. B-3

Specimen Identification	Classification	Max. Density	MC%
● B-01 0.0	SILTY SAND - CLEAN SAND SP-SM	121.0	11.5
☒ B-02 0.0	WELL-GRADED SAND with SILT SW-SM	123.0	10.0
▲ B-04 0.0	SILTY SAND SM	122.0	10.0

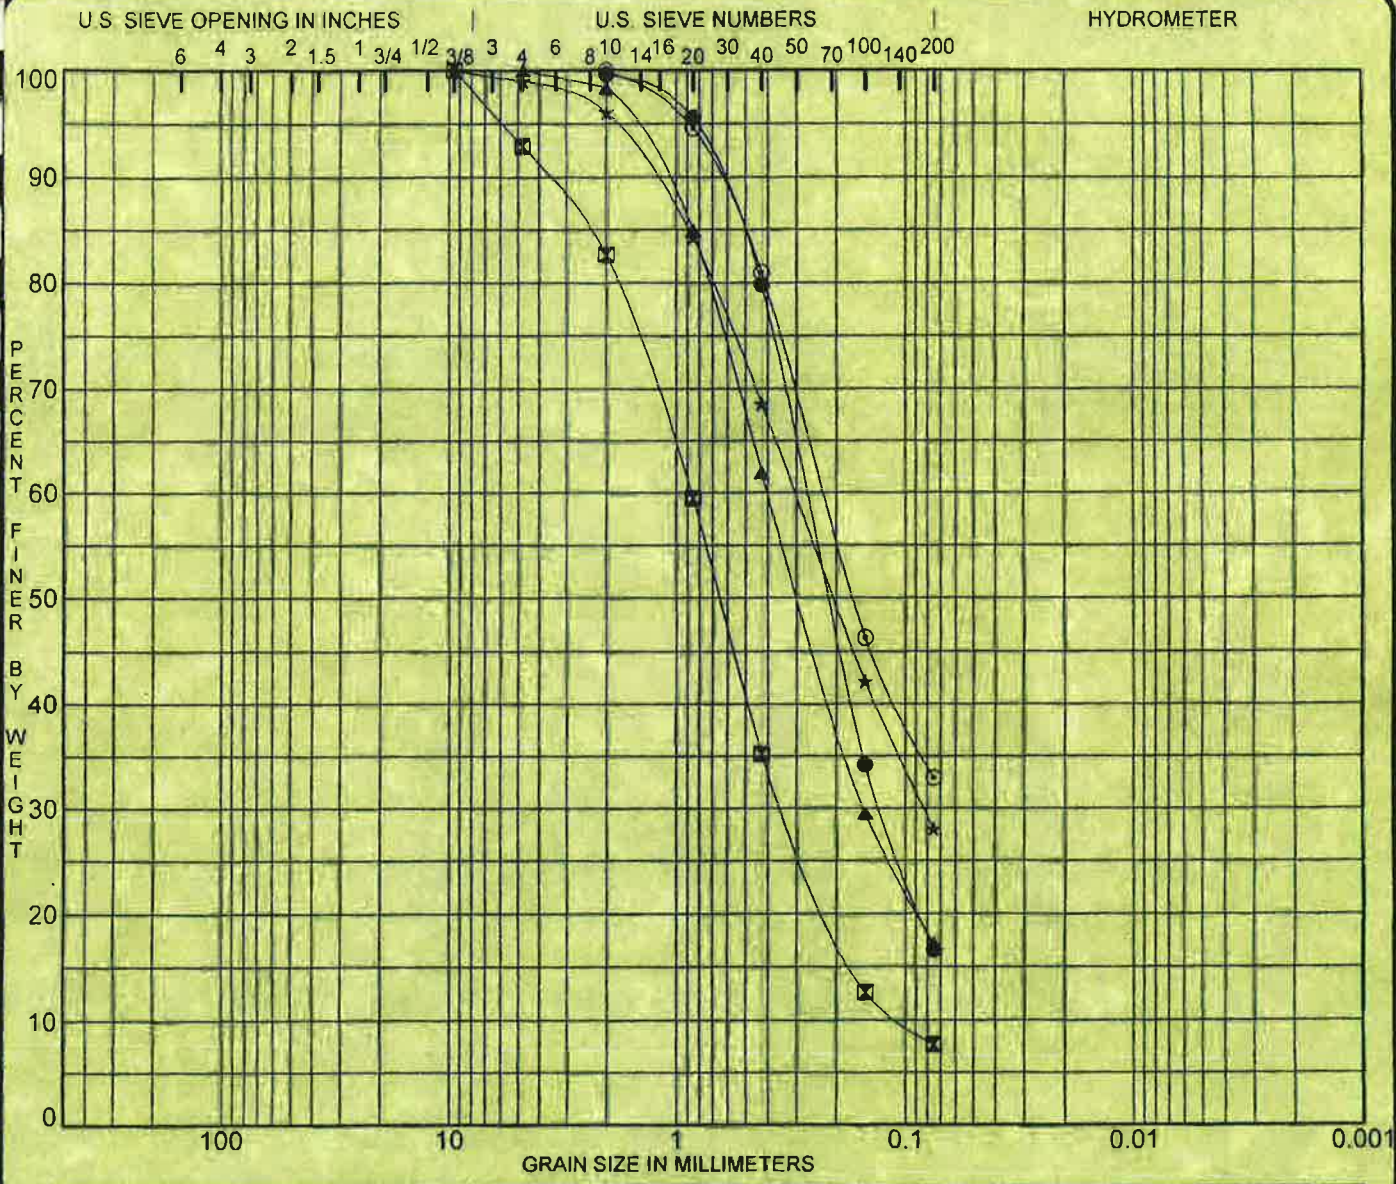
FIGURE NO. B-4

Specimen Identification	Classification	S.G.	LL	PL	PI	Cc	Cu
● B-01 0.0	SILTY SAND SM		NP	NP	NP		
⊗ B-02 0.0	WELL-GRADED SAND with SILT SW-SM		NP	NP	NP	1.24	8.3
▲ B-04 0.0	SILTY SAND SM		NP	NP	NP		
★ B-04 11.0	SILTY SAND SM		NP	NP	NP		
⊙ B-04 20.5	SILTY SAND SM		NP	NP	NP

**GRADATION CURVES**  
 Inland Foundation Engineering, Inc.  
 San Jacinto, California 92583

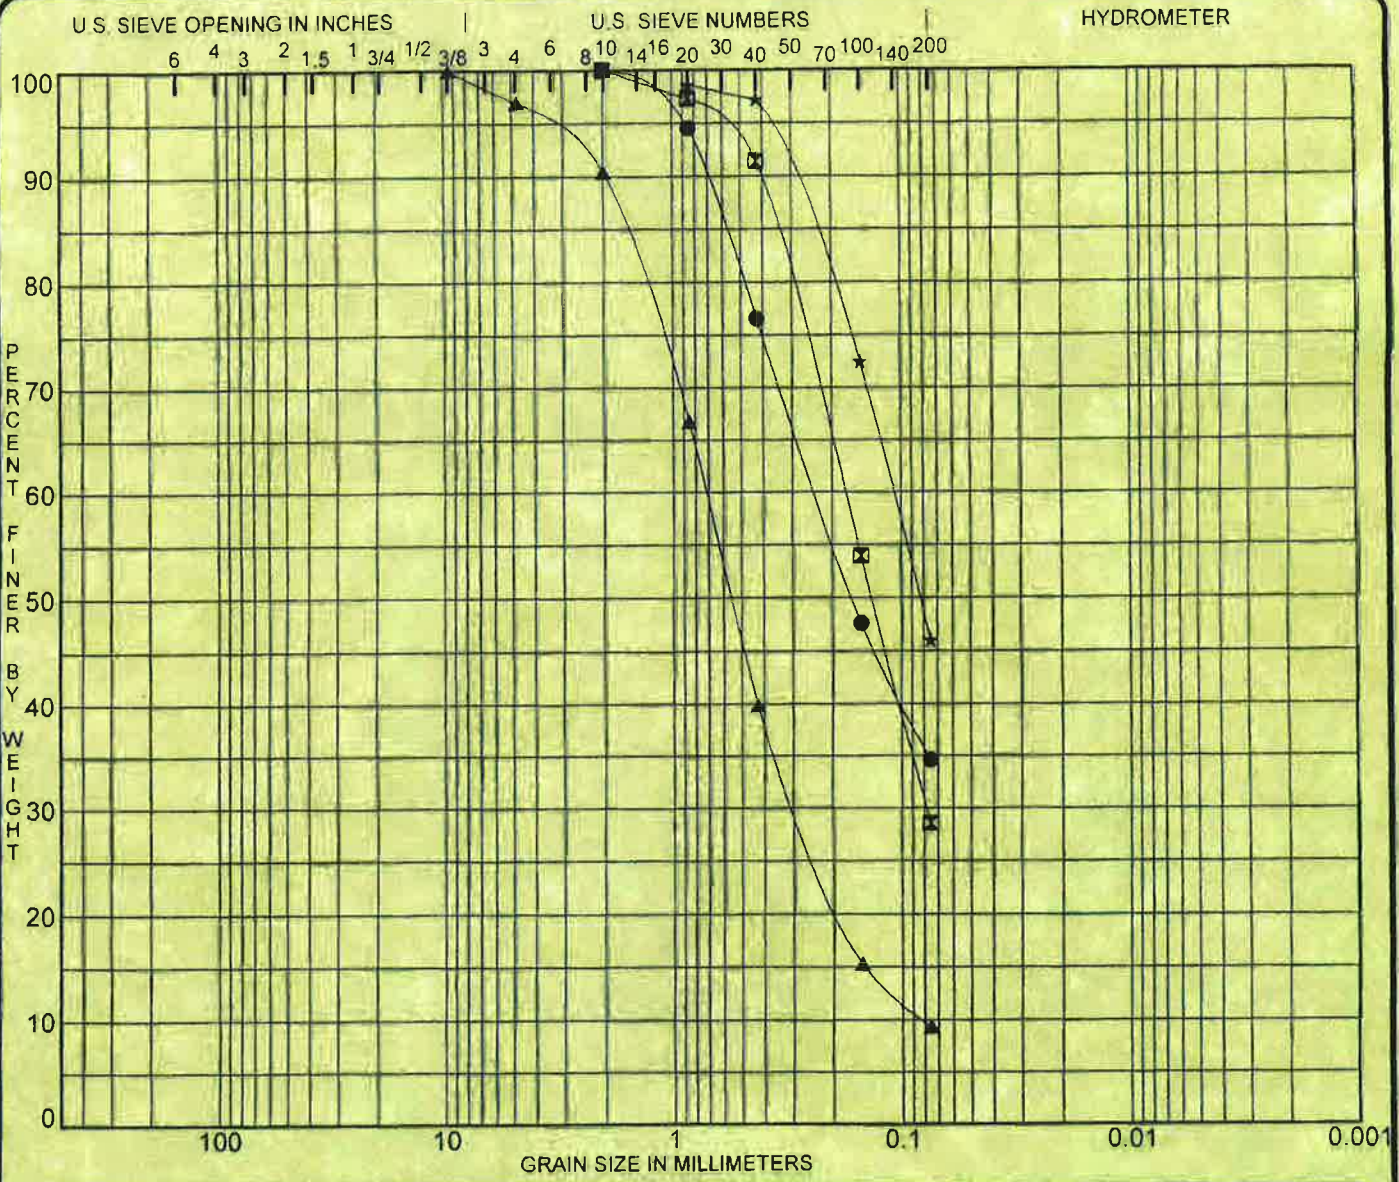
FIGURE NO. B-5

Specimen Identification	Classification		S.G.	LL	PL	PI	Cc	Cu
● B-04 25.5	SILTY SAND SM			NP	NP	NP		
⊠ B-04 30.5	SILTY SAND SM			NP	NP	NP		
▲ B-04 35.5	WELL-GRADED SAND with SILT SW-SM			NP	NP	NP	1.36	8.8
★ B-04 50.5	SILTY SAND SM			NP	NP	NP

**GRADATION CURVES**  
 Inland Foundation Engineering, Inc.  
 San Jacinto, California 92583

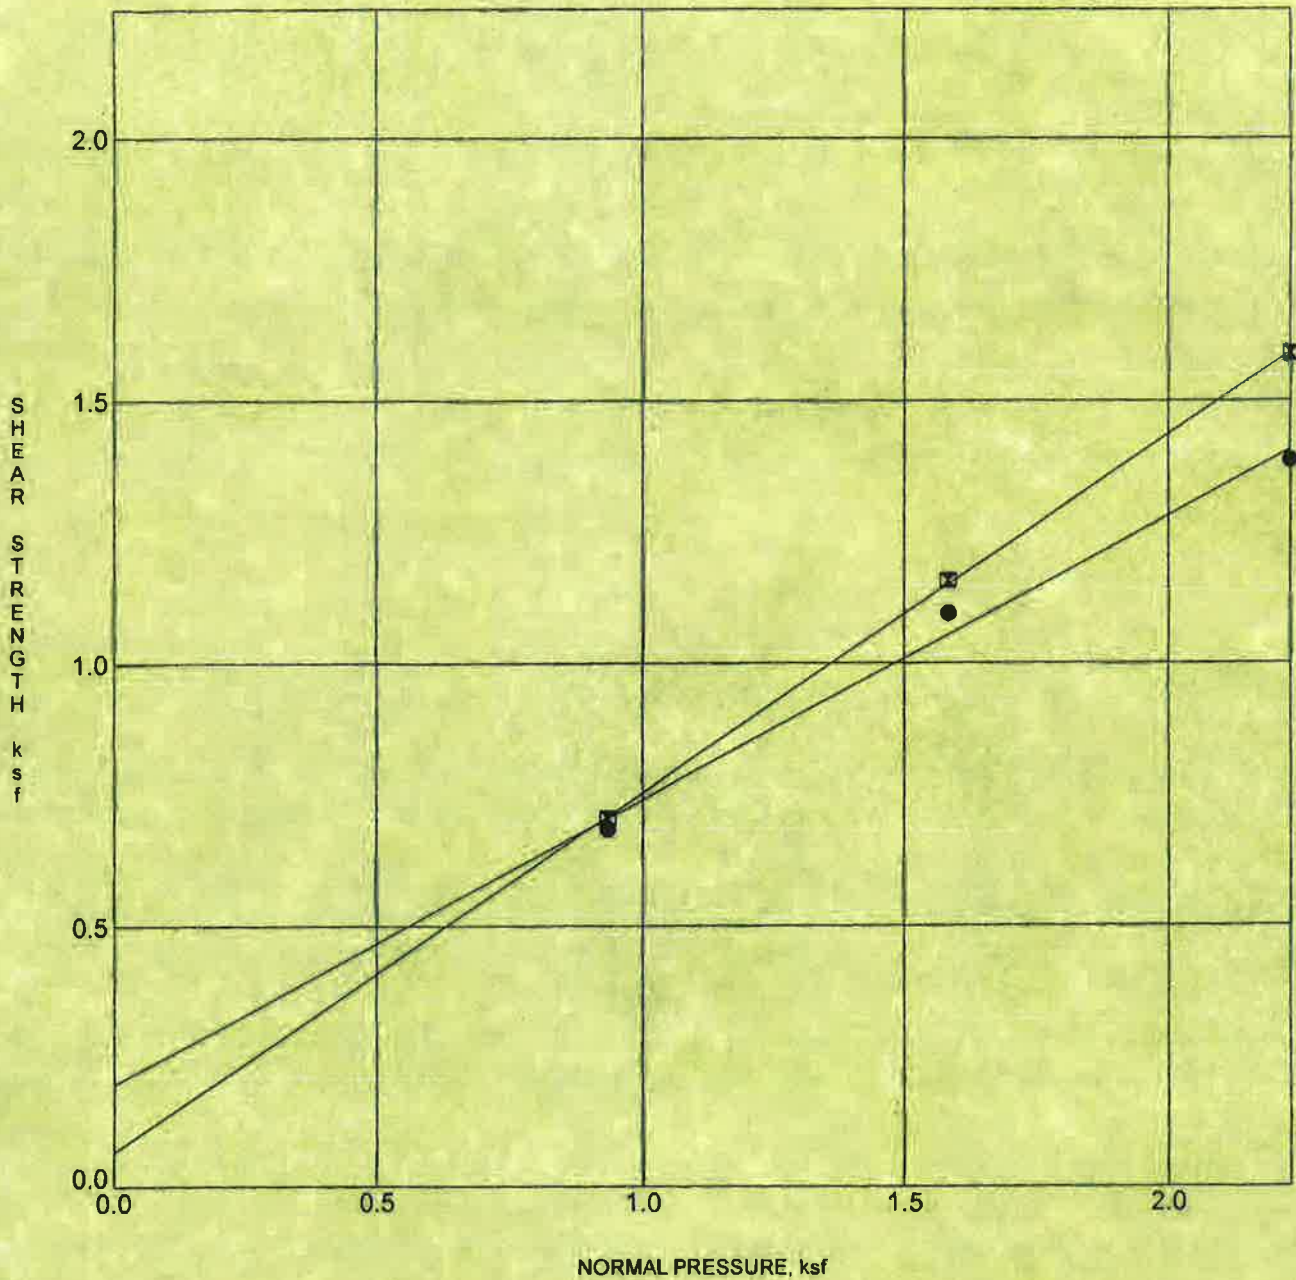
FIGURE NO. B-6

Specimen Identification	Classification	Phi	Cohesion	DD	MC%
● B-01 0.0	SILTY SAND SM	28	0.196	109	13
□ B-04 0.0	SILTY SAND SM	34	0.100	112	11

**SHEAR TEST DIAGRAM**  
 Inland Foundation Engineering, Inc.  
 San Jacinto, California 92583

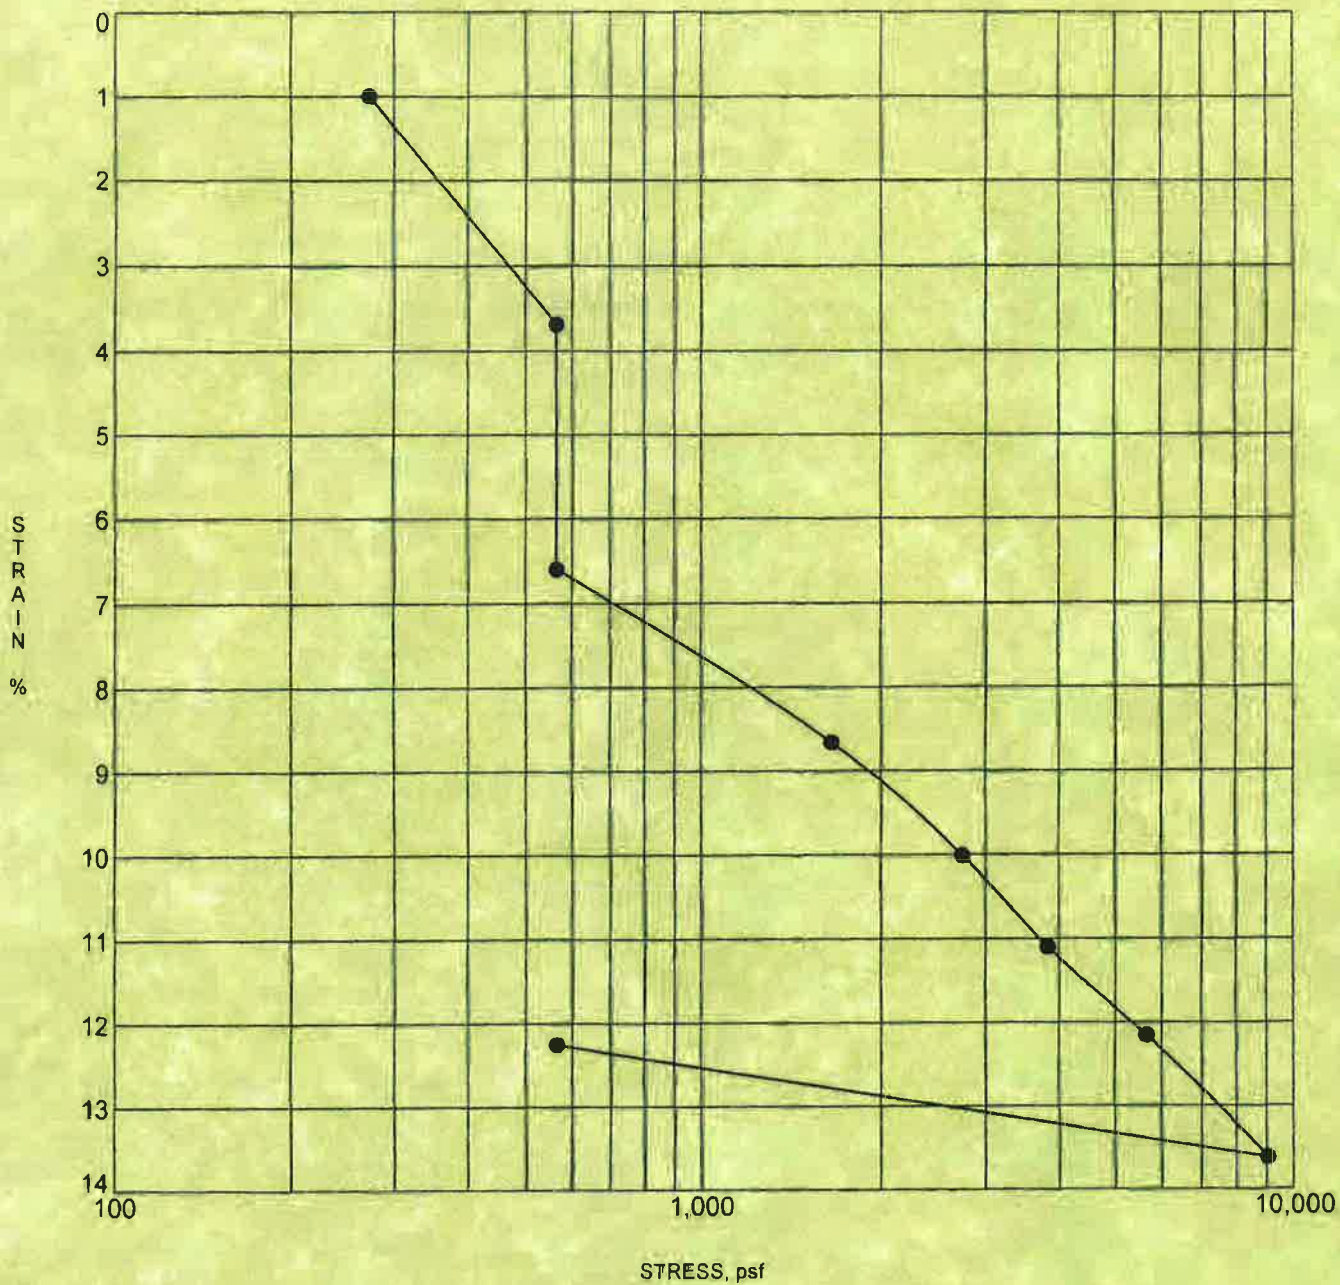
FIGURE NO. B-7

Specimen Identification	Classification	DD	MC%
● B-01      5.5	SILTY SAND SM	89	16

**CONSOLIDATION TEST**  
 Inland Foundation Engineering, Inc.  
 San Jacinto, California 92583

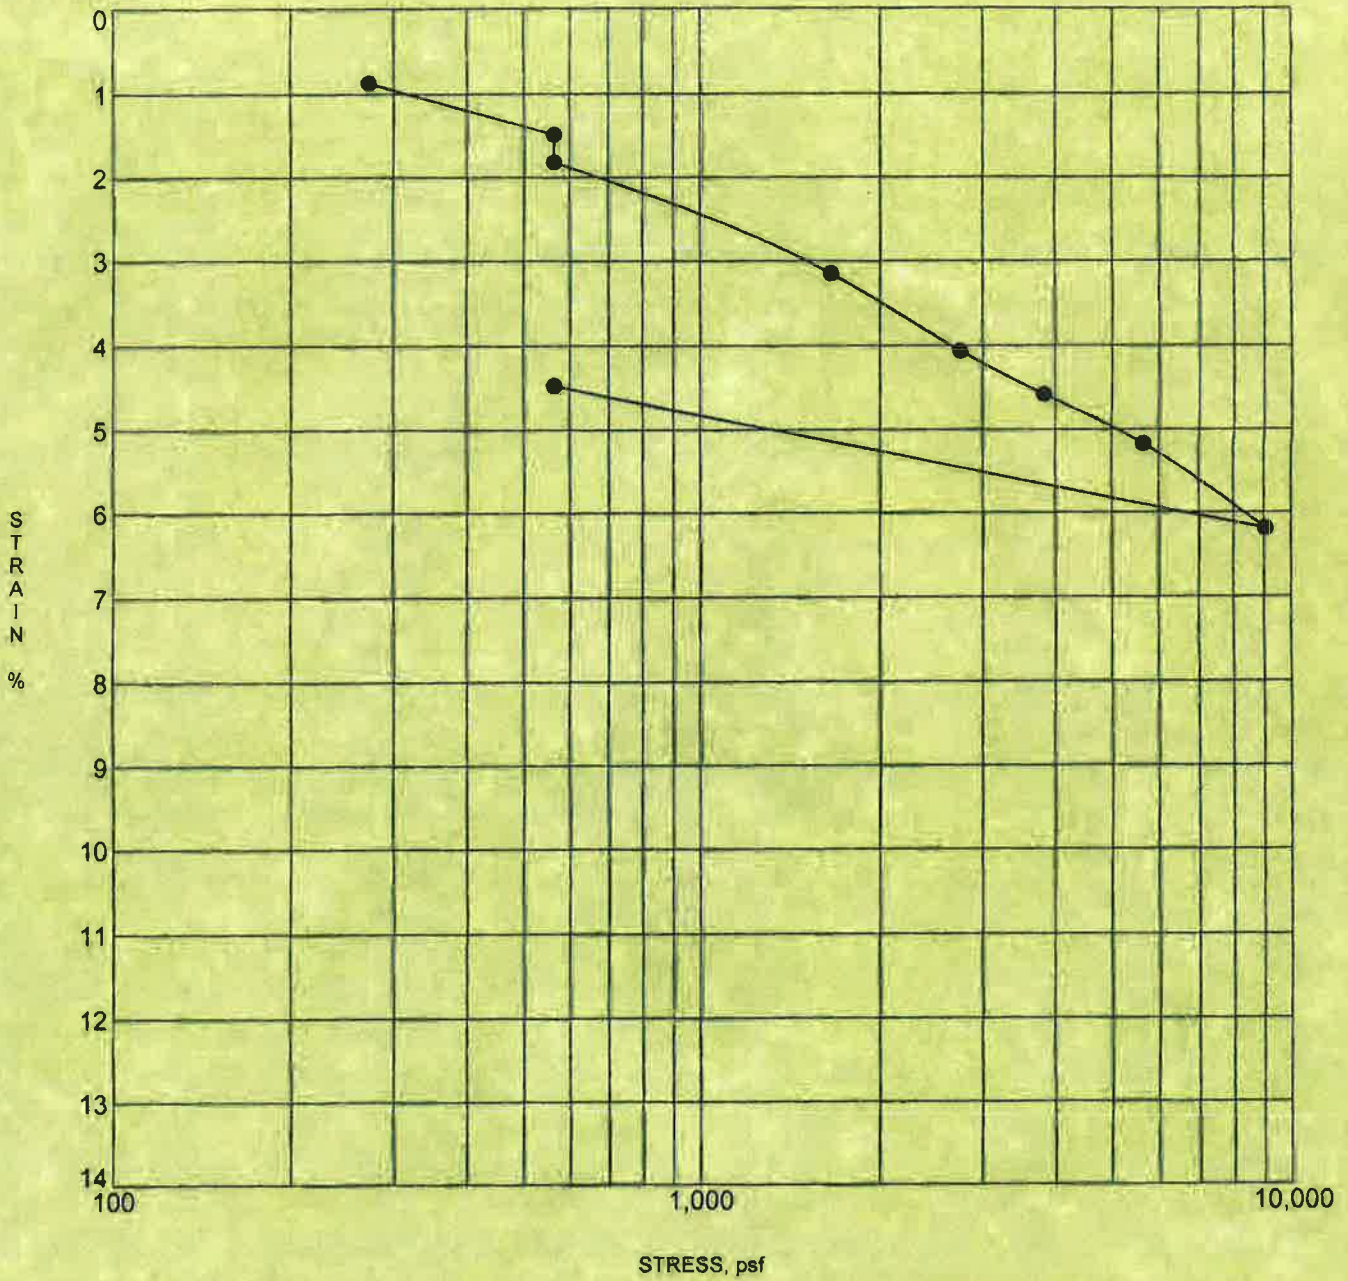
FIGURE NO. B-8

Specimen Identification	Classification	DD	MC%
● B-01      11.5	SILTY SAND SM	103	4

**CONSOLIDATION TEST**  
 Inland Foundation Engineering, Inc.  
 San Jacinto, California 92583

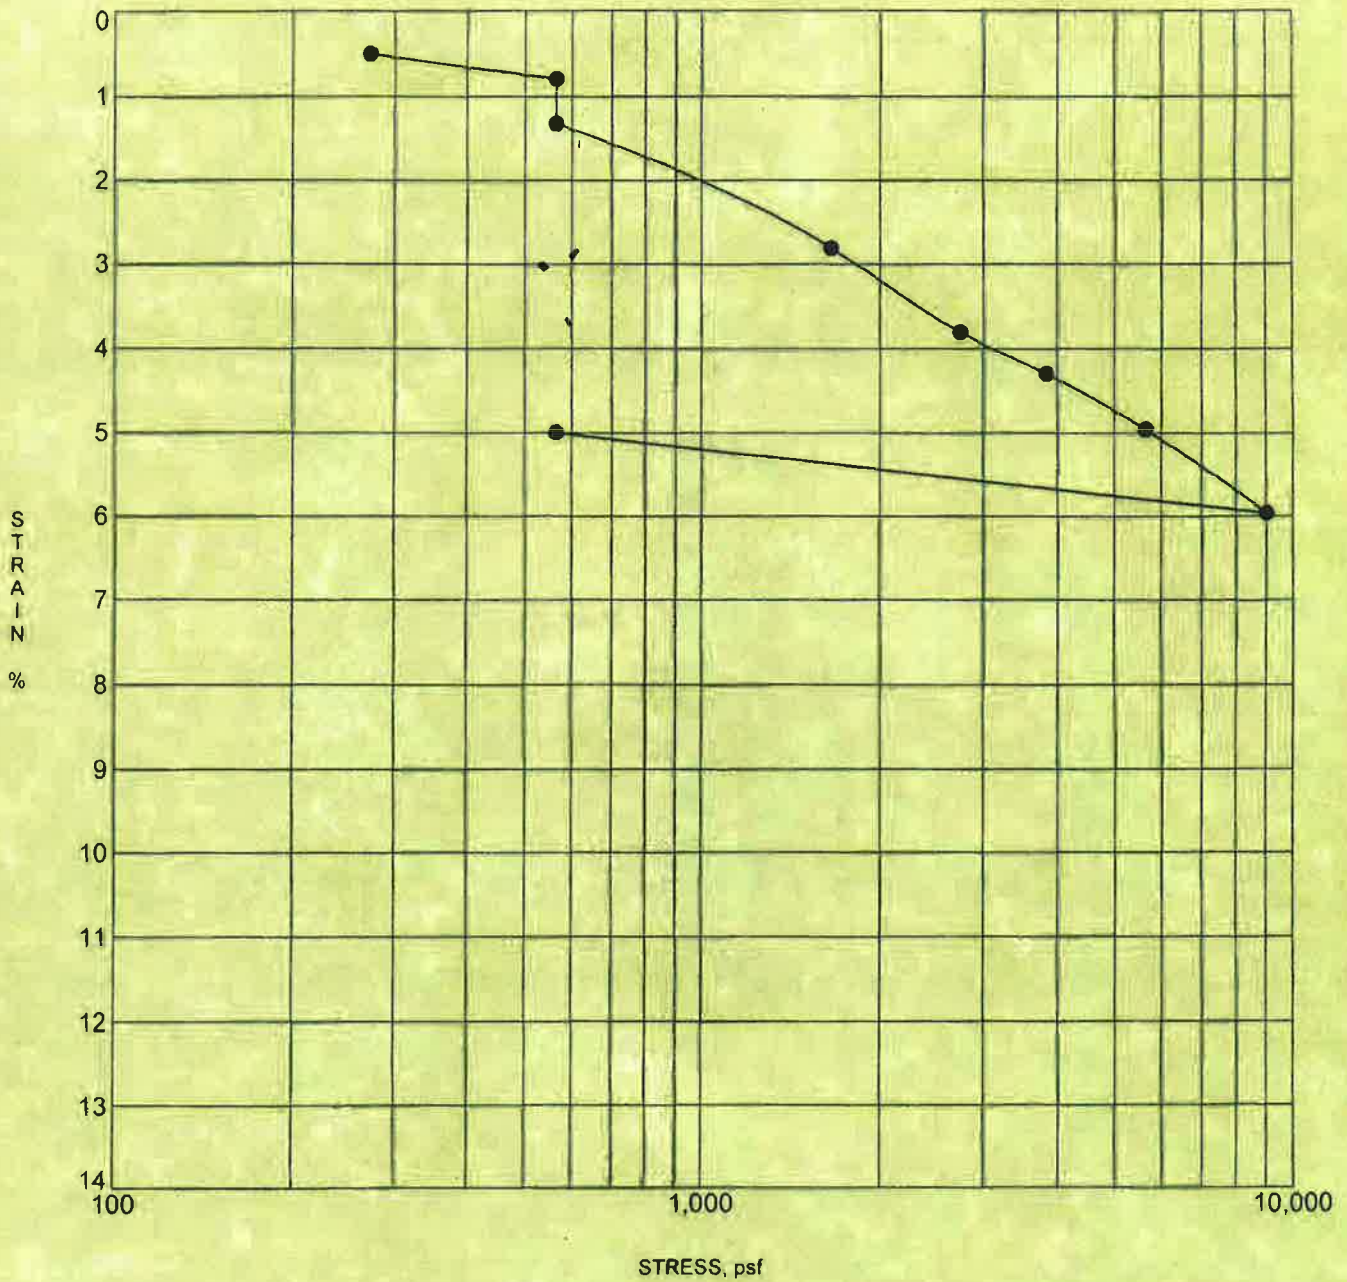
Specimen Identification		Classification	DD	MC%
●	B-02      6.5	POORLY GRADED SAND SP	105	5
