## VALLEY FEVER Blythe II Solar Project Potential Risks

**GLARE ANALYSIS**  
**FOR**  
**BLYTHE II PV SOLAR PROJECT**  
**LOCATED AT THE**  
**BLYTHE AIRPORT IN BLYTHE, CALIFORNIA**

The Blythe II Solar Project is a proposed 20 MW photovoltaic (PV) solar project proposed to be located on approximately 156 acres of land at the Blythe Airport (BLH) near Blythe, California. **Figure 1** shows the location of the proposed solar project in relation to the airport and runways.

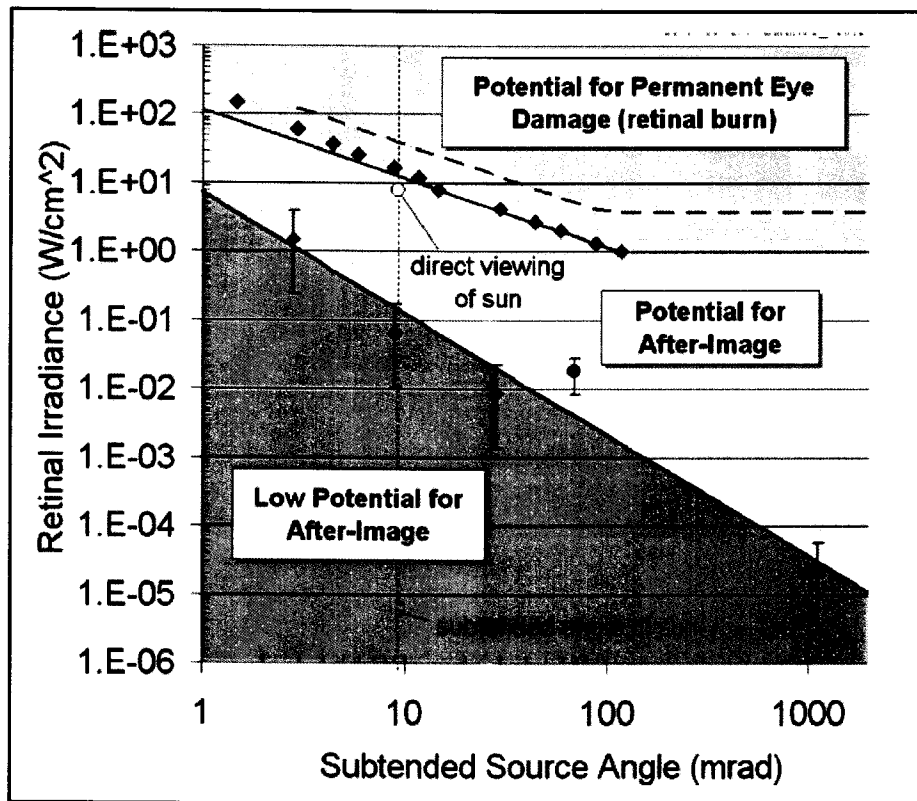
Figure 2  
OCULAR HAZARD PLOT

FAA adopted the *Solar Glare Hazard Analysis Plot* shown in **Figure 2** below as the standard for measuring the ocular impact of any proposed solar energy system on an airport under FAA jurisdiction. To obtain FAA approval, the airport sponsor and proponent are required to demonstrate that the proposed solar energy system meets the following standards:

To conduct the analysis to determine the potential for ocular impact, in cooperation with the DOE, the FAA is requiring the use of the *Solar Glare Hazard Analysis Tool* (SGHAT) developed by Sandia National Laboratories. If glare is found, the tool calculates the retinal irradiance and subtended source angle (size/distance) of the glare source to predict potential ocular hazards ranging from temporary afterimage to retinal burn. The results are presented in a simple, easy-to-interpret plot that specifies when glare will occur throughout the year, with color codes that are consistent with the hazard plot indicating the potential ocular hazard.

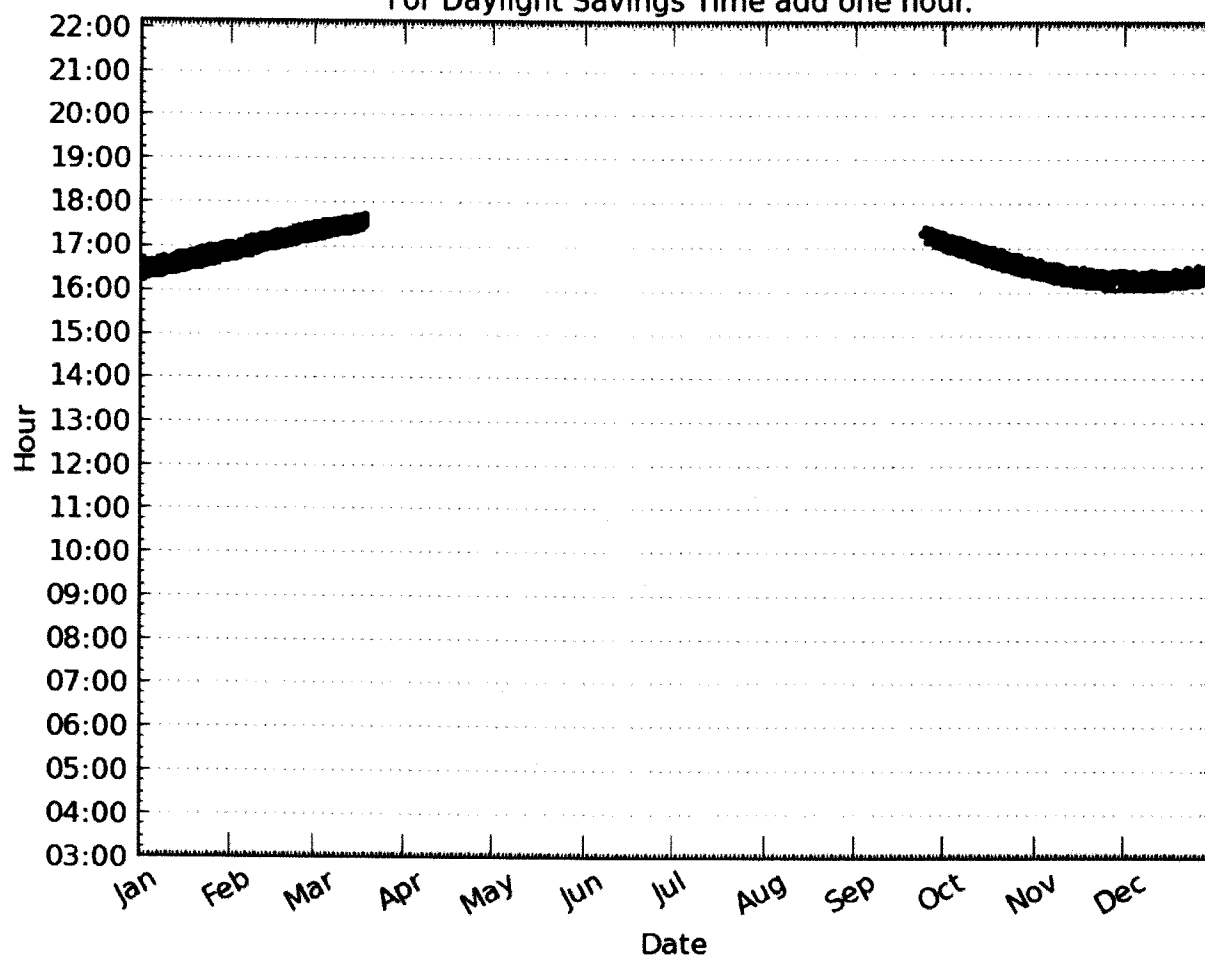
1-minute time interval.  
All times are in standard time.  
For Daylight Savings Time add one hour.

- Glare beyond 50 deg from pilot line-of-sight
- Low potential for temporary after-image
- Potential for temporary after-image
- Potential for permanent eye damage

- Southbound Approach to BLH Runway 17 – Low intensity glare could be seen at the landing threshold and a half mile away during the late afternoon during winter months.
- Westbound Approach to BLH Runway 26 – Low intensity glare could be seen at the landing threshold during the late afternoon and at 0.75 to 2 miles in the early morning during summer months.
- Northbound Approach to BLH Runway 35 – Low intensity glare could be seen at the landing threshold and near during the late afternoon during summer months.
- Eastbound Approach to BLH Runway 8 – Low intensity glare could be seen at all approach distances during the late afternoon during summer months and during spring and fall.

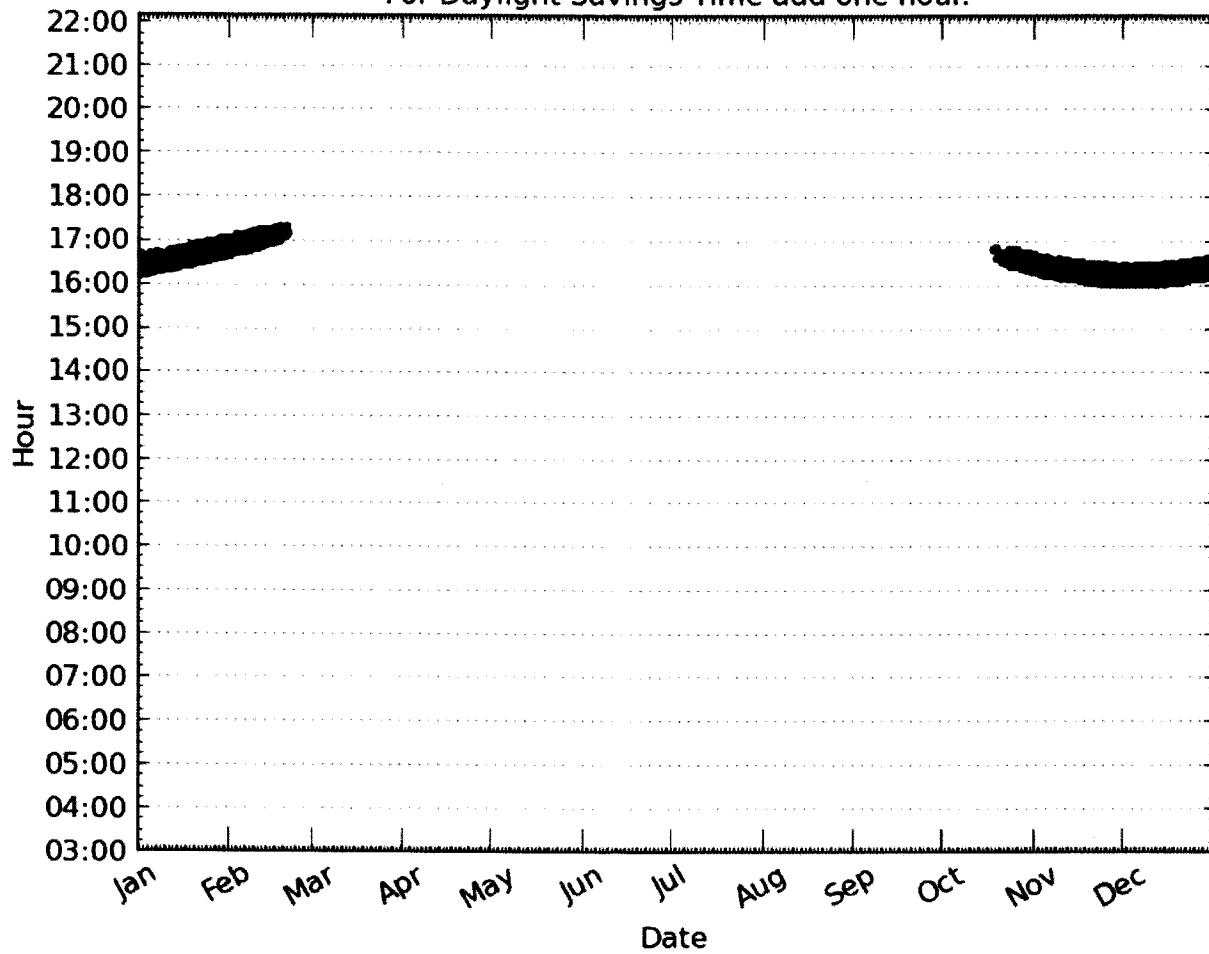
1/4 mi

1-minute time interval.  
All times are in standard time.  
For Daylight Savings Time add one hour.

- Glare beyond 50 deg from pilot line-of-sight
- Low potential for temporary after-image
- Potential for temporary after-image
- Potential for permanent eye damage

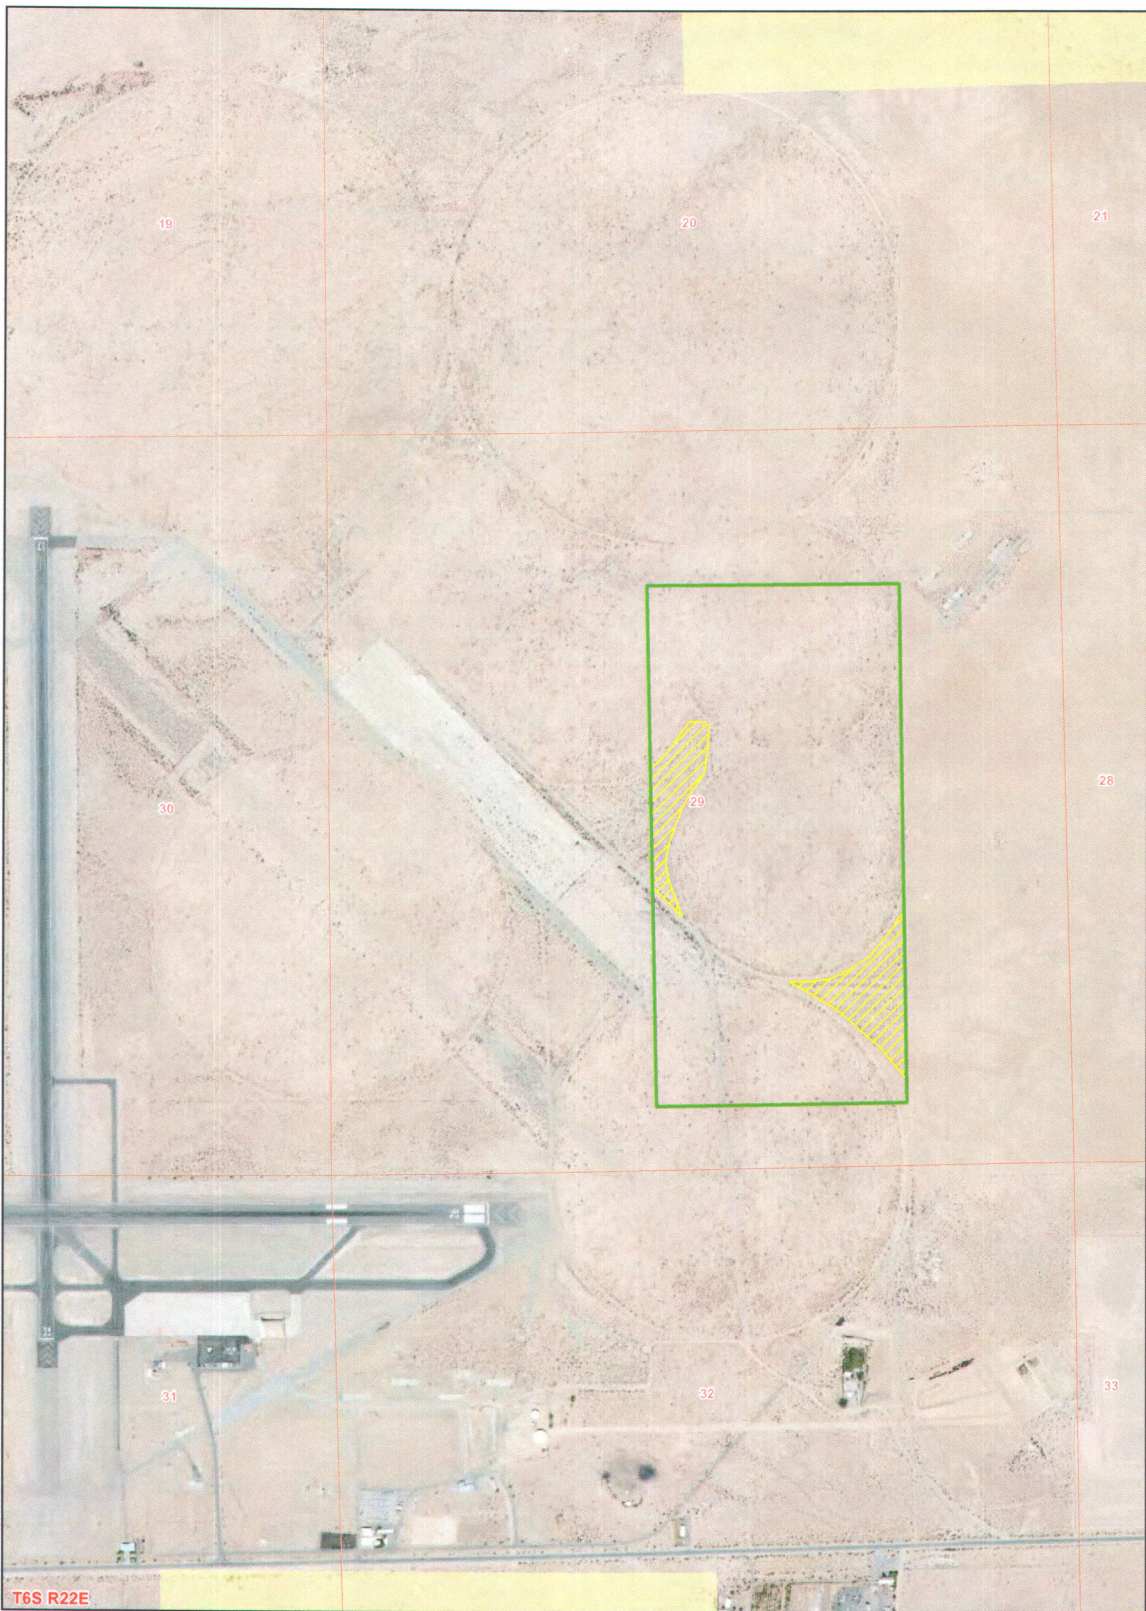
**Figure 3**  
**Habitat Assessment**

The low quality disturbed creosotebush scrub habitat patches (**Figure 2**) have gravelly sand soils that are generally hard-packed. There are no hummocks, or raised areas, at the base of shrubs, where desert tortoise prefer to excavate burrows. Certain areas support friable soils, while others do not, and very few small mammal burrows were observed, indicating that soils are generally not friable. No suitable desert tortoise burrows or other sign were observed.

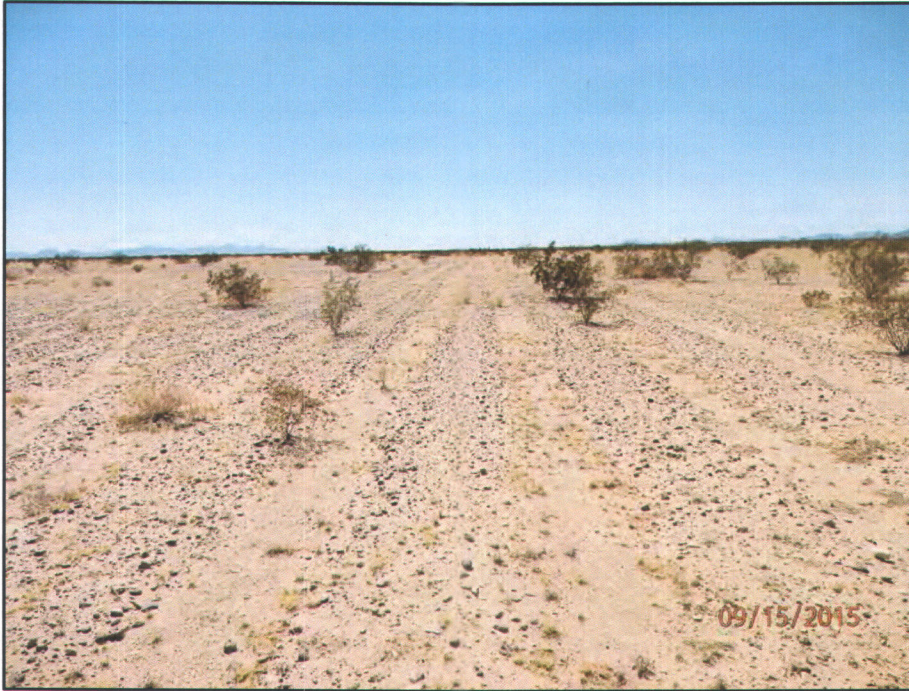
Photo 1  
Abandoned agriculture pivot depicting compact soils and sparse vegetation

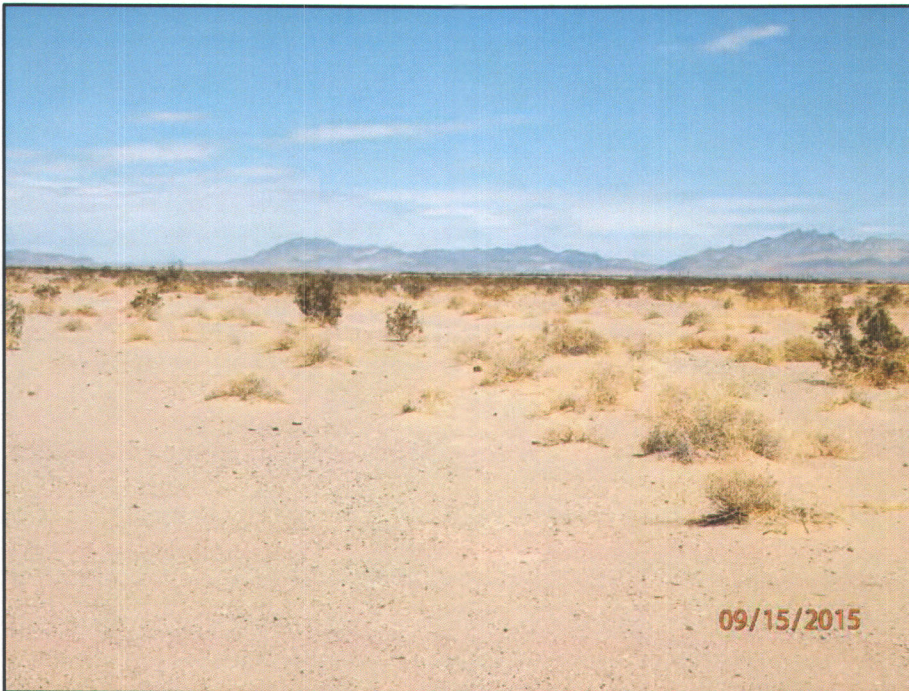
Photo 2  
Perimeter patch - disturbed creosotebush scrub

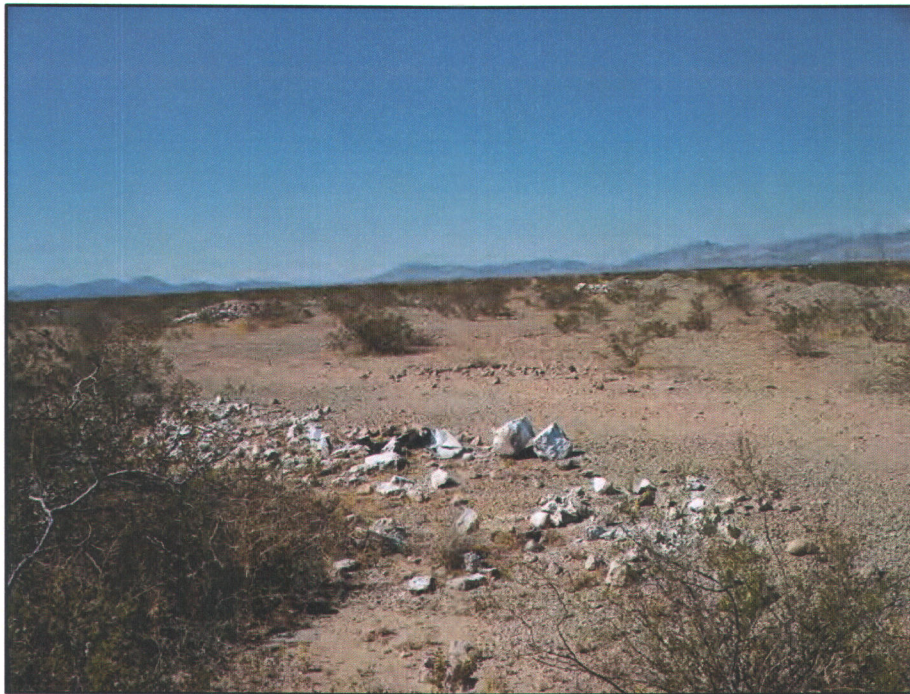
Photo 3  
Disturbed creosotebush scrub with old pieces of runway and other refuse

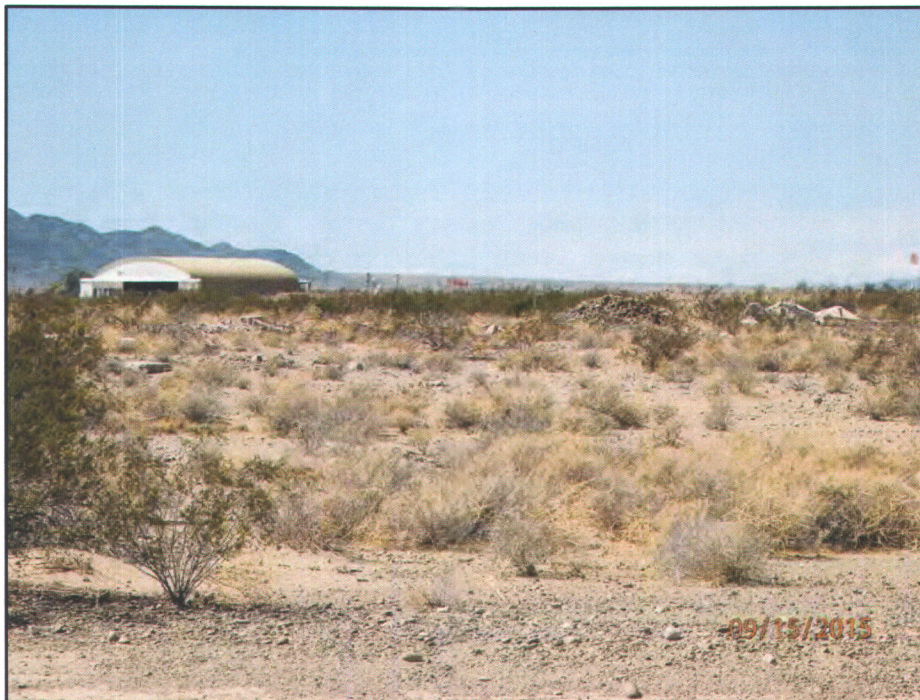
Photo 4  
Interior patch with runway rubble

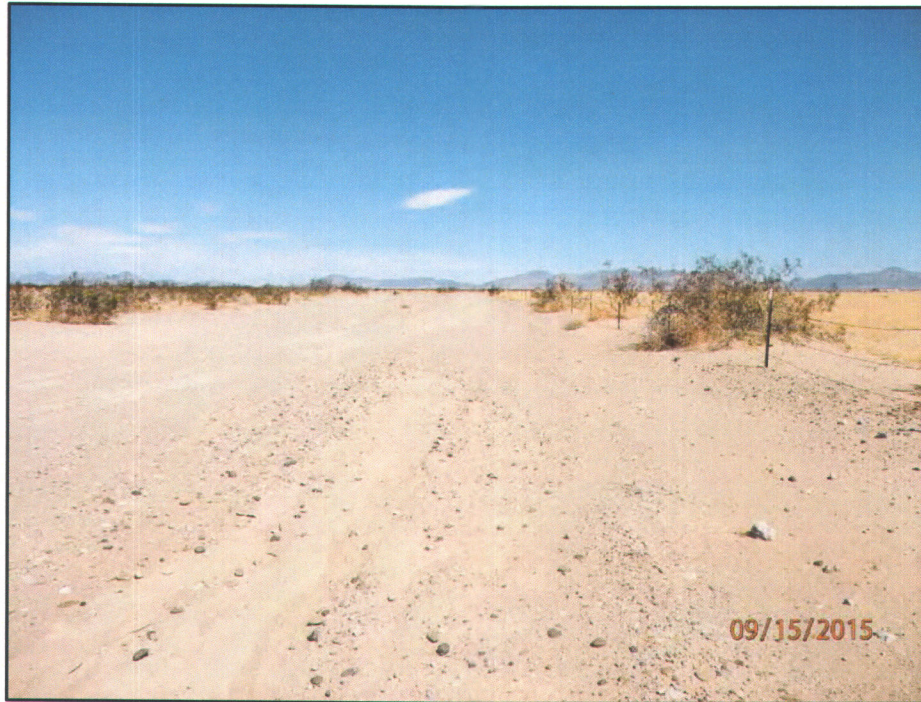
Photo 5  
Access road and gen-tie line corridor along Butch Boulevard looking north toward solar facility  
(0.1 mile segment)

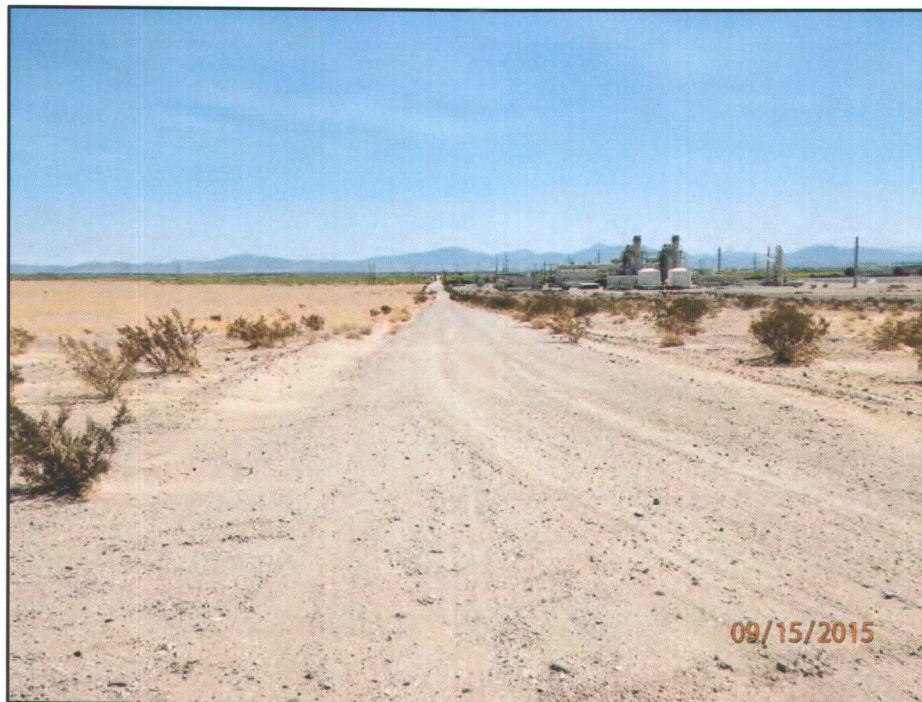
Photo 6  
Access Road and gen-tie line corridor along Riverside Drive looking east toward existing power plant  
(0.7 mile segment)
