**SUBMITTAL TO THE BOARD OF SUPERVISORS
 COUNTY OF RIVERSIDE, STATE OF CALIFORNIA**

SUBJECT: Agreement by and between the County of Riverside, Valley Wide Recreation and Park District, and Hemet Unified School District for the construction of a Multi-Purpose Community Park Site in the Community of Valle Vista; CEQA Exempt; District 3 [\$380,000; 3rd District Development Agreement Public Facilities Fund - \$130,000 and Gas Tax - \$250,000].

**PRELIMINARY GEOTECHNICAL INVESTIGATION
VALLE VISTA JOINT USE PROJECT**

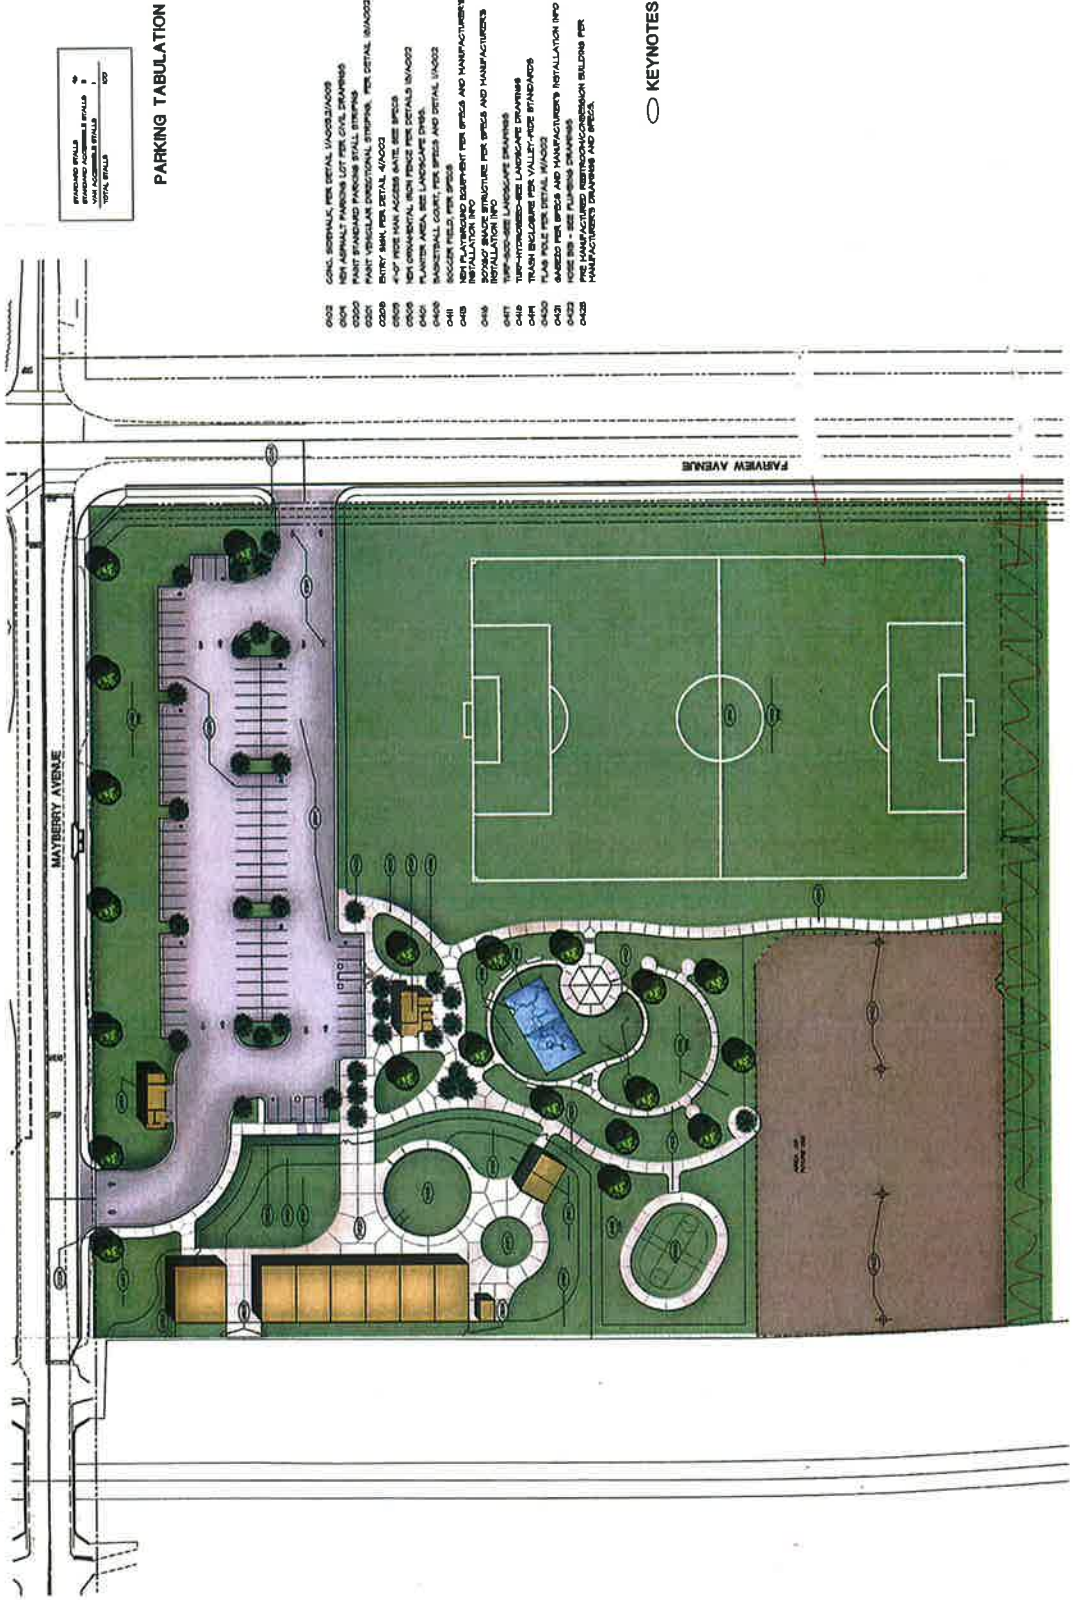
EXHIBIT A

Conceptual Site Plan
Exchange Club Park

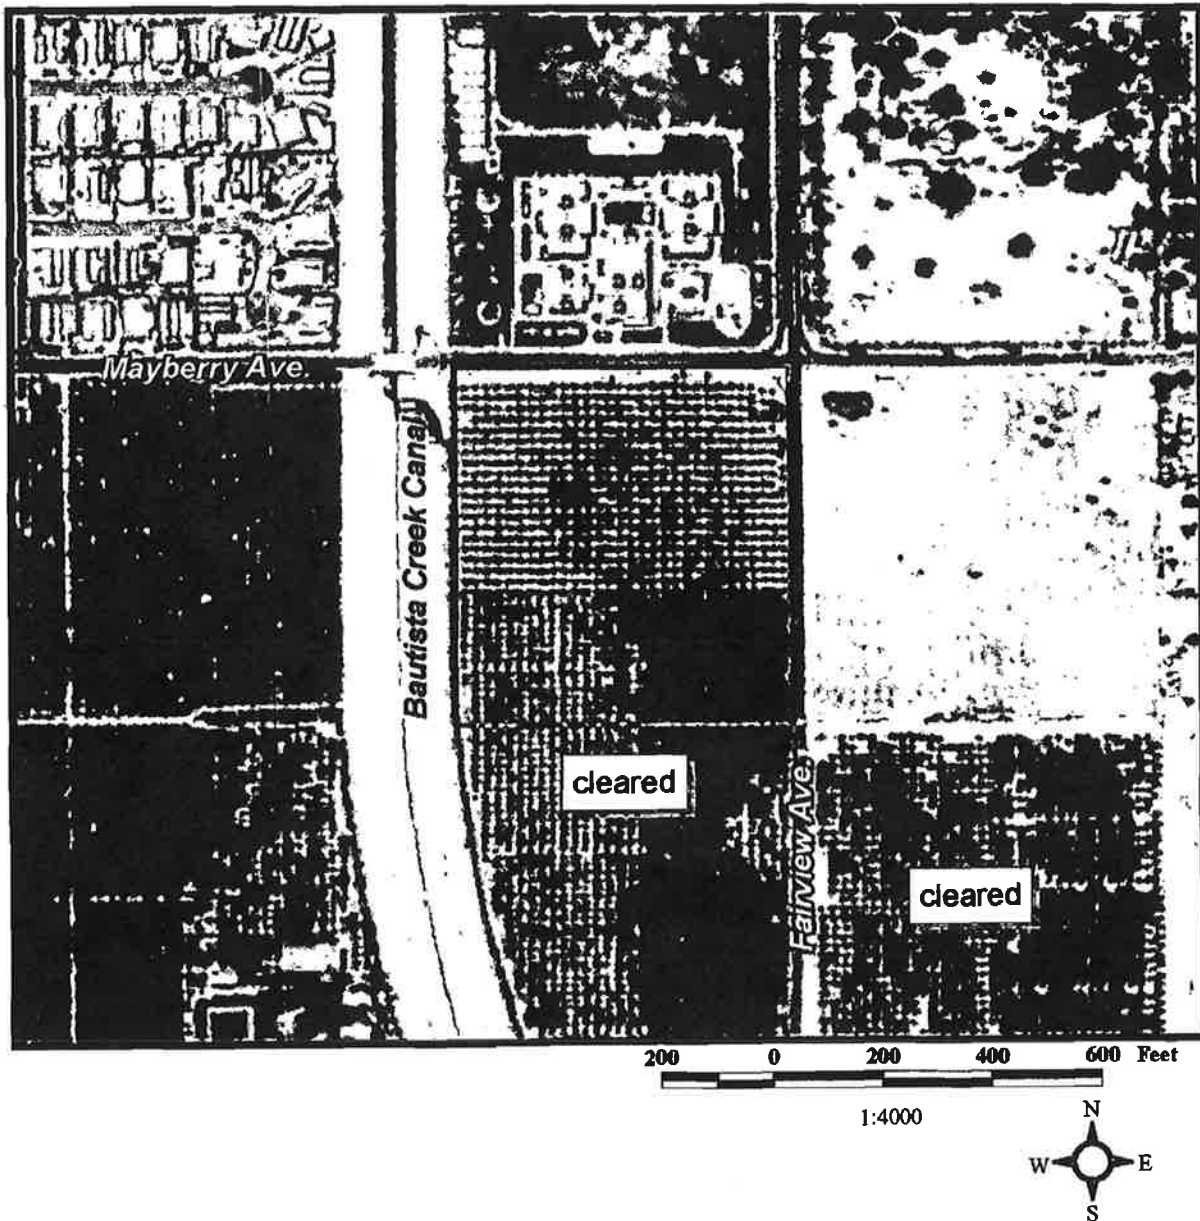
Figure 3. Site Conditions

Conditions on site and in the vicinity are largely identical to those shown in this aerial photo. The only difference is the citrus fields south and southeast of the site that have been cleared since this photo was taken.

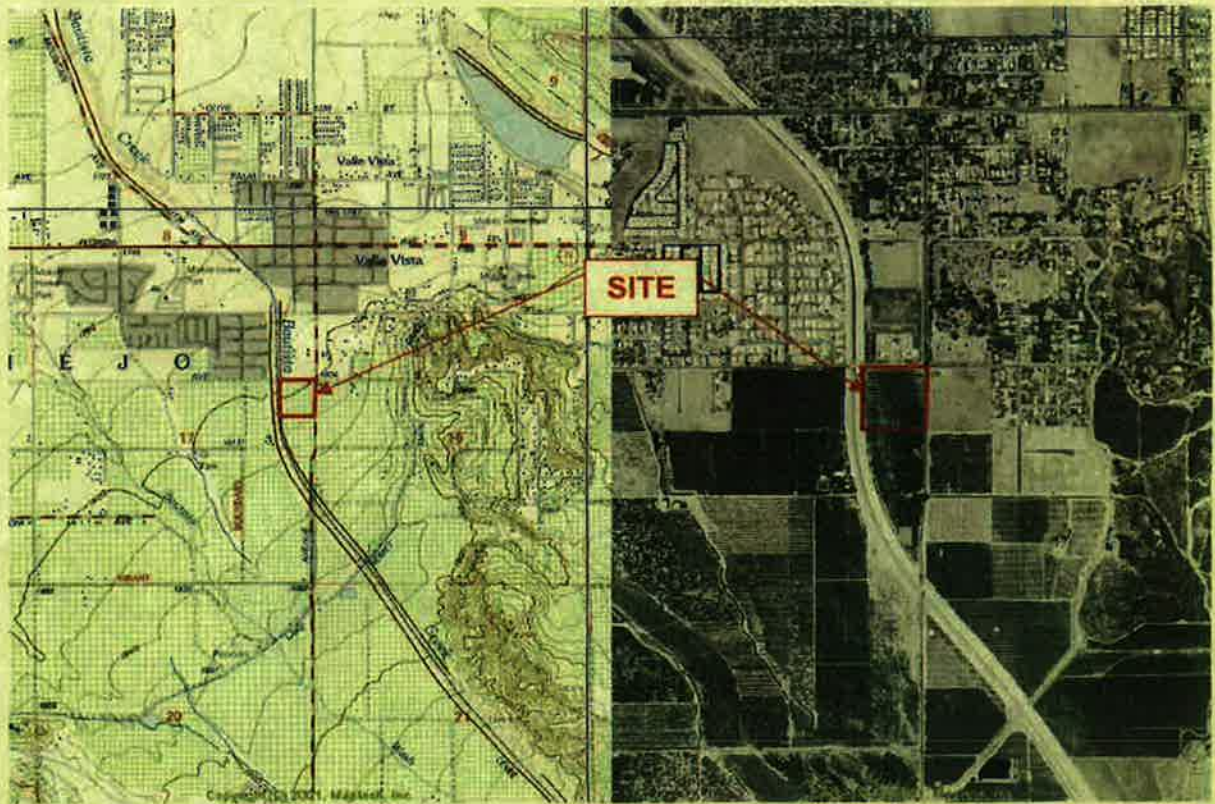
U.S.G.S. Topographic Map, Hemet Quadrangle (1996) and Aerial Photograph (1996)

At the present time, the site consists of a citrus grove. The topography may be described as relatively planar with a gradient of approximately two percent to the northwest. A well is located near the south center portion of the site. Irrigation systems are present through the grove.

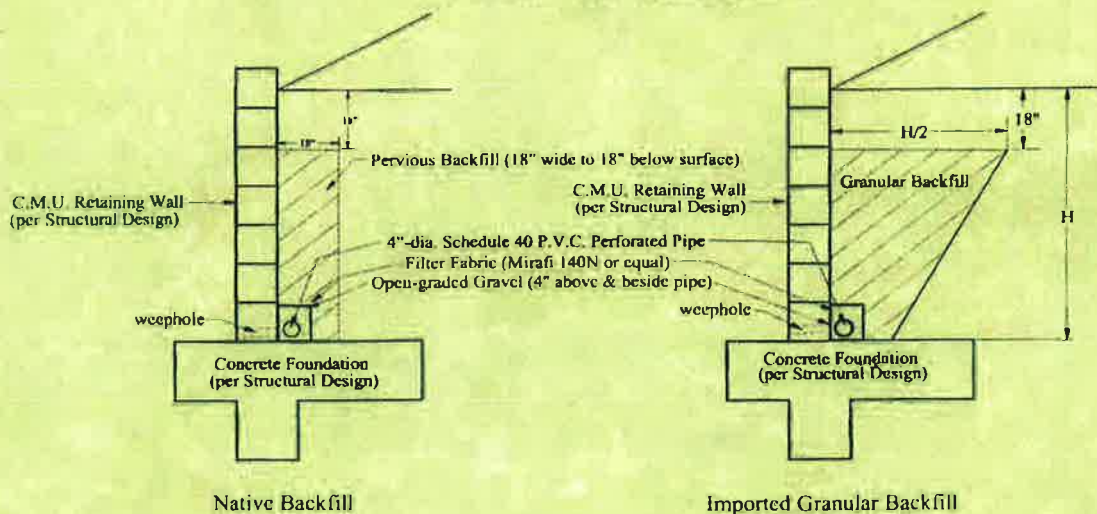
RETAINING WALL - TYPICAL PROFILE

Any applicable construction and seismic surcharges should be added to the above pressures. At least 12 inches of granular material should be used in the backfill behind the walls and water pressure should not be permitted to build up behind retaining walls. The upper 12 to 18 inches of the backfill should consist of impervious soil. A subdrain should be constructed along the base of the backfill.

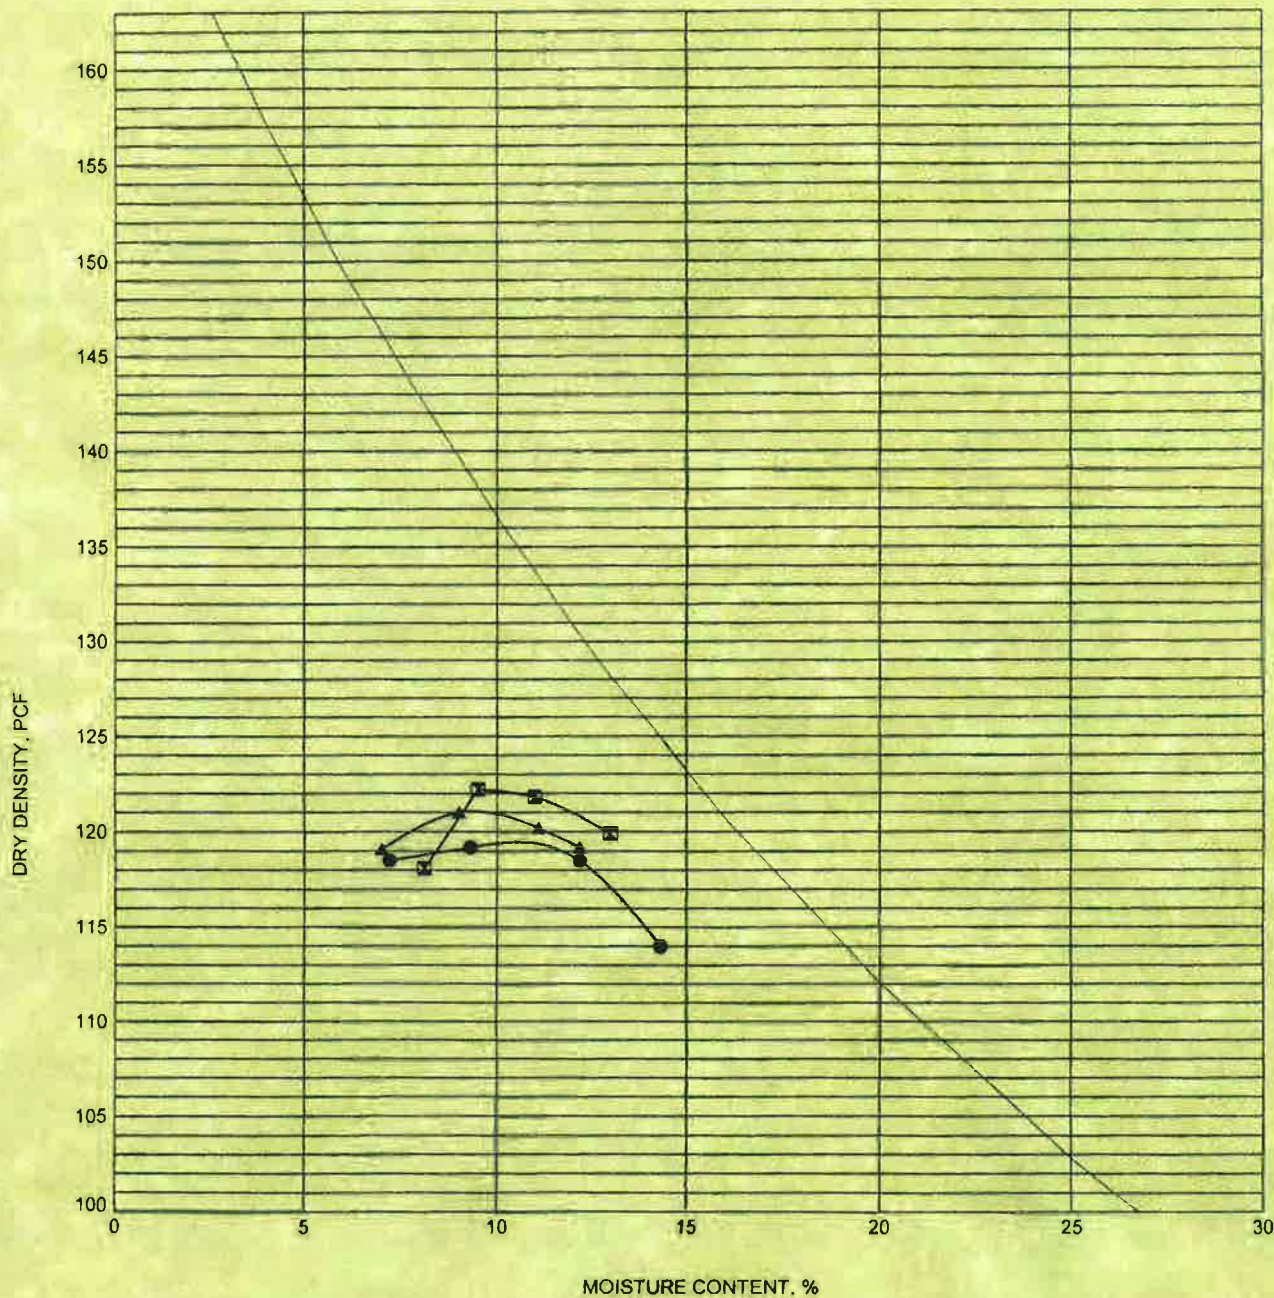
FIGURE NO. B-3

Specimen Identification	Classification	Max. Density	MC%
● B-01 0.0	SILTY SAND - CLEAN SAND SP-SM	121.0	11.5
⊠ B-02 0.0	WELL-GRADED SAND with SILT SW-SM	123.0	10.0
▲ B-04 0.0	SILTY SAND SM	122.0	10.0

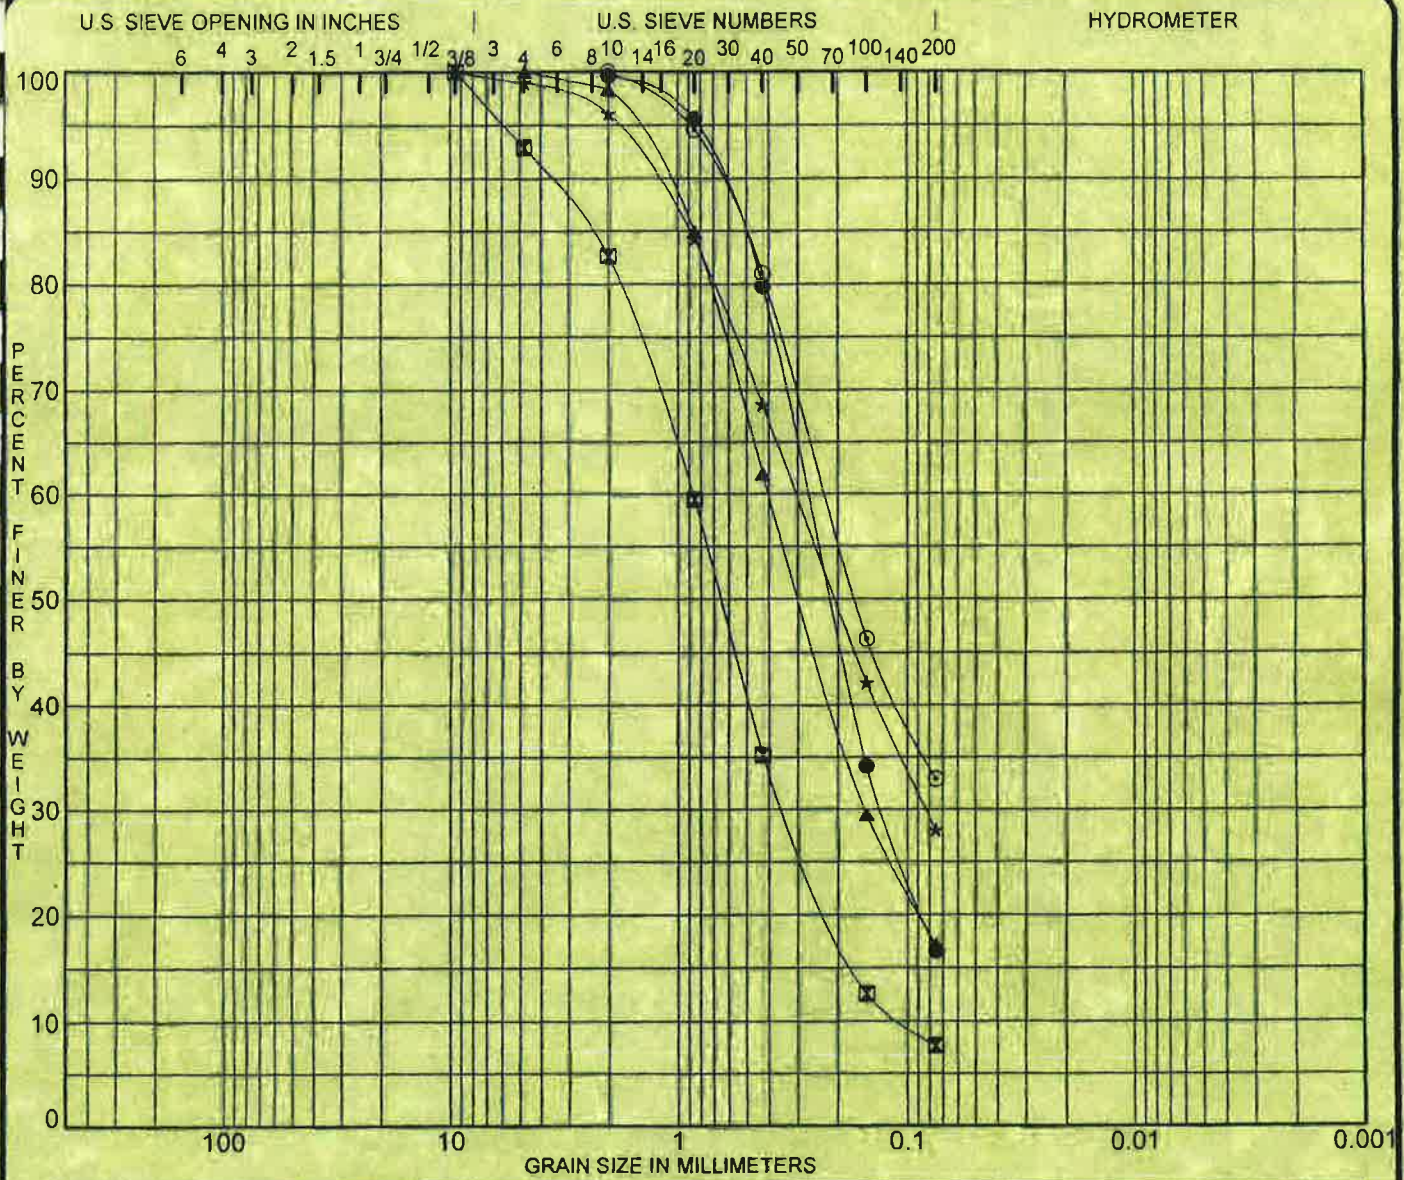
FIGURE NO. B-4

Specimen Identification	Classification	S.G.	LL	PL	PI	Cc	Cu
● B-01 0.0	SILTY SAND SM		NP	NP	NP		
☒ B-02 0.0	WELL-GRADED SAND with SILT SW-SM		NP	NP	NP	1.24	8.3
▲ B-04 0.0	SILTY SAND SM		NP	NP	NP		
★ B-04 11.0	SILTY SAND SM		NP	NP	NP		
◎ B-04 20.5	SILTY SAND SM		NP	NP	NP

GRADATION CURVES
Inland Foundation Engineering, Inc.
San Jacinto, California 92583

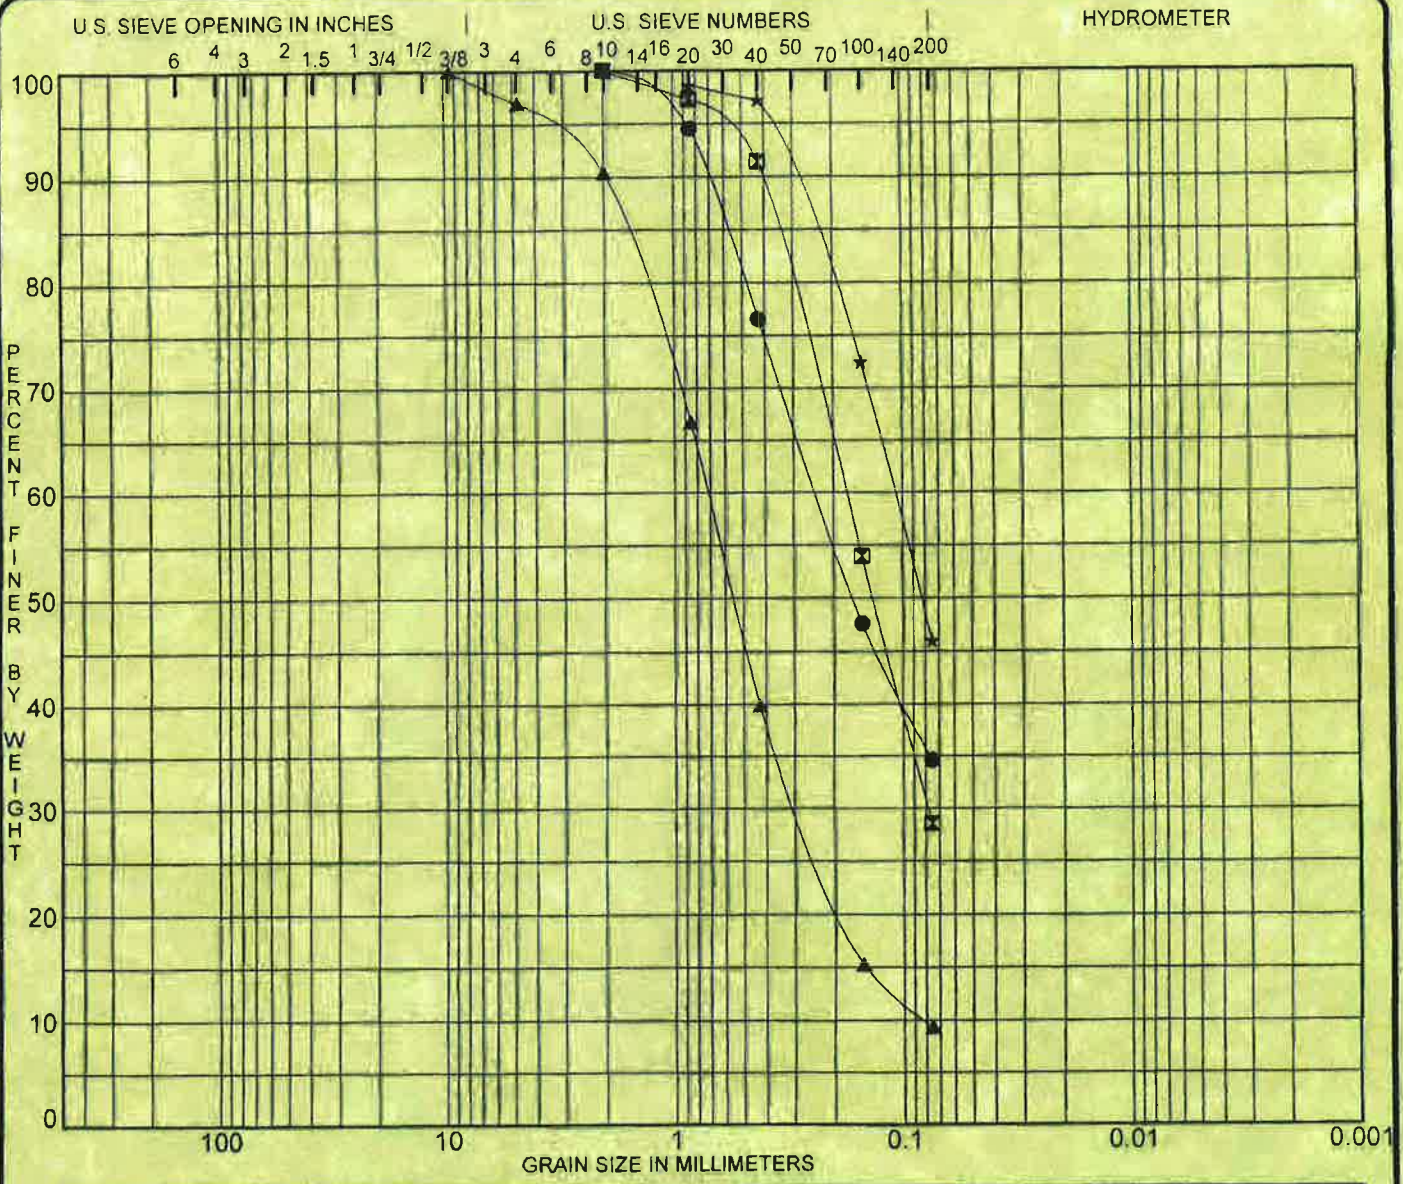
FIGURE NO. B-5

Specimen Identification	Classification	S.G.	LL	PL	PI	Cc	Cu
● B-04 25.5	SILTY SAND SM		NP	NP	NP		
☒ B-04 30.5	SILTY SAND SM		NP	NP	NP		
▲ B-04 35.5	WELL-GRADED SAND with SILT SW-SM		NP	NP	NP	1.36	8.8
★ B-04 50.5	SILTY SAND SM		NP	NP	NP

GRADATION CURVES
 Inland Foundation Engineering, Inc.
 San Jacinto, California 92583

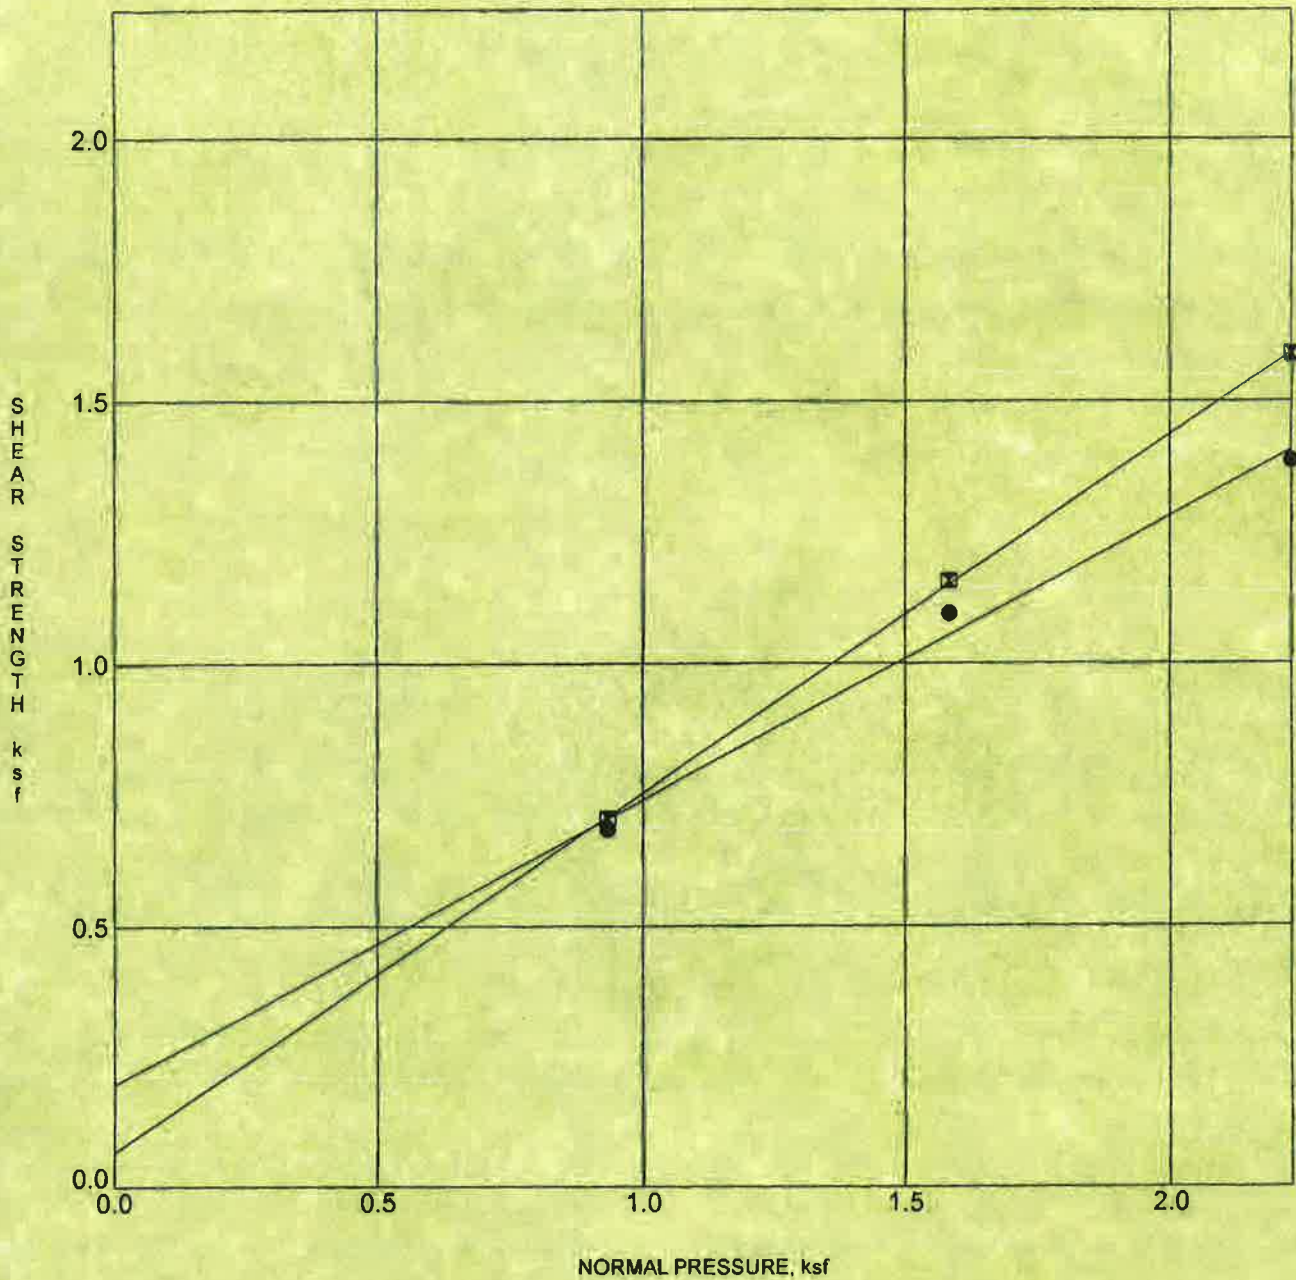
FIGURE NO. B-6

Specimen Identification	Classification	Phi	Cohesion	DD	MC%
● B-01 0.0	SILTY SAND SM	28	0.196	109	13
□ B-04 0.0	SILTY SAND SM	34	0.100	112	11

SHEAR TEST DIAGRAM
Inland Foundation Engineering, Inc.
San Jacinto, California 92583

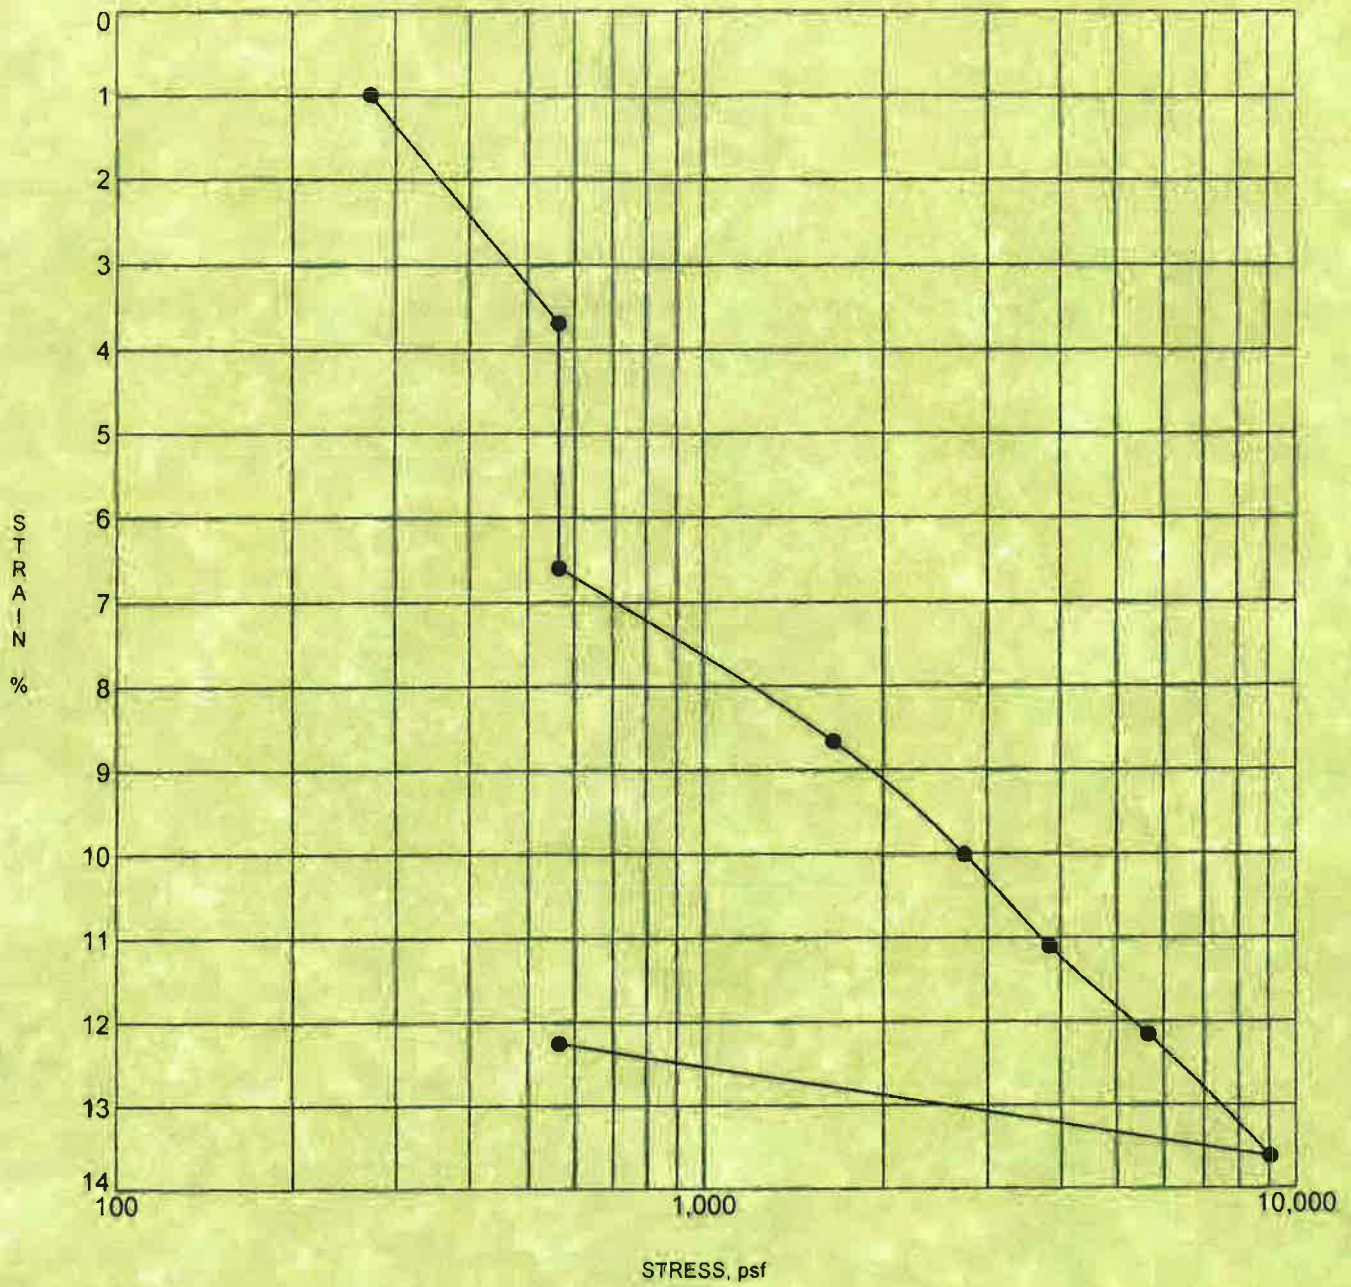
FIGURE NO. B-7

Specimen Identification	Classification	DD	MC%
● B-01 5.5	SILTY SAND SM	89	16

CONSOLIDATION TEST
 Inland Foundation Engineering, Inc.
 San Jacinto, California 92583

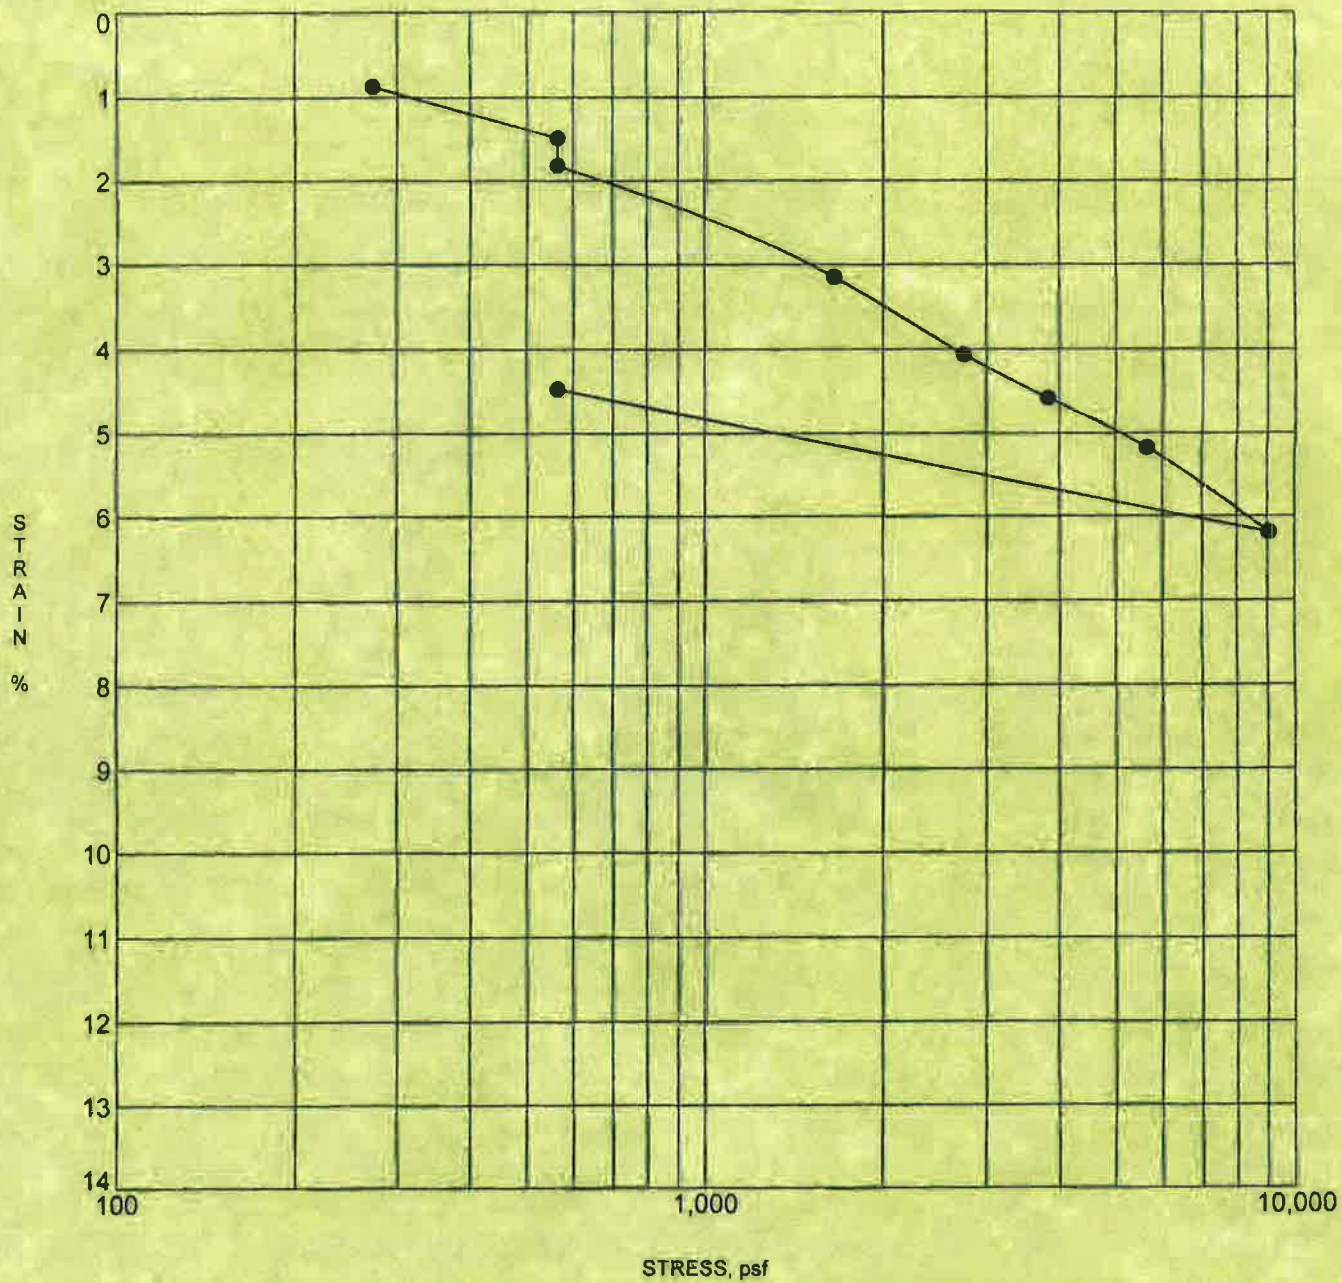
FIGURE NO. B-8

Specimen Identification	Classification	DD	MC%
● B-01 11.5	SILTY SAND SM	103	4

CONSOLIDATION TEST
 Inland Foundation Engineering, Inc.
 San Jacinto, California 92583

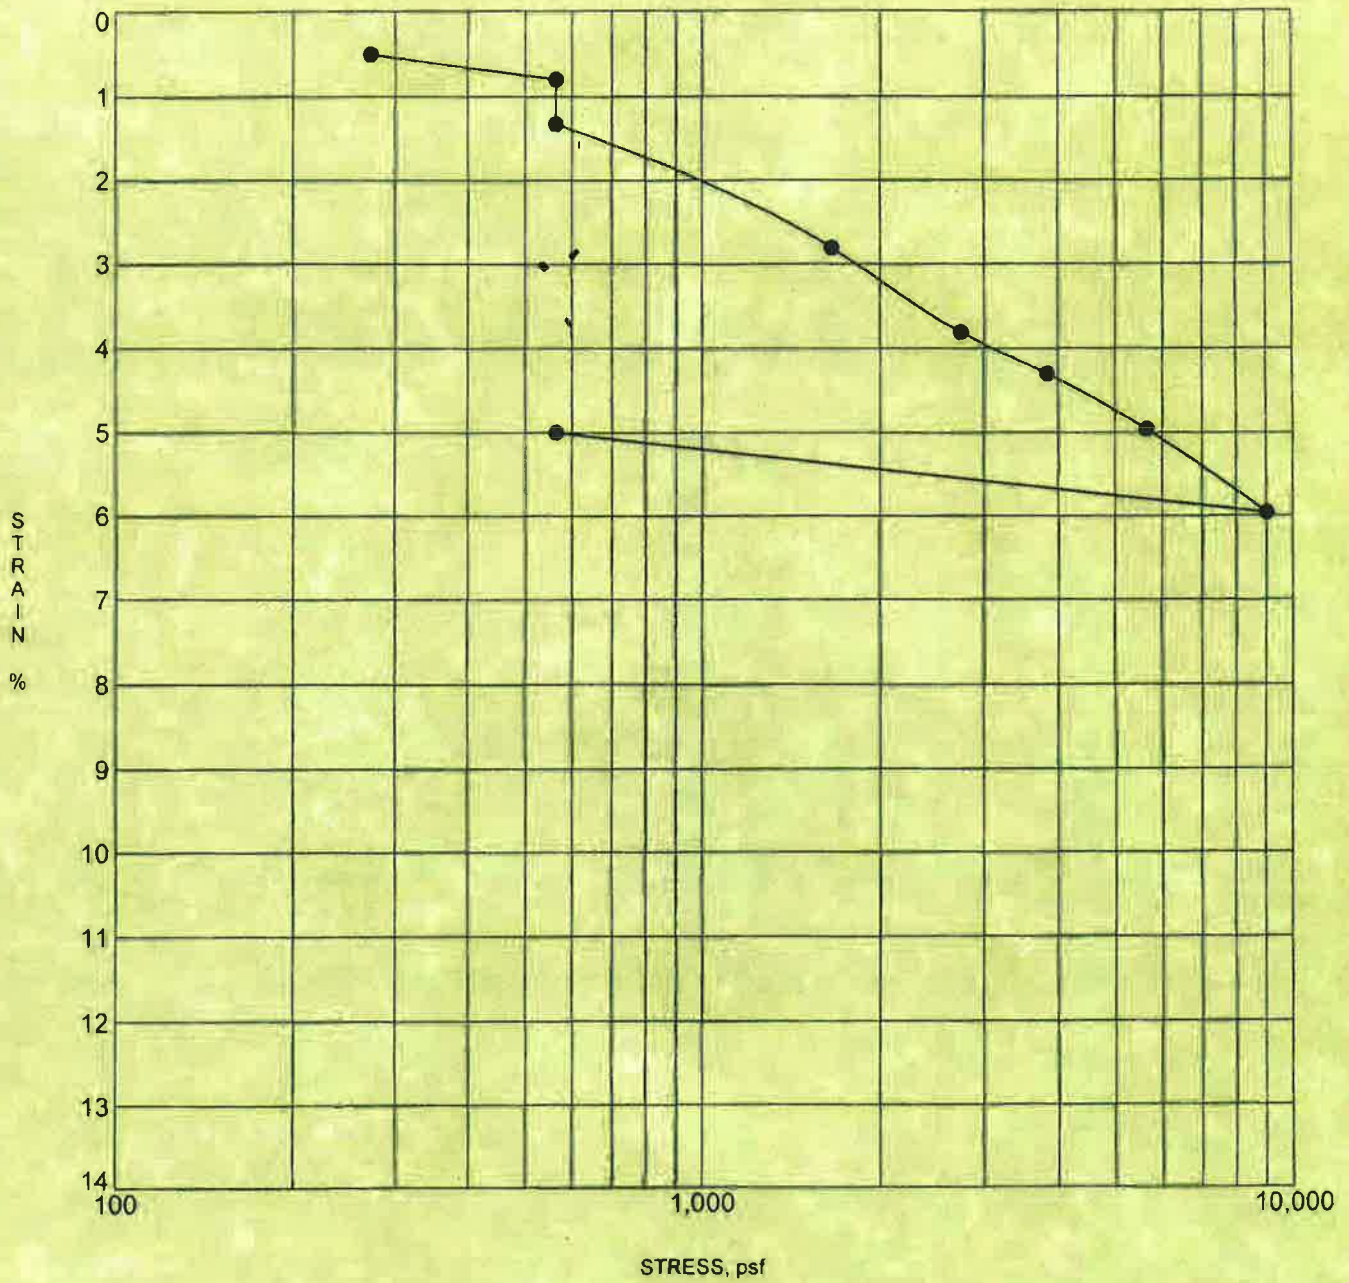
Specimen Identification	Classification	DD	MC%
● B-02 6.5	POORLY GRADED SAND SP	105	5
