BIOLOGICAL ASSESSMENT AND MSHCP CONSISTENCY ANALYSIS

RIVERSIDE COUNTY FIRE STATION #77
EXPANSION PROJECT

Lake Riverside Community, Riverside County,
California

**PRELIMINARY GEOTECHNICAL REPORT
NEW APPARATUS BAY, FIRE STATION 77
49937 COMANCHE COURT
AGUANGA, CALIFORNIA**

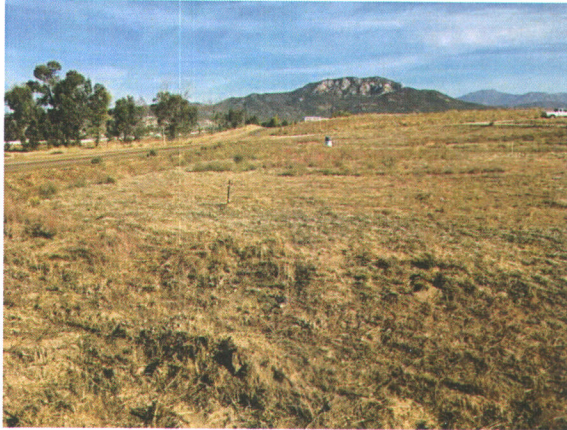
Location 1: Recently mowed California annual grassland, facing northwest from the southwestern corner of the project site.

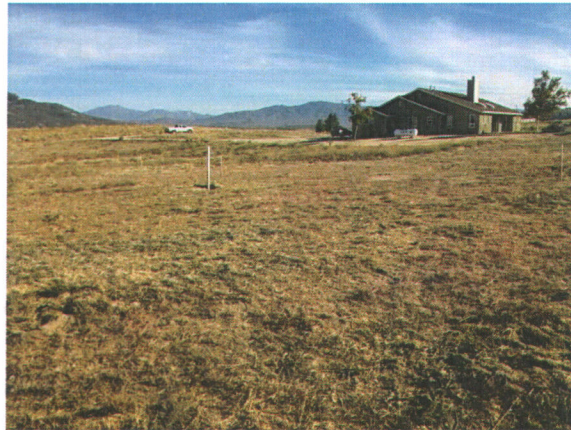
Location 2: The existing fire station that is slated for improvement, northeast from the southwestern border of the project site.

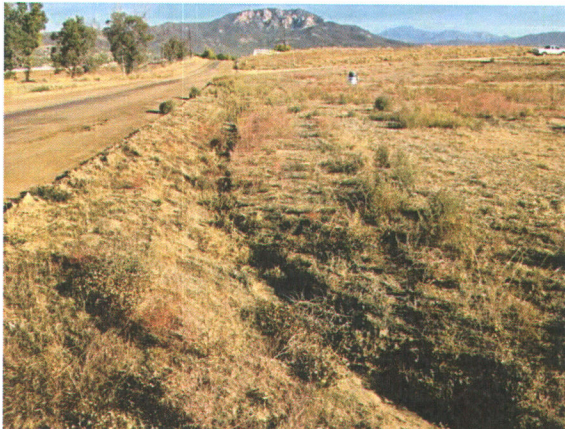
Location 3: Non-jurisdictional swale along the western border of the project site. Facing north.

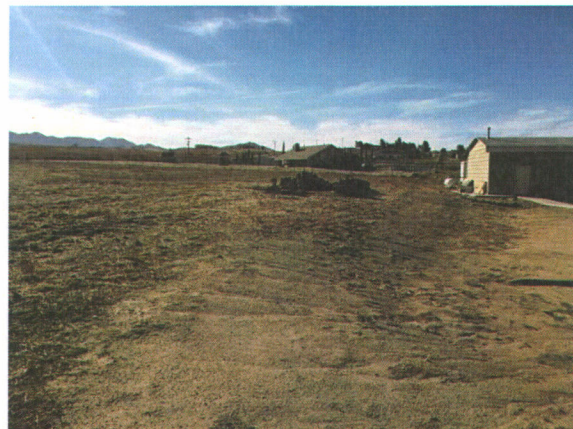
Location 4: California annual grassland behind the fire station, facing south from the northeastern portion of the project site.

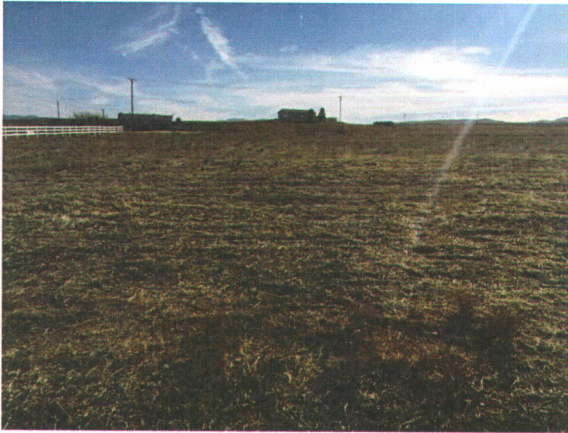
<p>Location 5: Facing east into the project buffer from behind the existing fire station.</p>	<p>Location 6: Non-jurisdictional swale between the fire station and the garage. Facing west.</p>

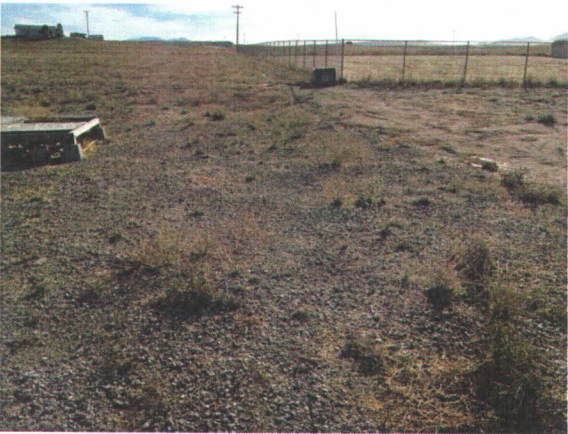
<p>Location 7: Sparse vegetation behind the fire station, facing east.</p>	<p>Location 8: Example of California ground squirrel burrows found on the project site.</p>

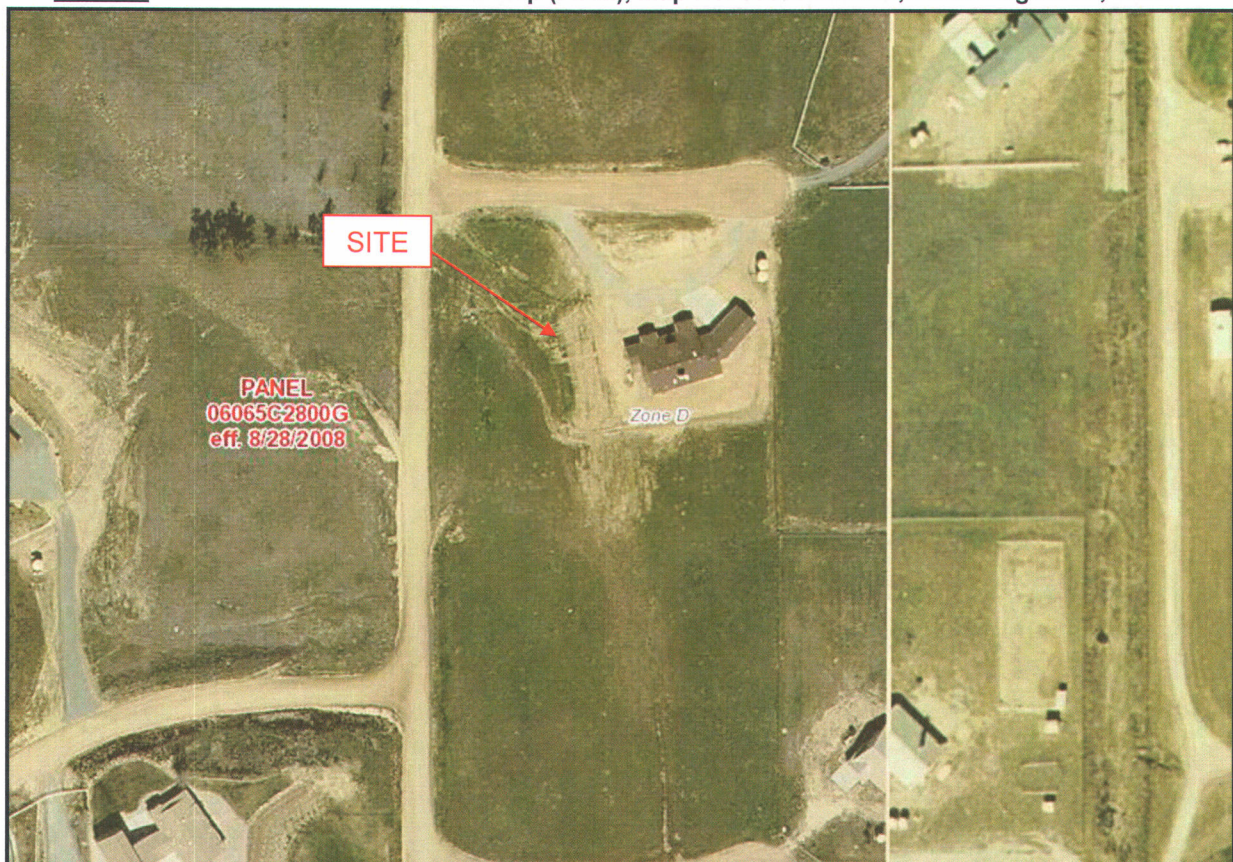
Figure 4: FEMA Flood Insurance Rate Map (FIRM), Map No. 06065C2800G, dated August 28, 2008

Surface Water: A very shallow seasonal drainage swale traverses through the southwesterly portion of the site, draining to the northwest. A review of the Federal Emergency Management Agency (FEMA) Flood Insurance Rate Map (FIRM), Map No. 06065C2800G, dated August 28, 2008, indicates that the site is located in an area designated as "Zone D". According to FEMA, the Zone D designation is used for areas where there are possible but undetermined flood hazards, as no analysis of flood hazards has been conducted. The designation of Zone D is also used when a community incorporates portions of another community's area where no map has been prepared (FEMA, 2015). Figure No. 4 shows a portion of the referenced FIRM Map indicating the site and mapped flood zone:

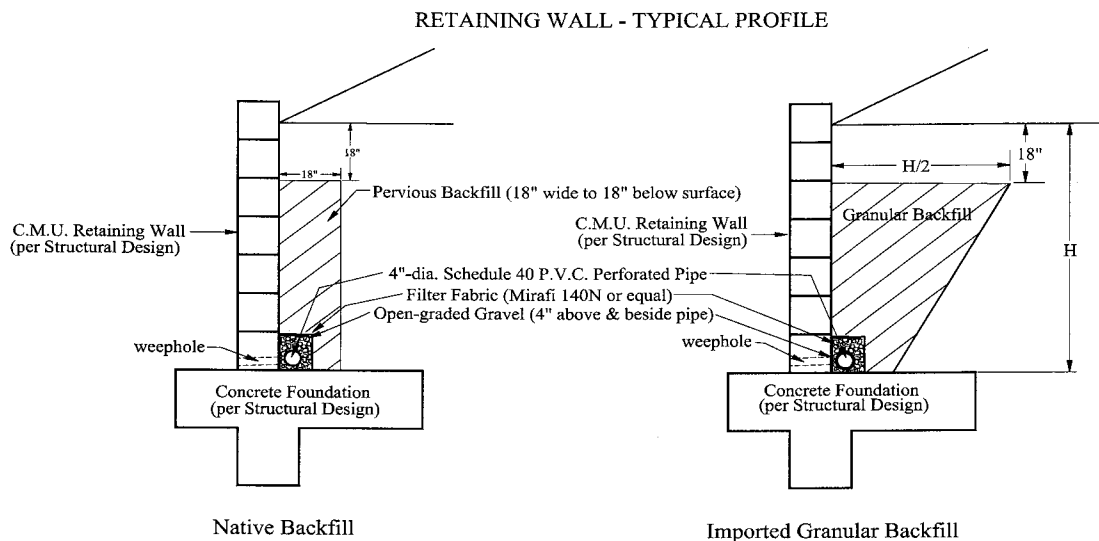
Figure 6: Typical Retaining Wall Profile

Any applicable construction and seismic surcharges should be added to the above pressures. Figure 6 presents a typical retaining profile.

At least 12 inches of granular material should be used in the backfill behind the walls and water pressure should not be permitted to build up behind retaining walls. The upper 12 to 18 inches of the backfill should consist of soil having a low permeability (less than 10^{-6} cm/sec). All backfill should be non-expansive. A subdrain should be constructed along the base of the backfill. Typical recommended retaining wall backfill and drainage details are shown in the detail above.

For walls that are restrained, an “at-rest” lateral equivalent fluid pressure of 65 pounds per cubic foot is recommended, with the resultant applied at mid-height of the wall.
