B. RECLAMATION PLAN

Dawson Canyon Reclamation Plan
 Corona Clay Company
 Corona, California

We have prepared a slope stability evaluation for the area of concern at the Corona Clay Company facility in Riverside County, California. The area of concern includes an existing steep bedrock slope in the northern portion of the facility, which is proposed to be flattened to a more stable inclination. Our services included evaluation of kinematic and global slope stability for suitable rock slopes under Surface Mining and Reclamation Act (SMARA) criteria for reclaimed slopes. The purposes of our evaluation were to evaluate the site conditions and provide recommendations for configuration of suitable reclamation slopes with regard to kinematic and limit-equilibrium stability.

GEOLOGIC MAP	
FOR: CORONA CLAY DATE: MARCH 2015	ENCLOSURE "A-2" JOB NUMBER 15112-8 CHJ Consultants
SLOPE STABILITY INVESTIGATION AREA OF CONCERN, CORONA CLAY QUARRY CORONA, CALIFORNIA	
LEGEND: f - fill Jbc - Jurassic Bedford Canyon Formation-slate with minor quartzite (18) structural data measurement location f - foliation j - joint s - shear A - Geologic Cross Section	
SCALE: 1" = 50'

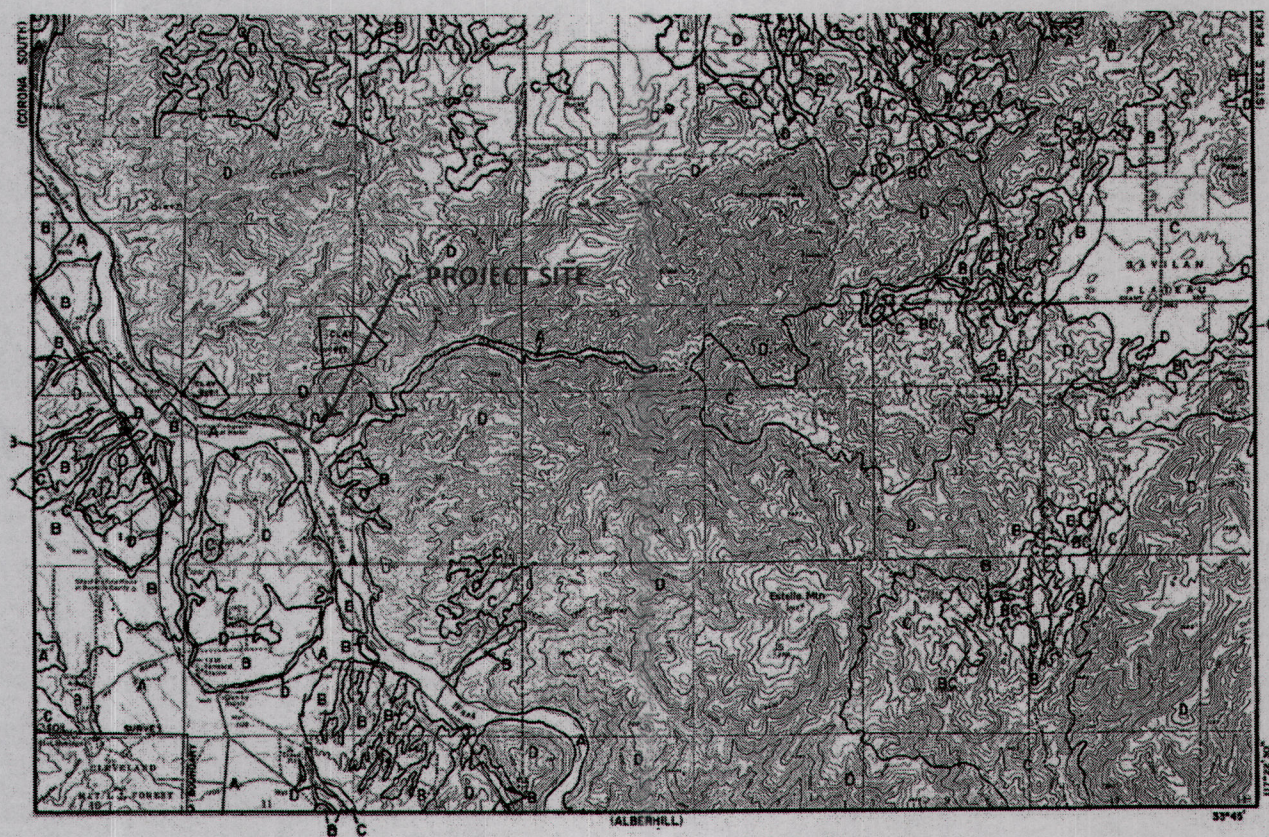
PLATE C-1.28

Hydrologic Soils Group for the project site
