RRM’S Request for Determination of Vested Rights Appendix B: Maps and Graphics

Appendix B – Maps and Graphics
 RRM Request for Determination of Vested Rights
 December 16, 2021

Confirmation of Geographic Scope of HH VRA
Hubbs/Harlow Quarry
Riverside County, California

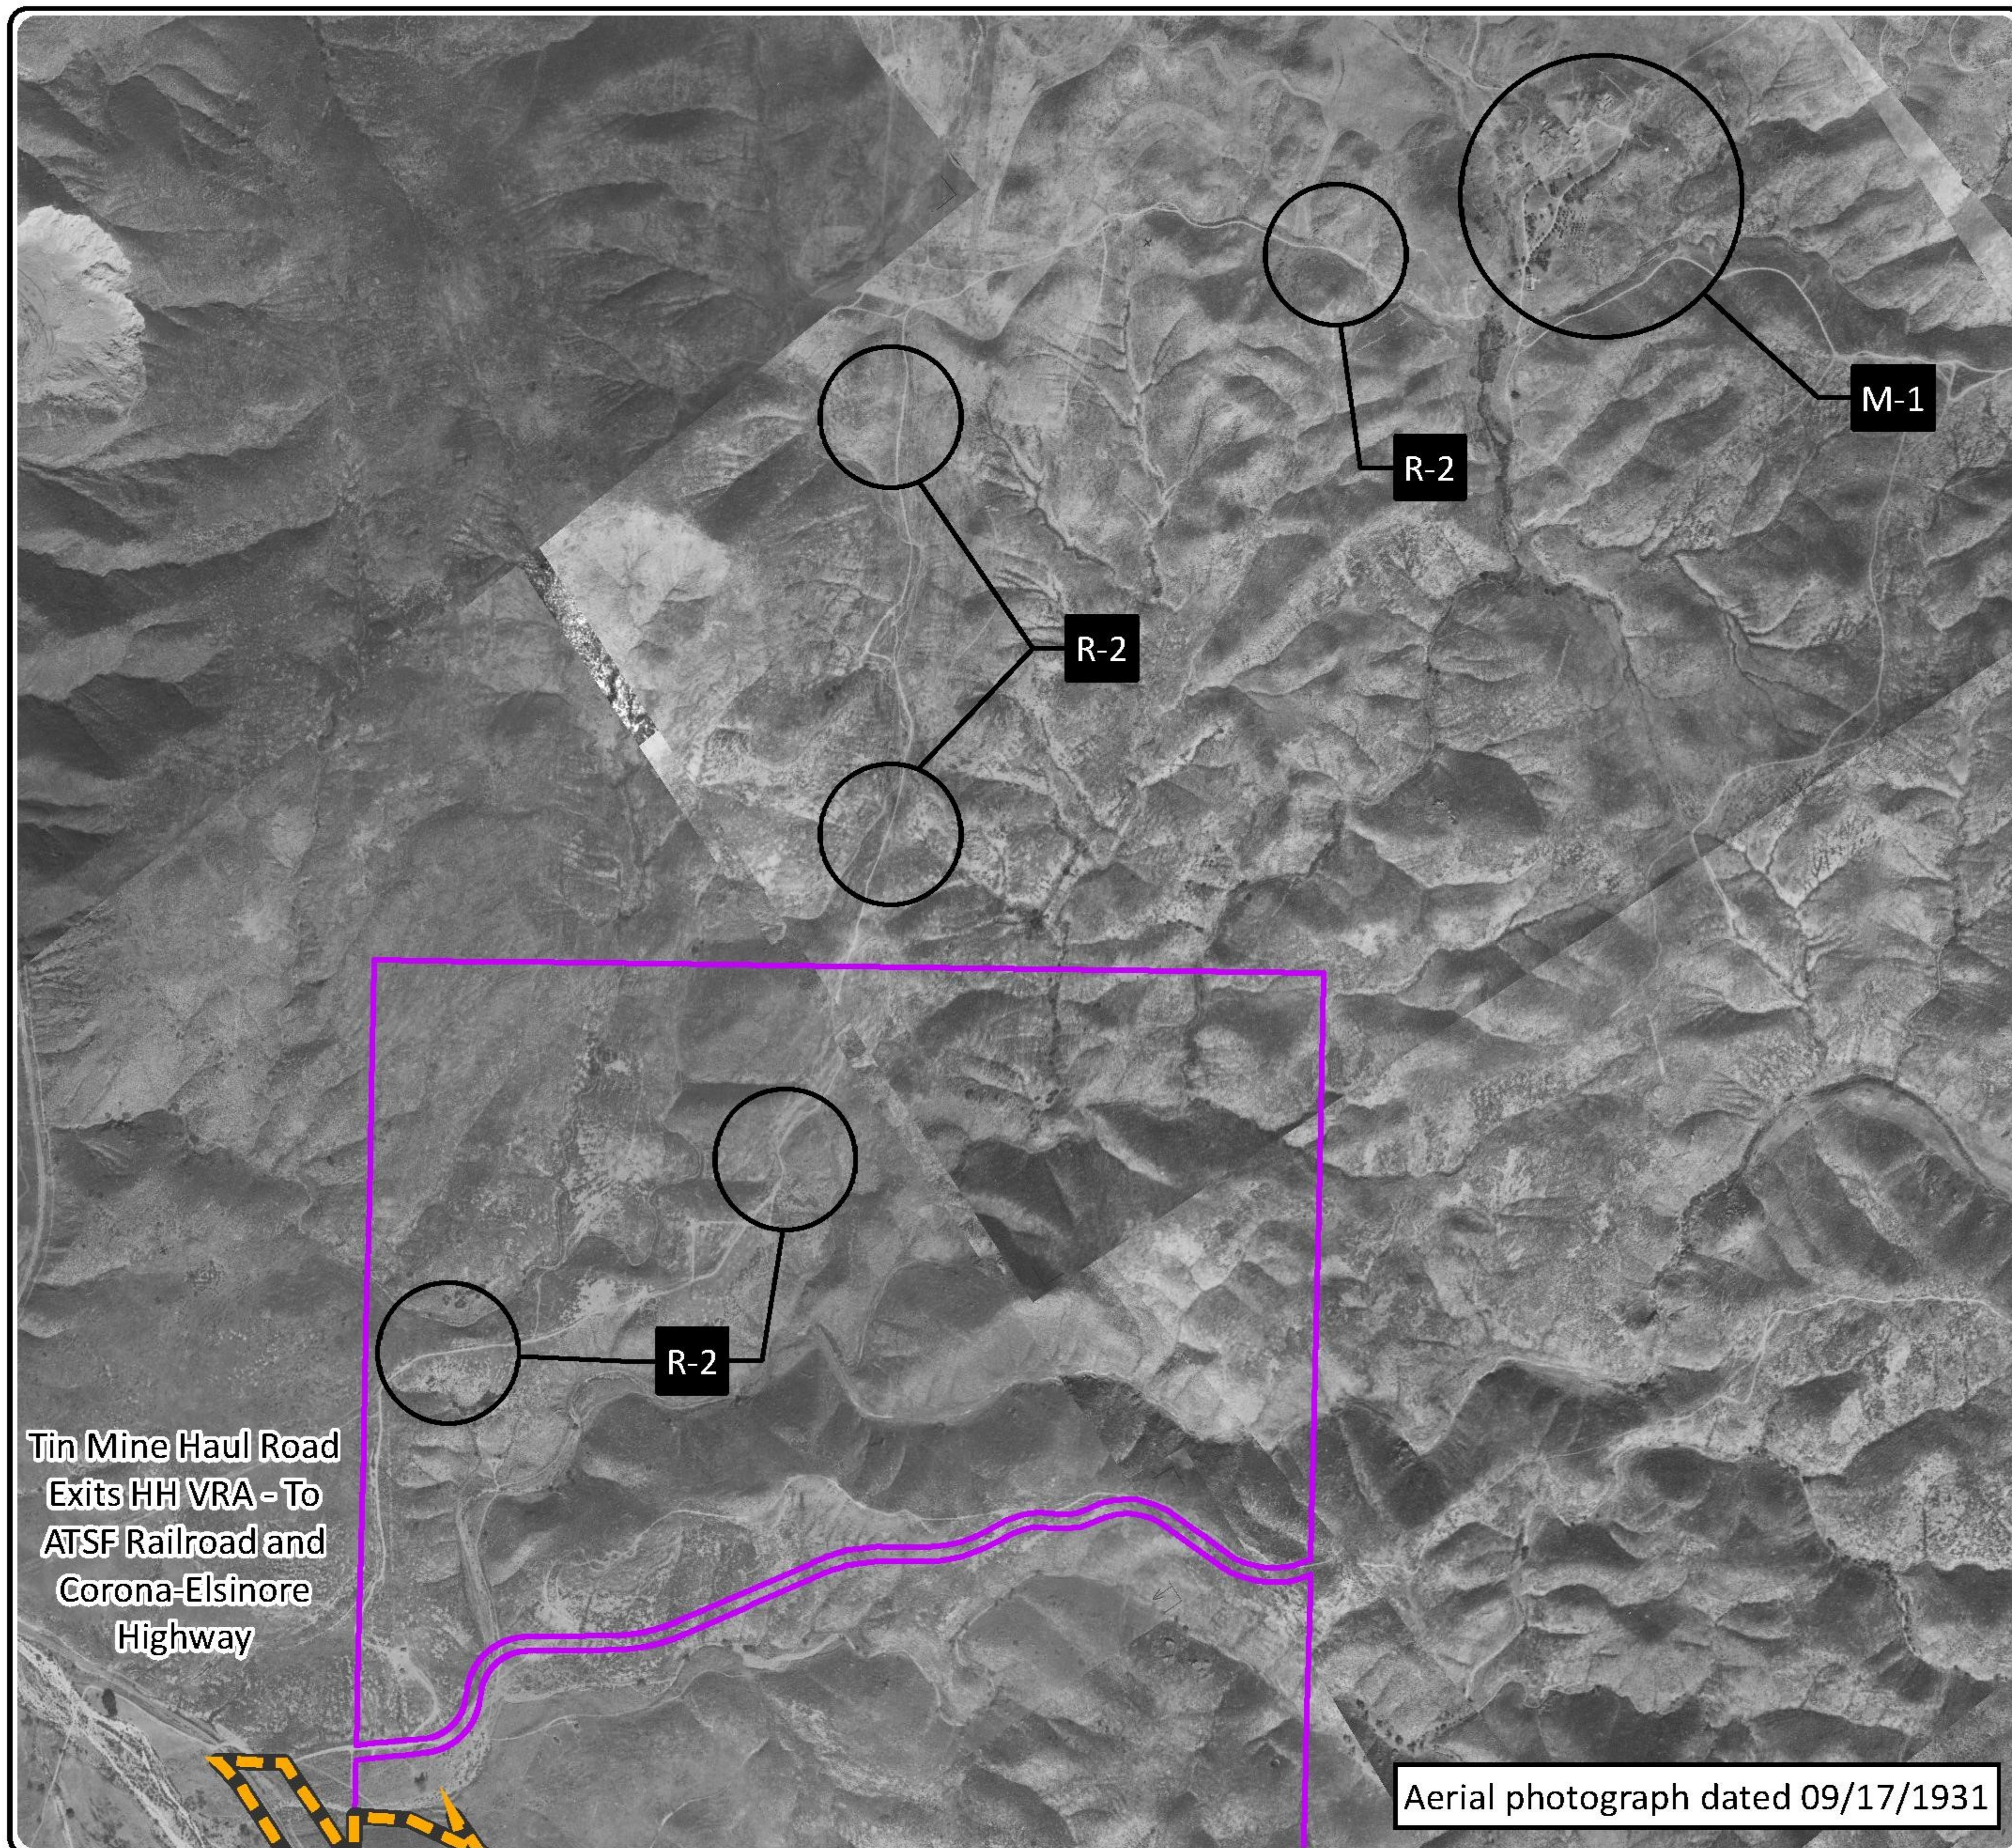
Disturbance Description:

Tin Mine Haul Road running northeast to southwest through HH VRA.

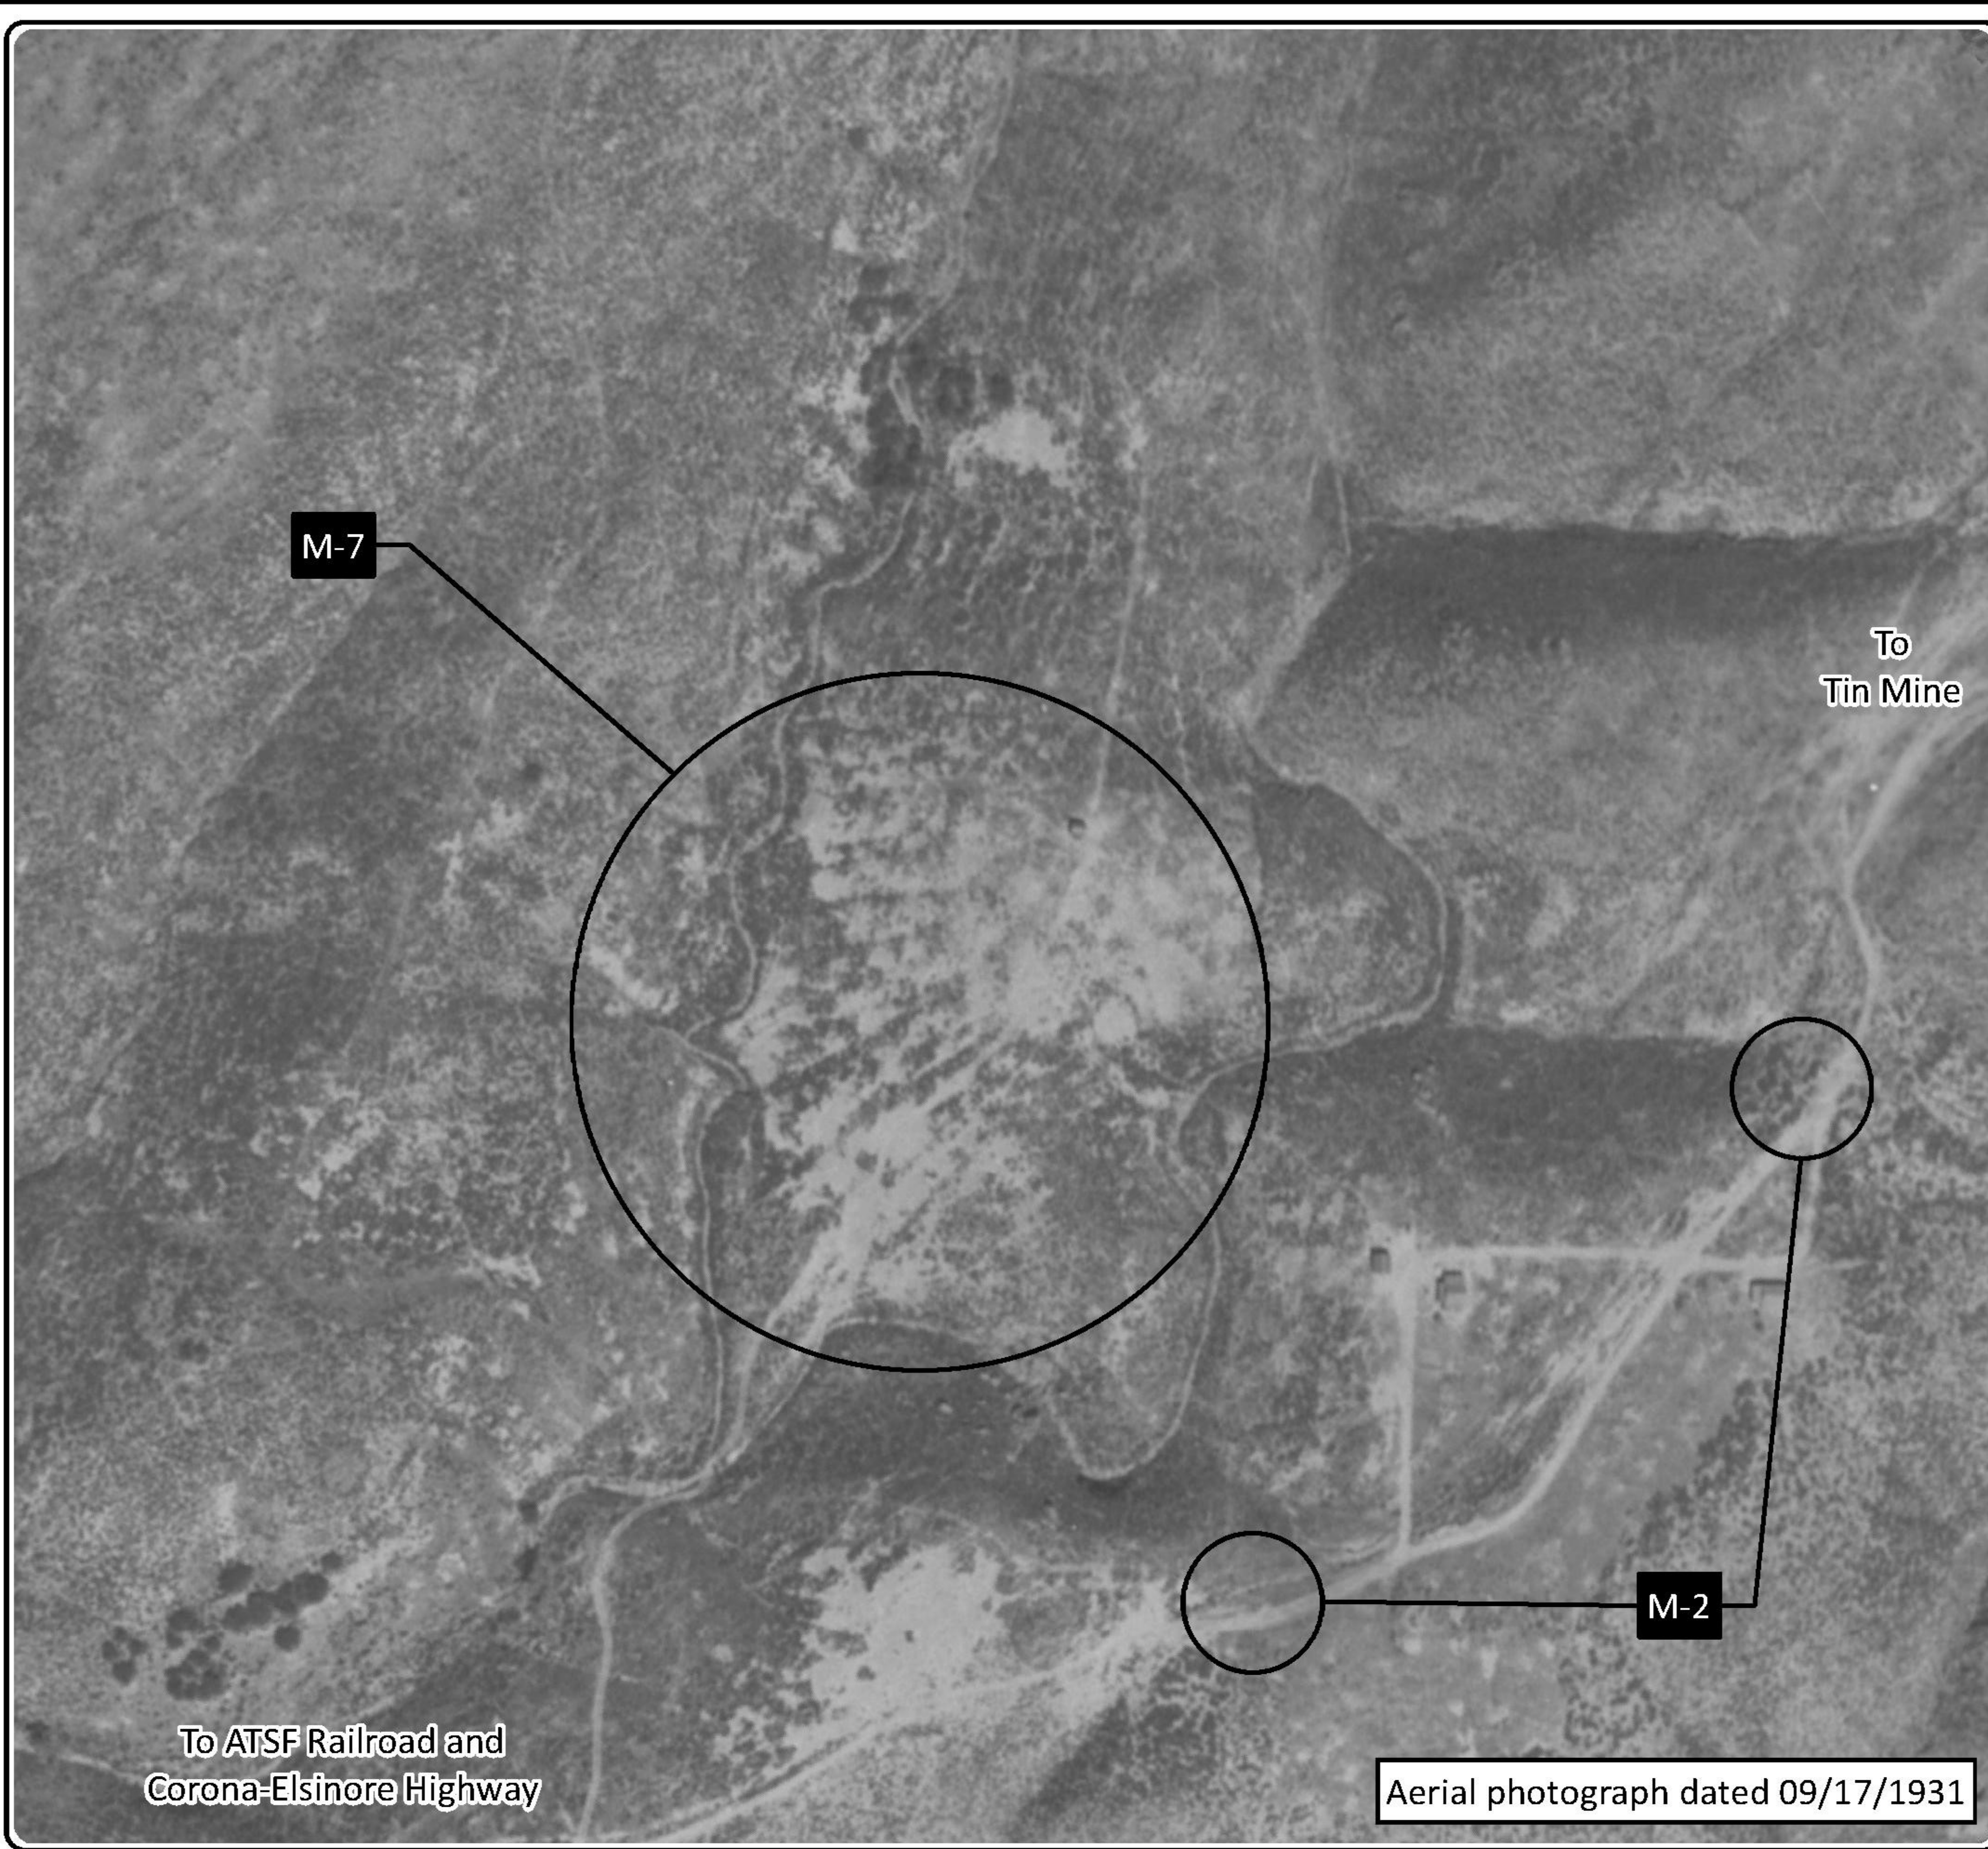
Disturbance Description:

M-7: Clay prospecting and mining (1911), made in conjunction with exploration of Sobrante clay resources, including evaluation of high-aluminum content clay in northwest quarter of HH VRA.

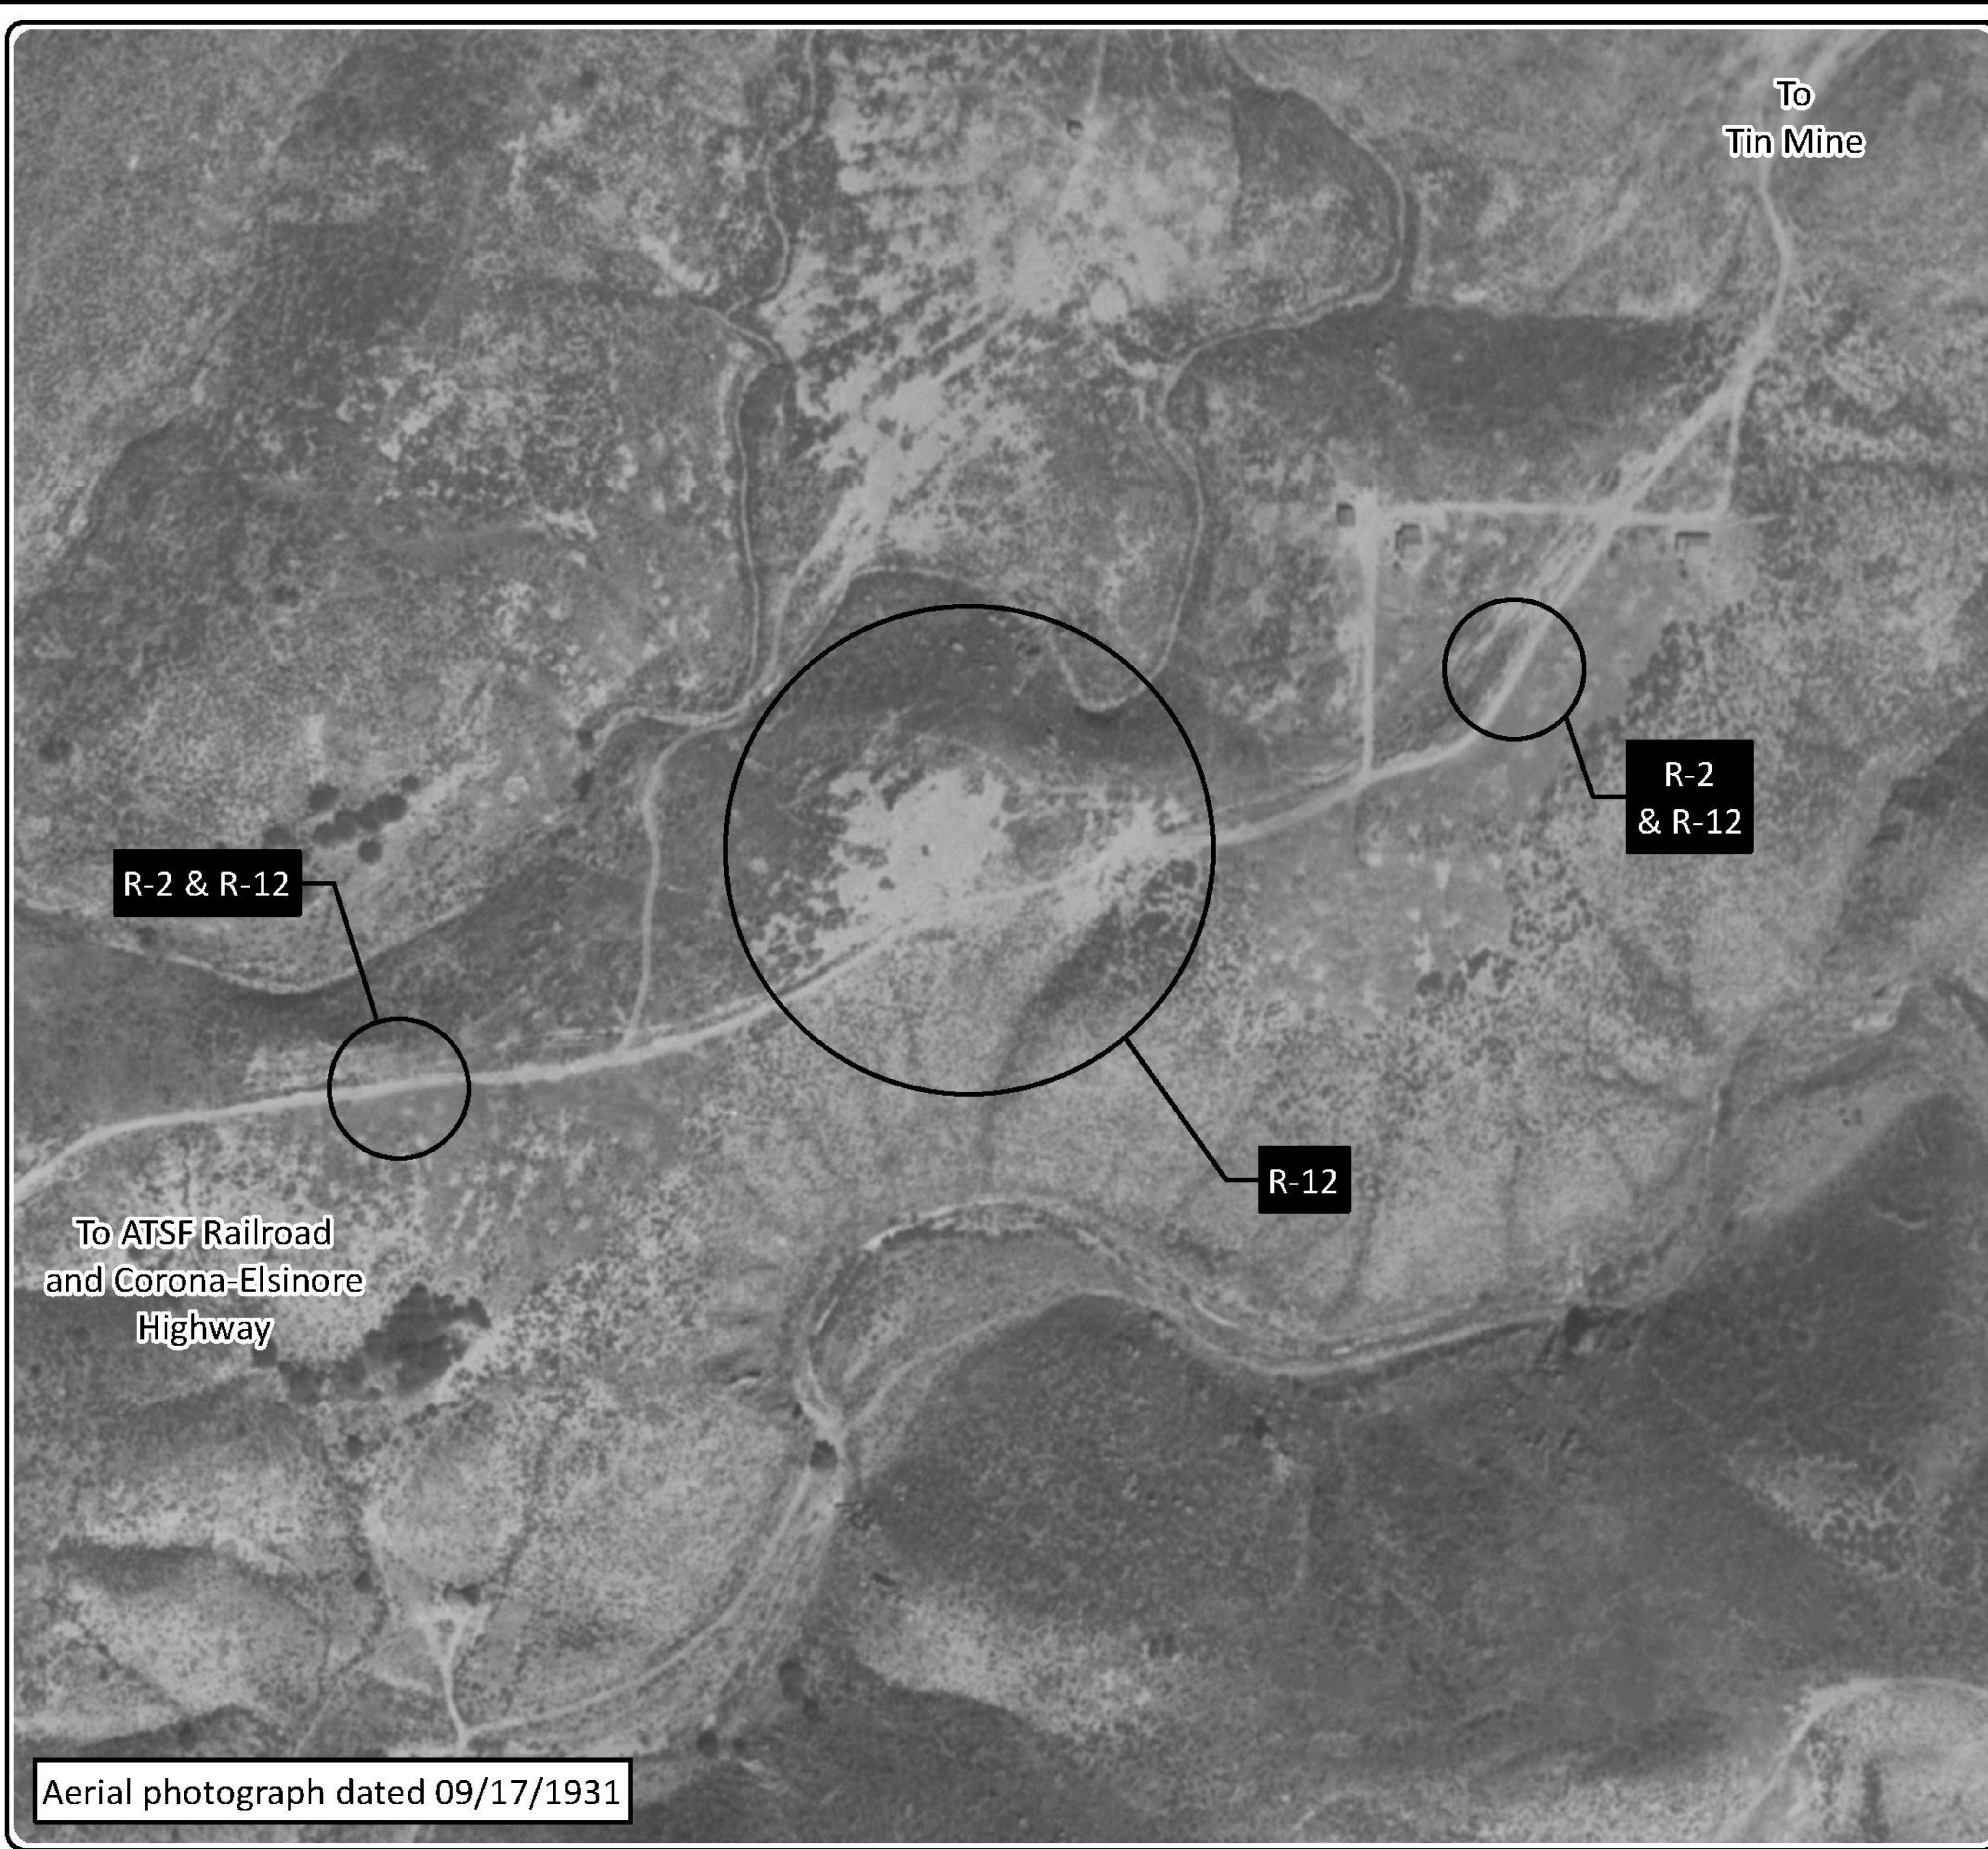
Disturbance Description:

R-12: Sobrante owners open borrow pits which are used to repair and maintain tin mine haul road, in Section 10, within the HH VRA, further facilitating movement of tin resources from northeast of the HH VRA, to market southwest of the HH VRA.

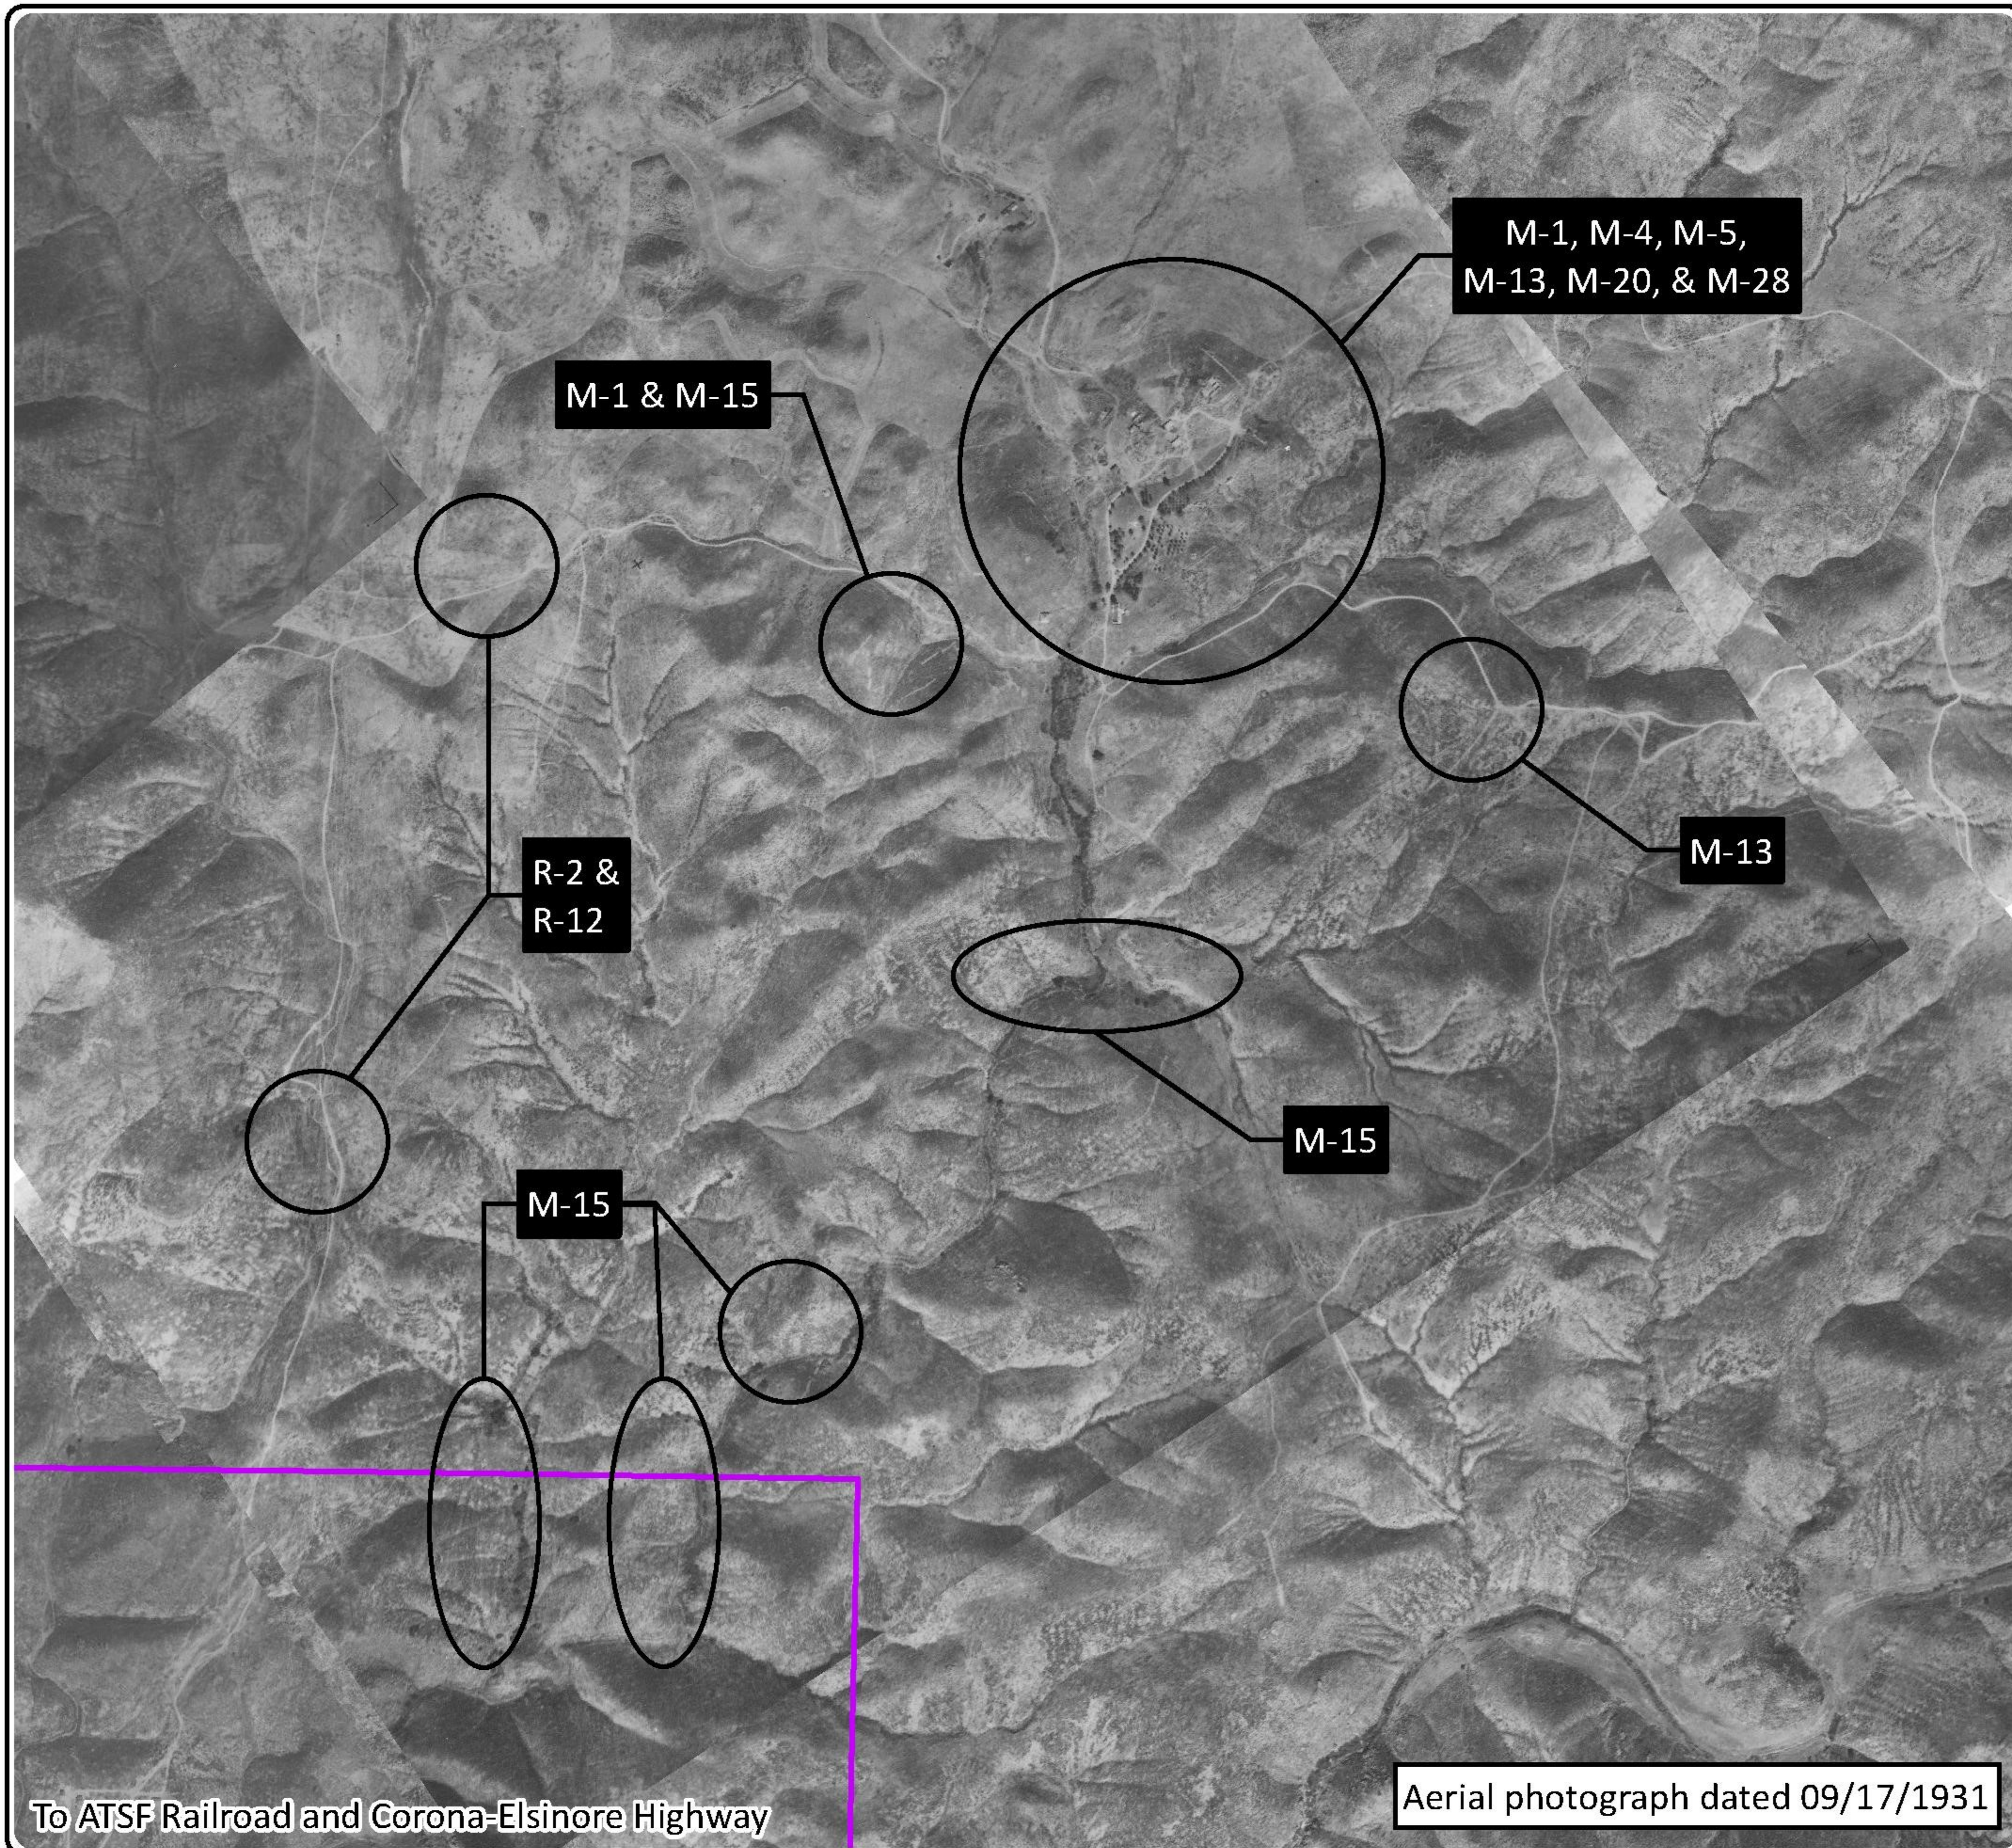
Disturbance Description:

M-15: Excavations of surface tourmaline (tin-bearing igneous rock) veins associated with the Cajalco Tin Mine.

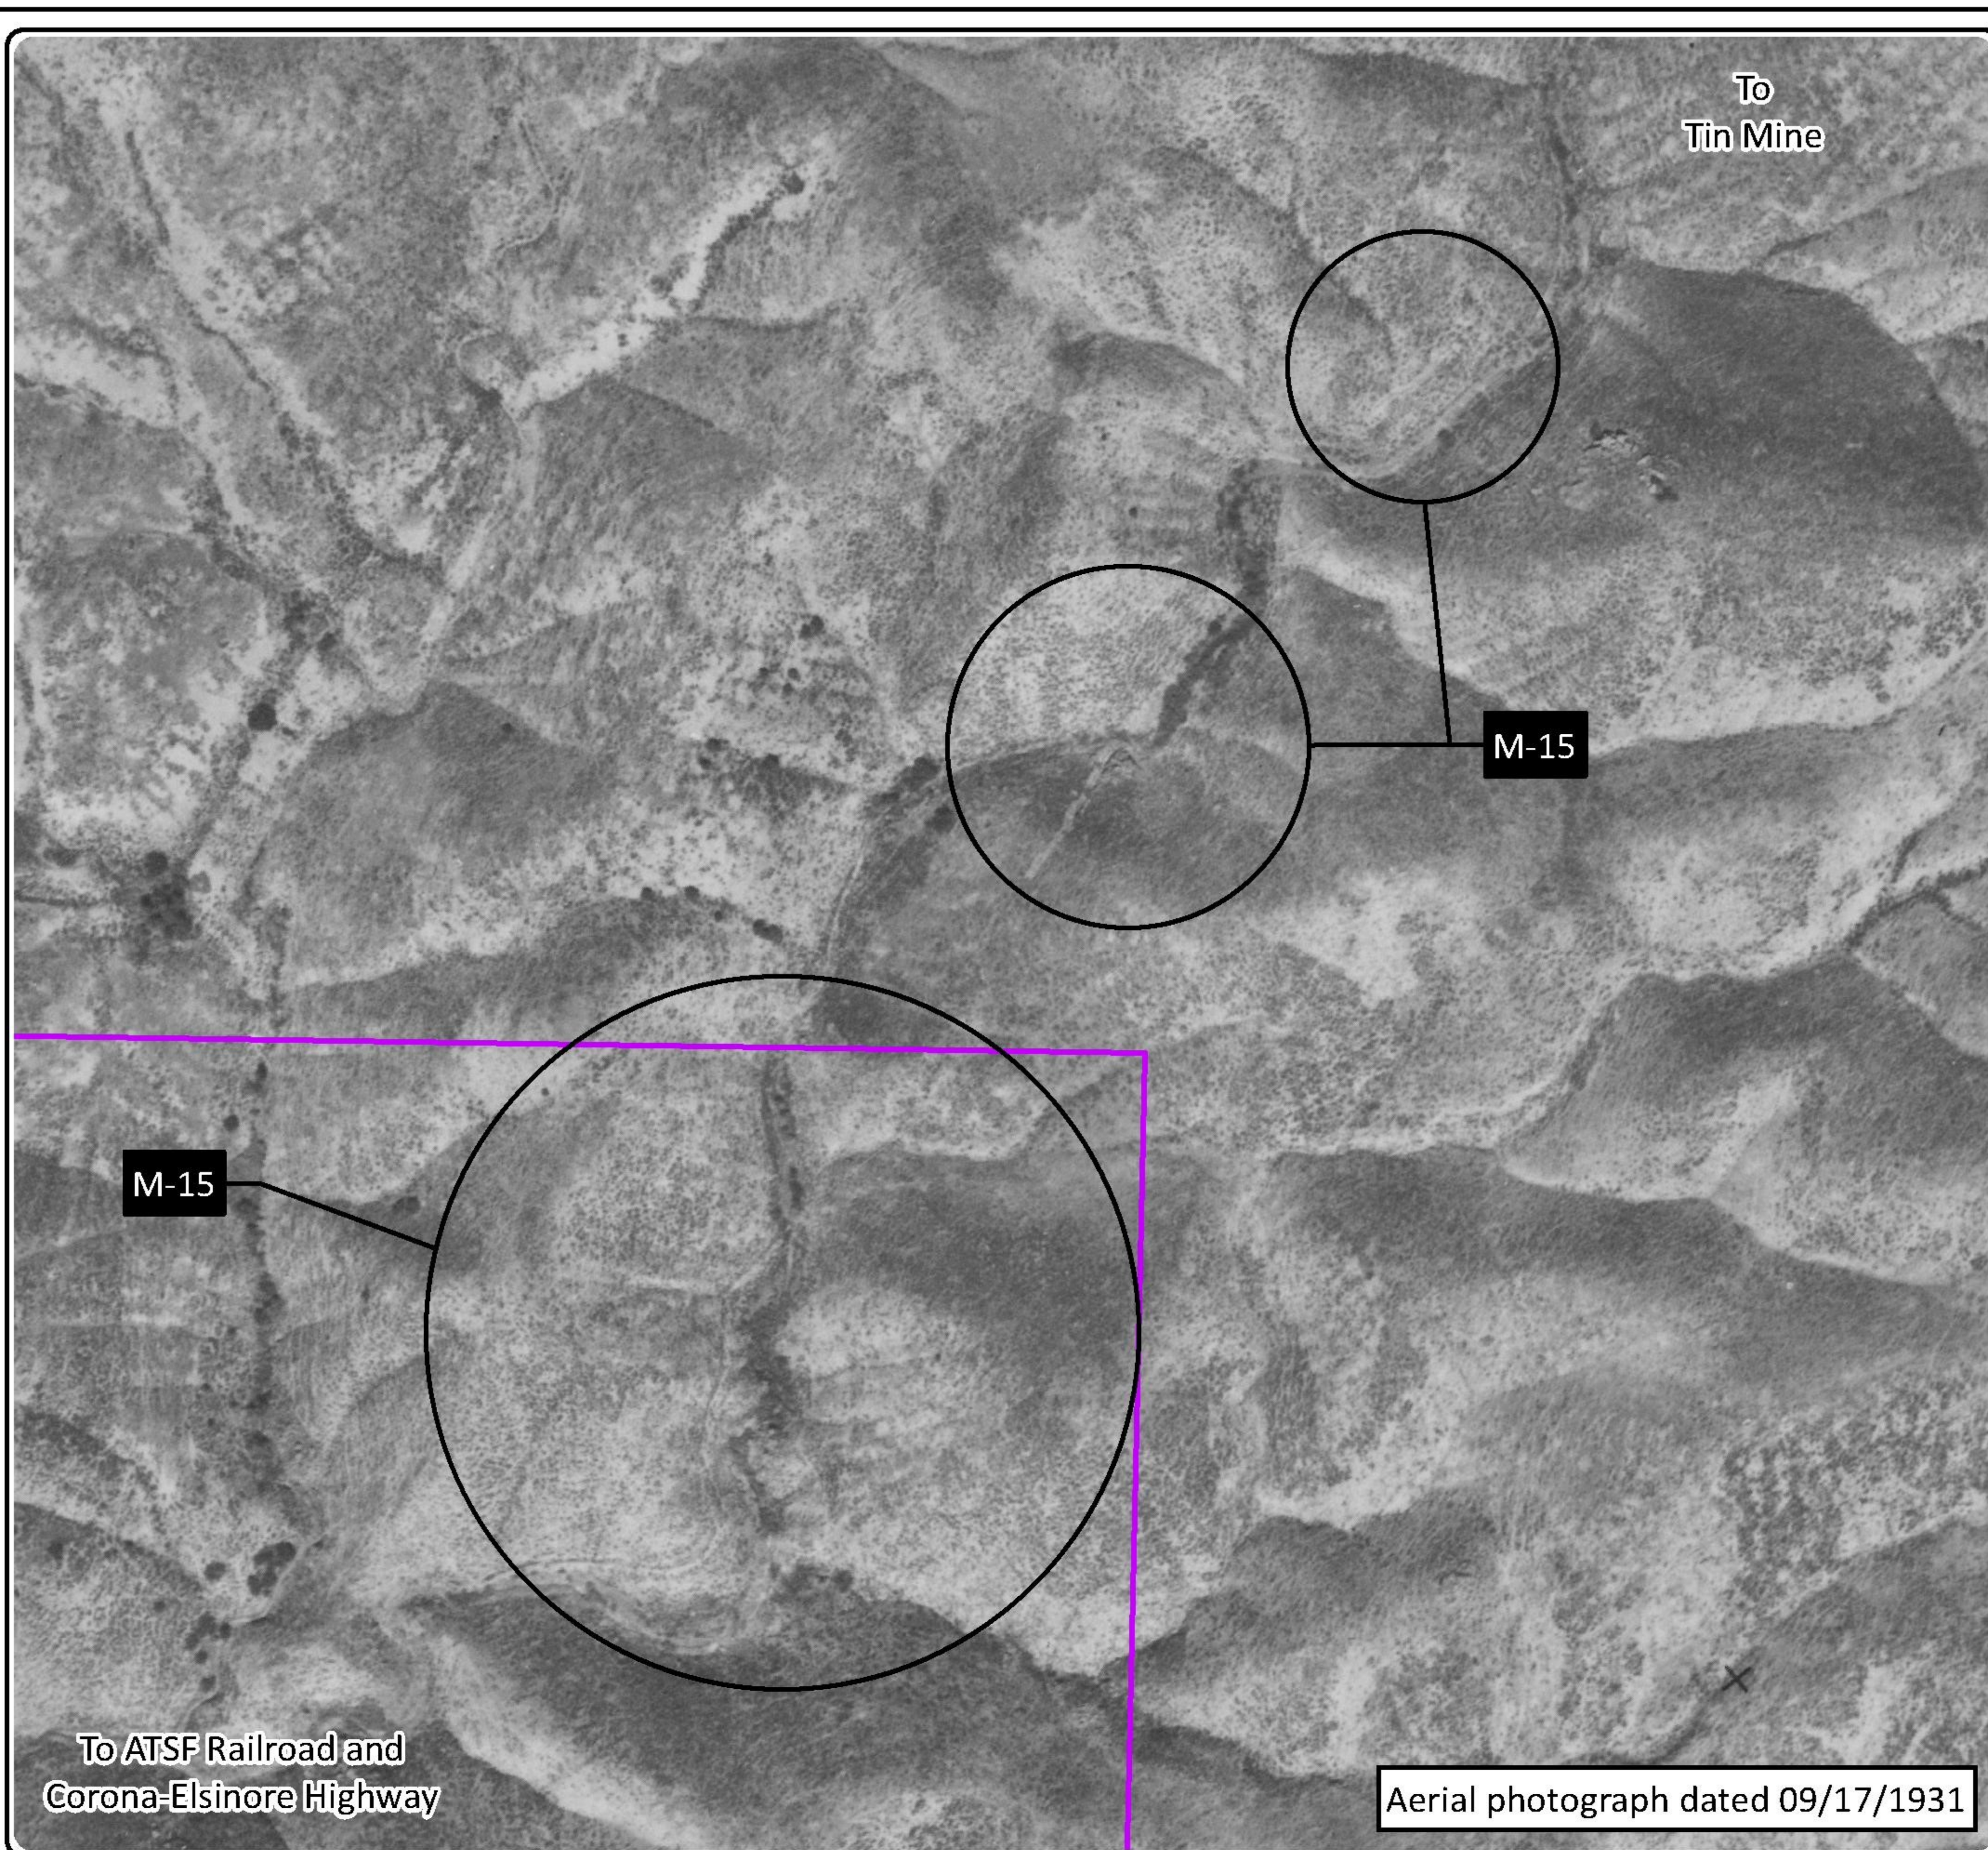
Disturbance Description:

M-15: Excavations of surface tourmaline (tin-bearing igneous rock) veins associated with the Cajalco Tin Mine.

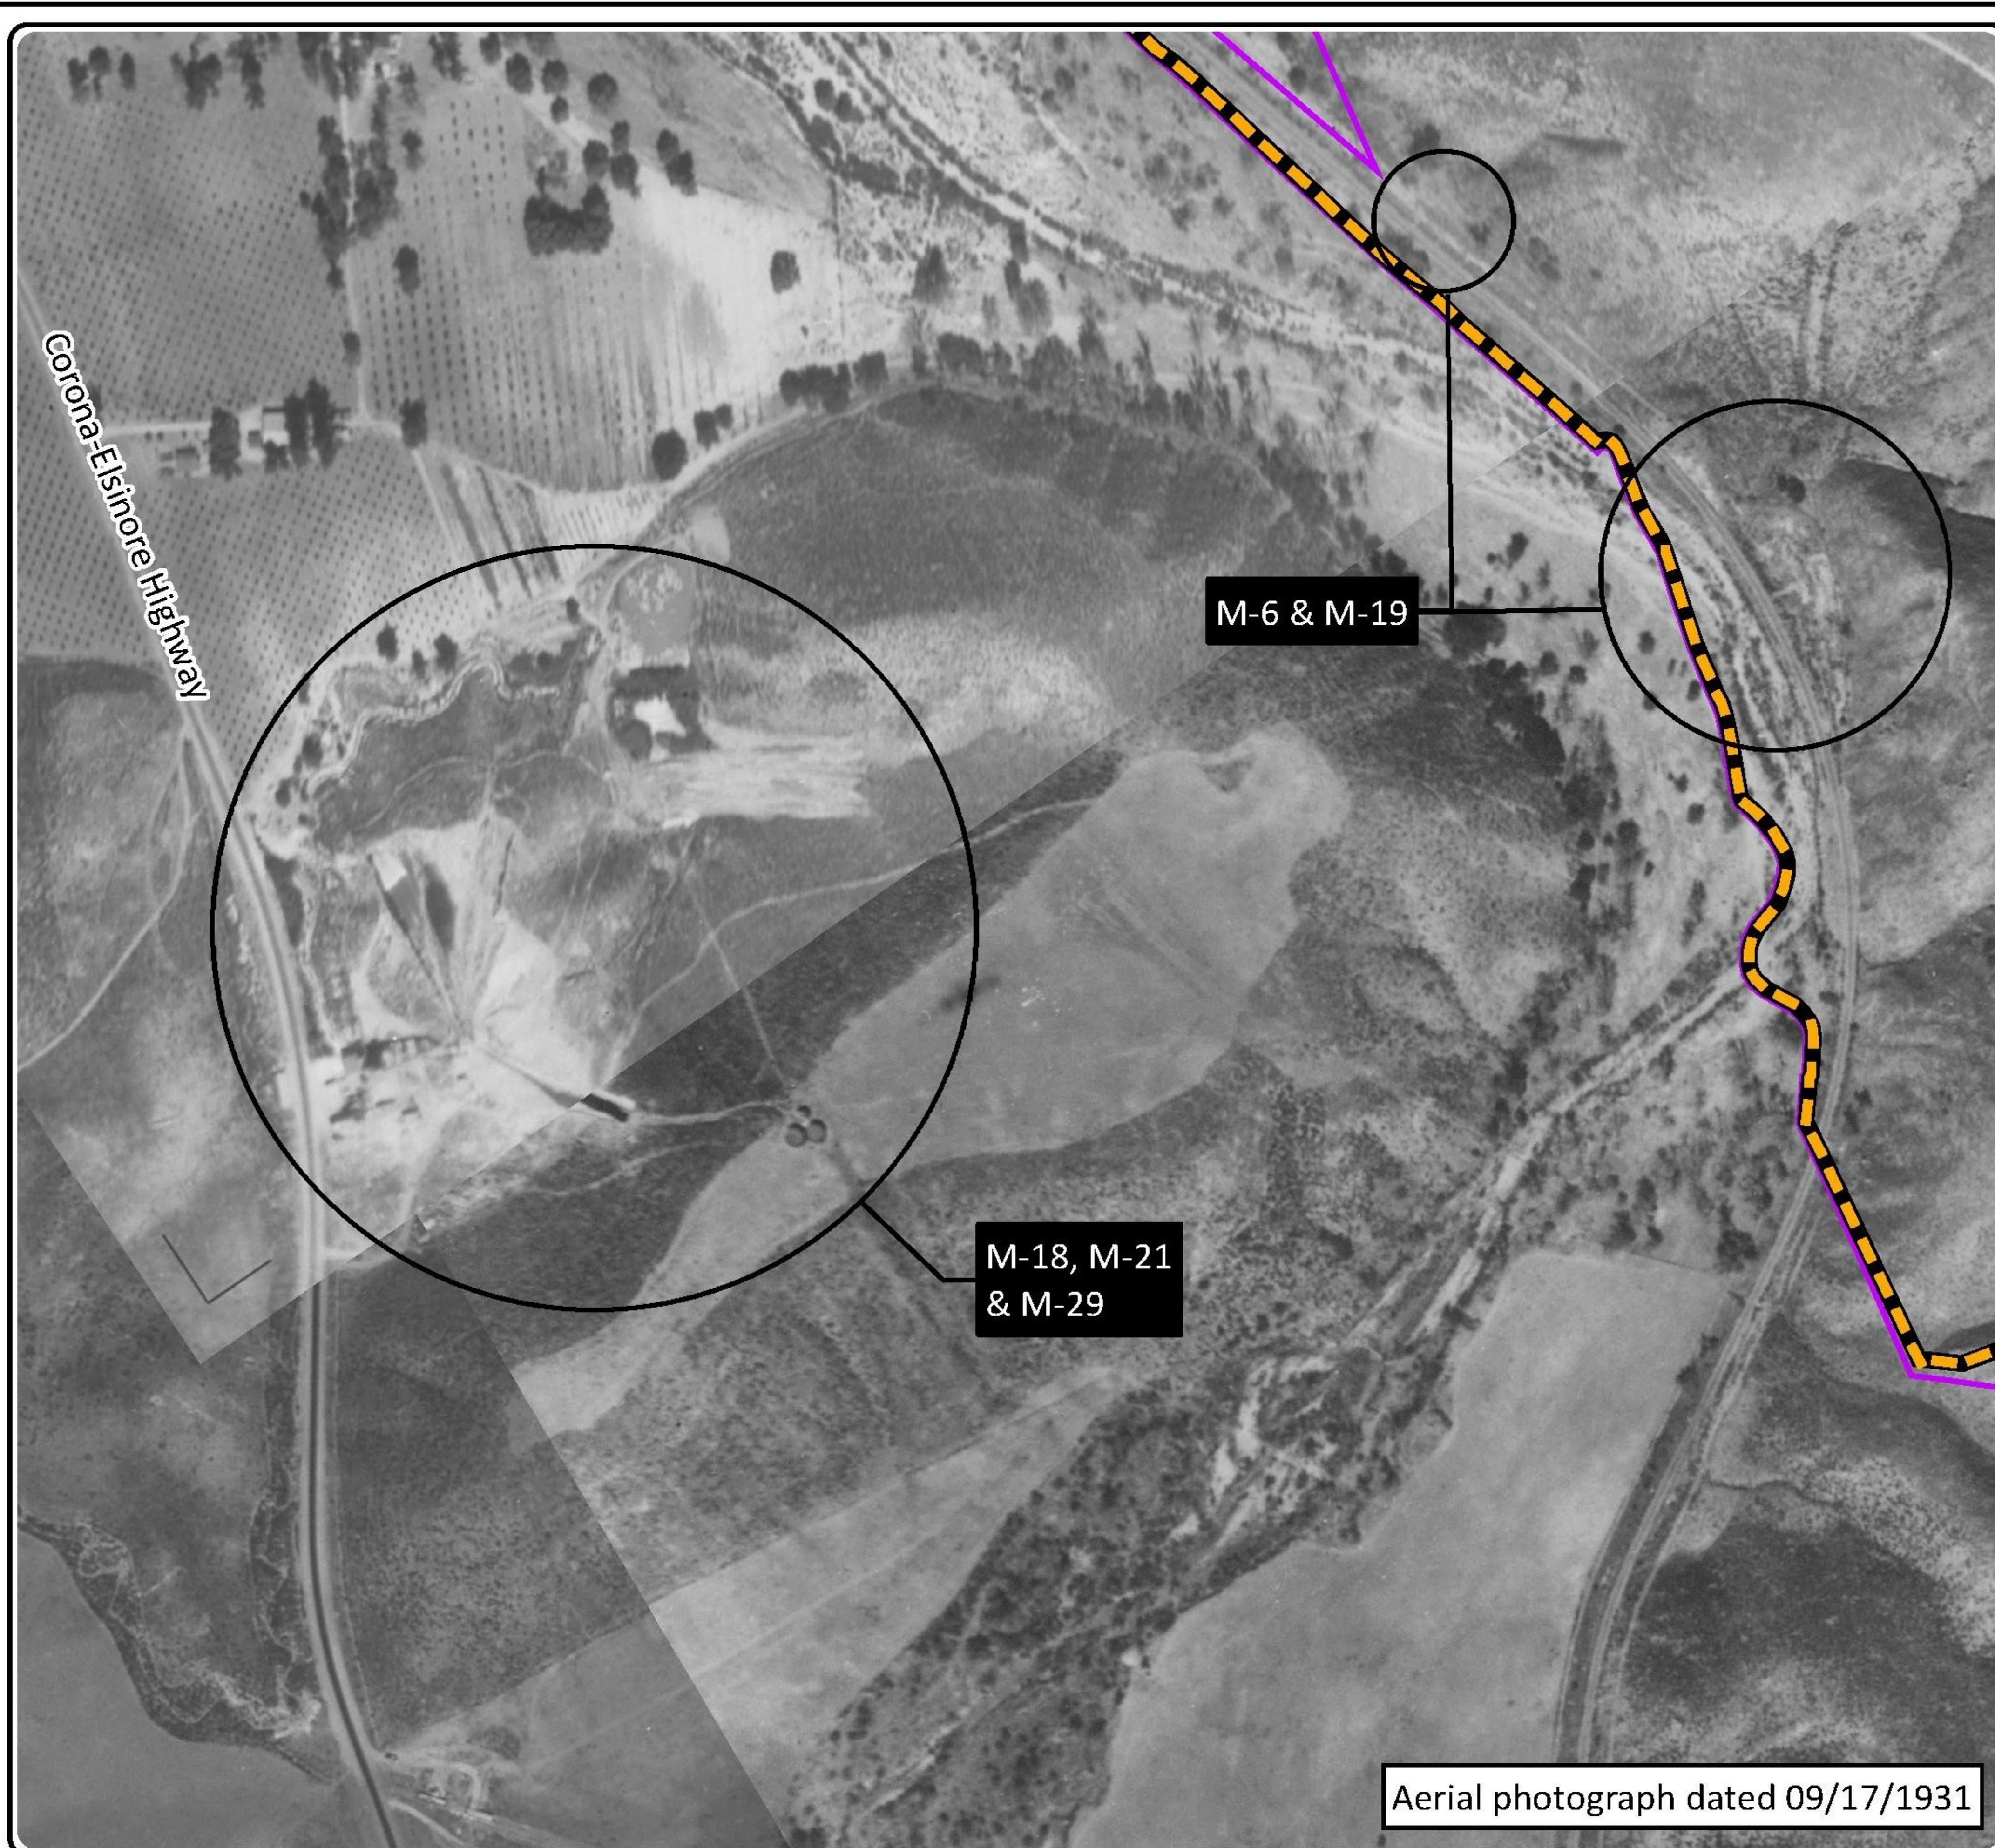
Disturbance Description:

Extent of silica sand disturbances associated with the Corona Sand and Silica Plant (P.J. Weisel), adjacent to and directly on the HH VRA, as of 1931.
