RRM’S Request for Determination of Vested Rights Appendix B: Maps and Graphics

Appendix B – Maps and Graphics
 RRM Request for Determination of Vested Rights
 December 16, 2021

Confirmation of Geographic Scope of HH VRA
Hubbs/Harlow Quarry
Riverside County, California

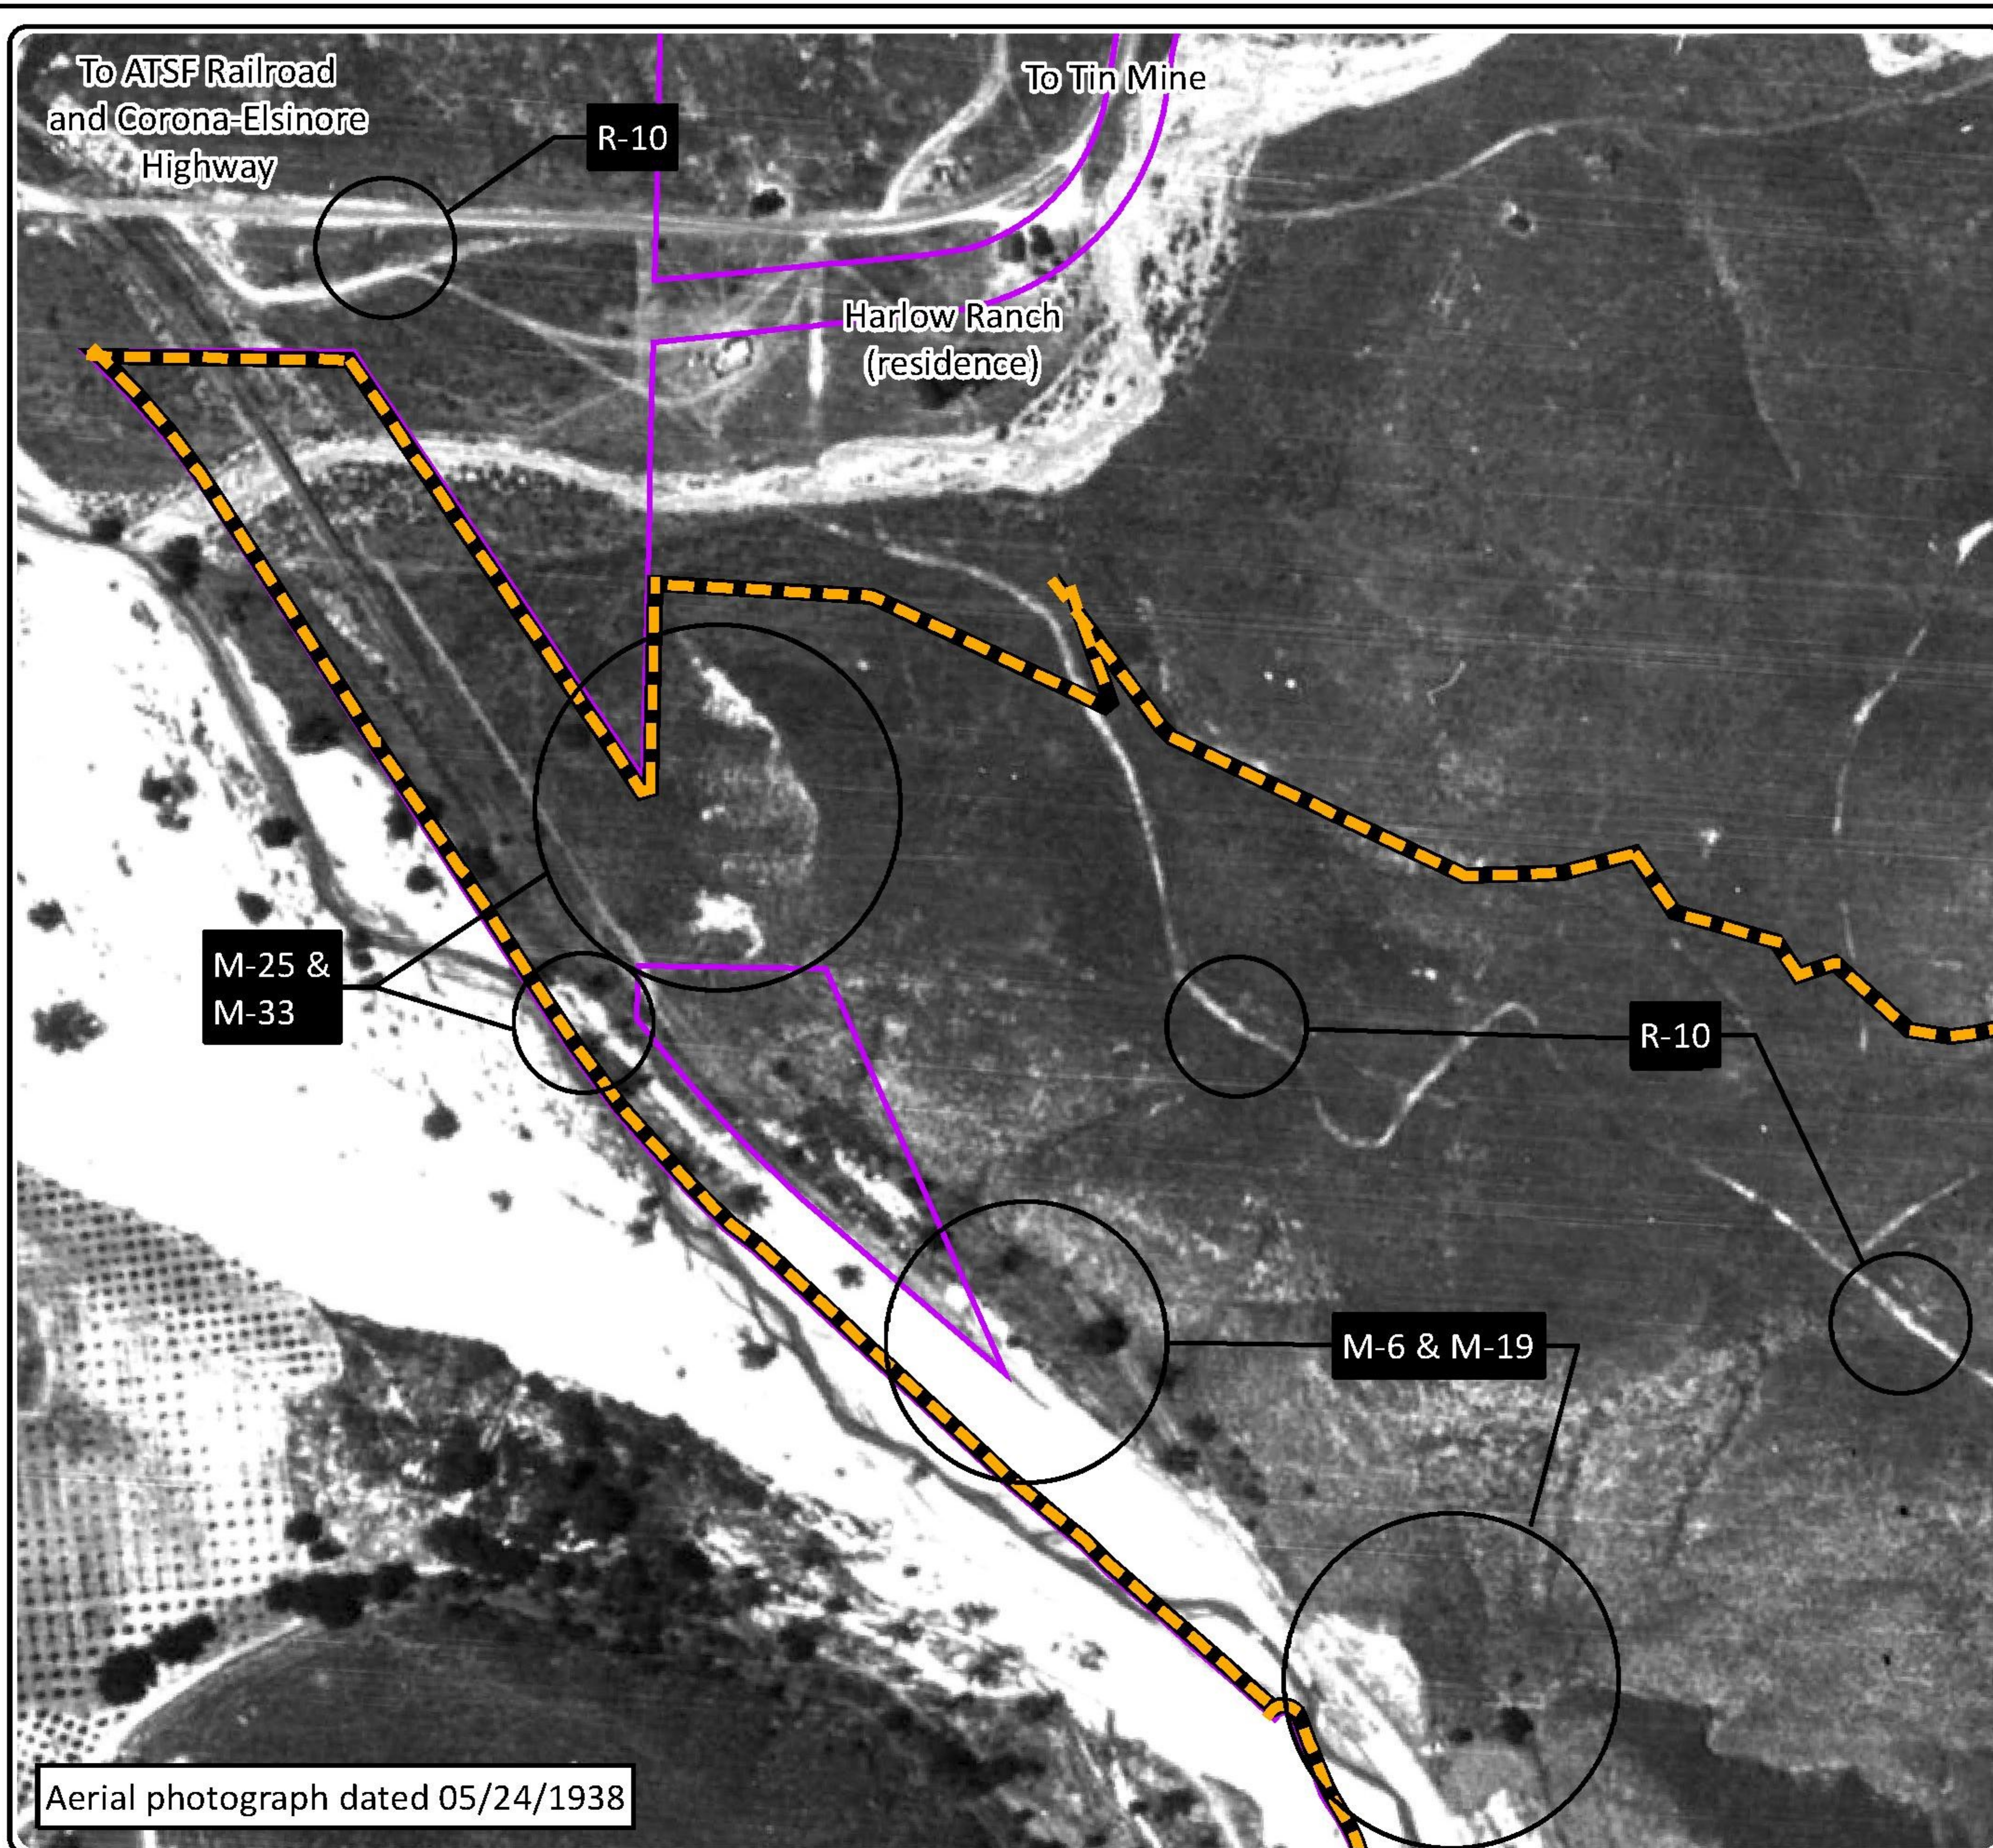
Disturbance Description:

M-25: Pacific Clay Products begins operations at Cajalco Clay Pit, located primarily within S-4 VRA.

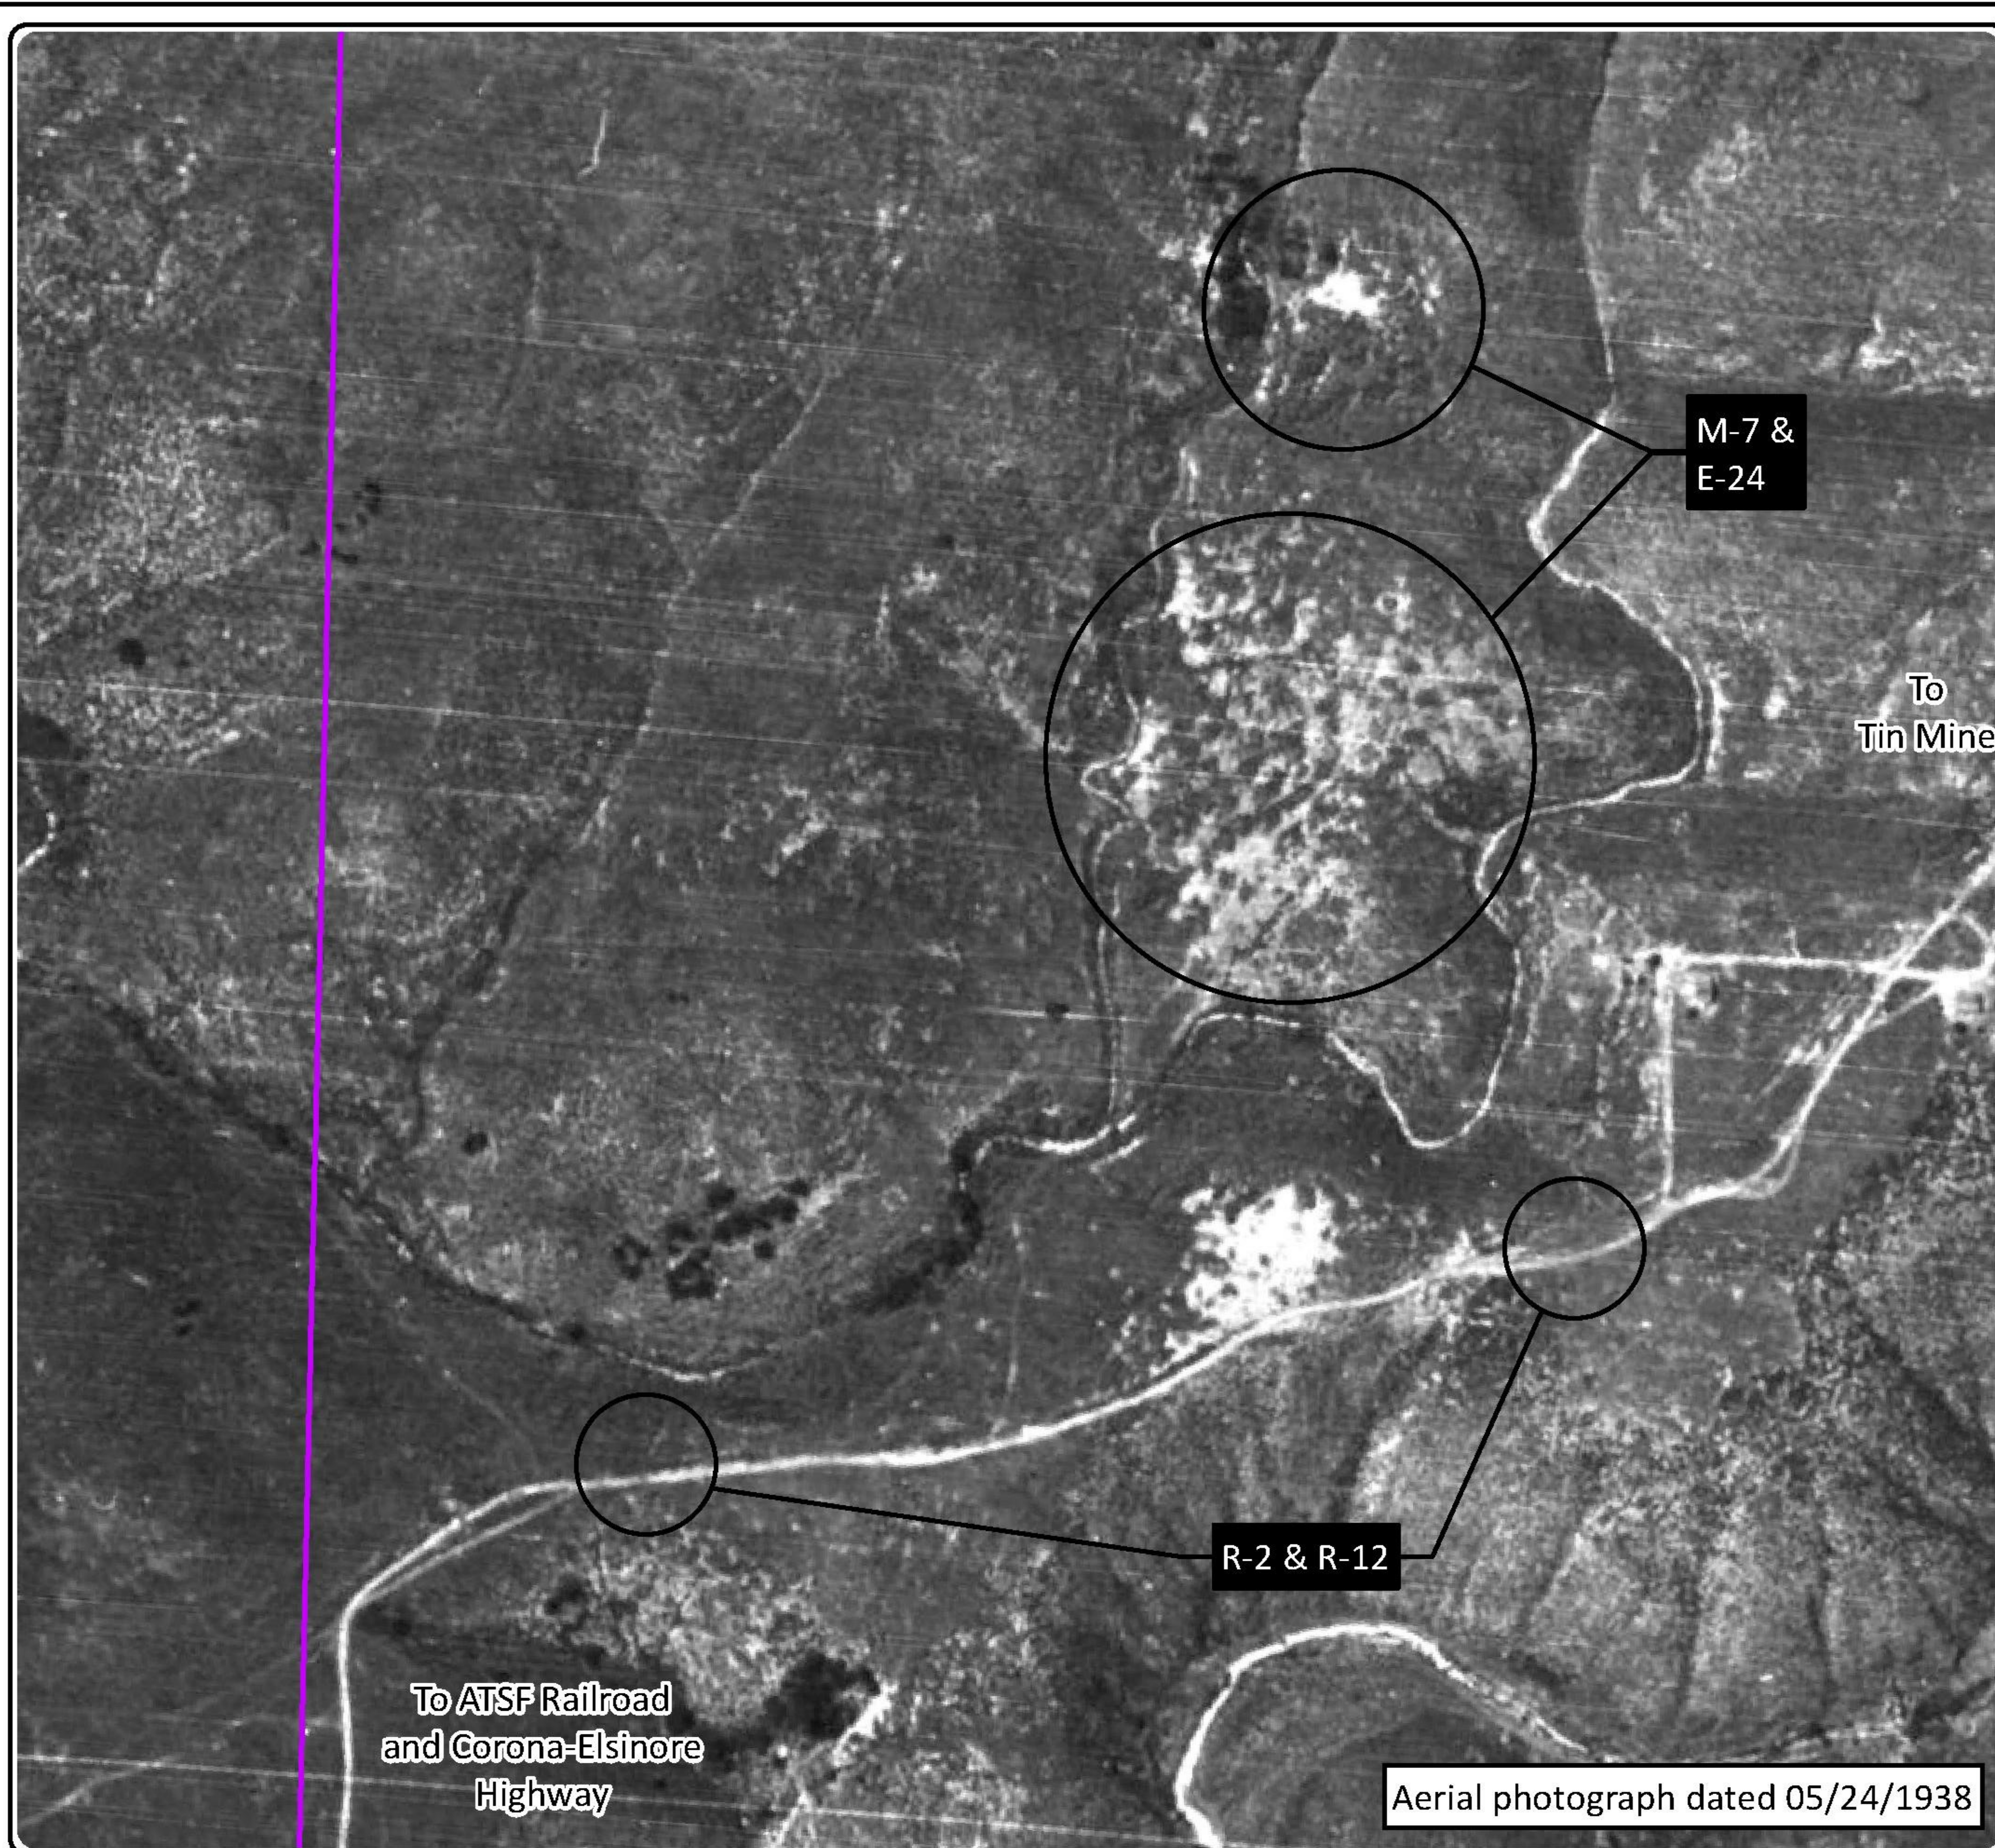
Disturbance Description:

M-7: Exploration of regional clay resources (See Figure 4.3 for detailed description).

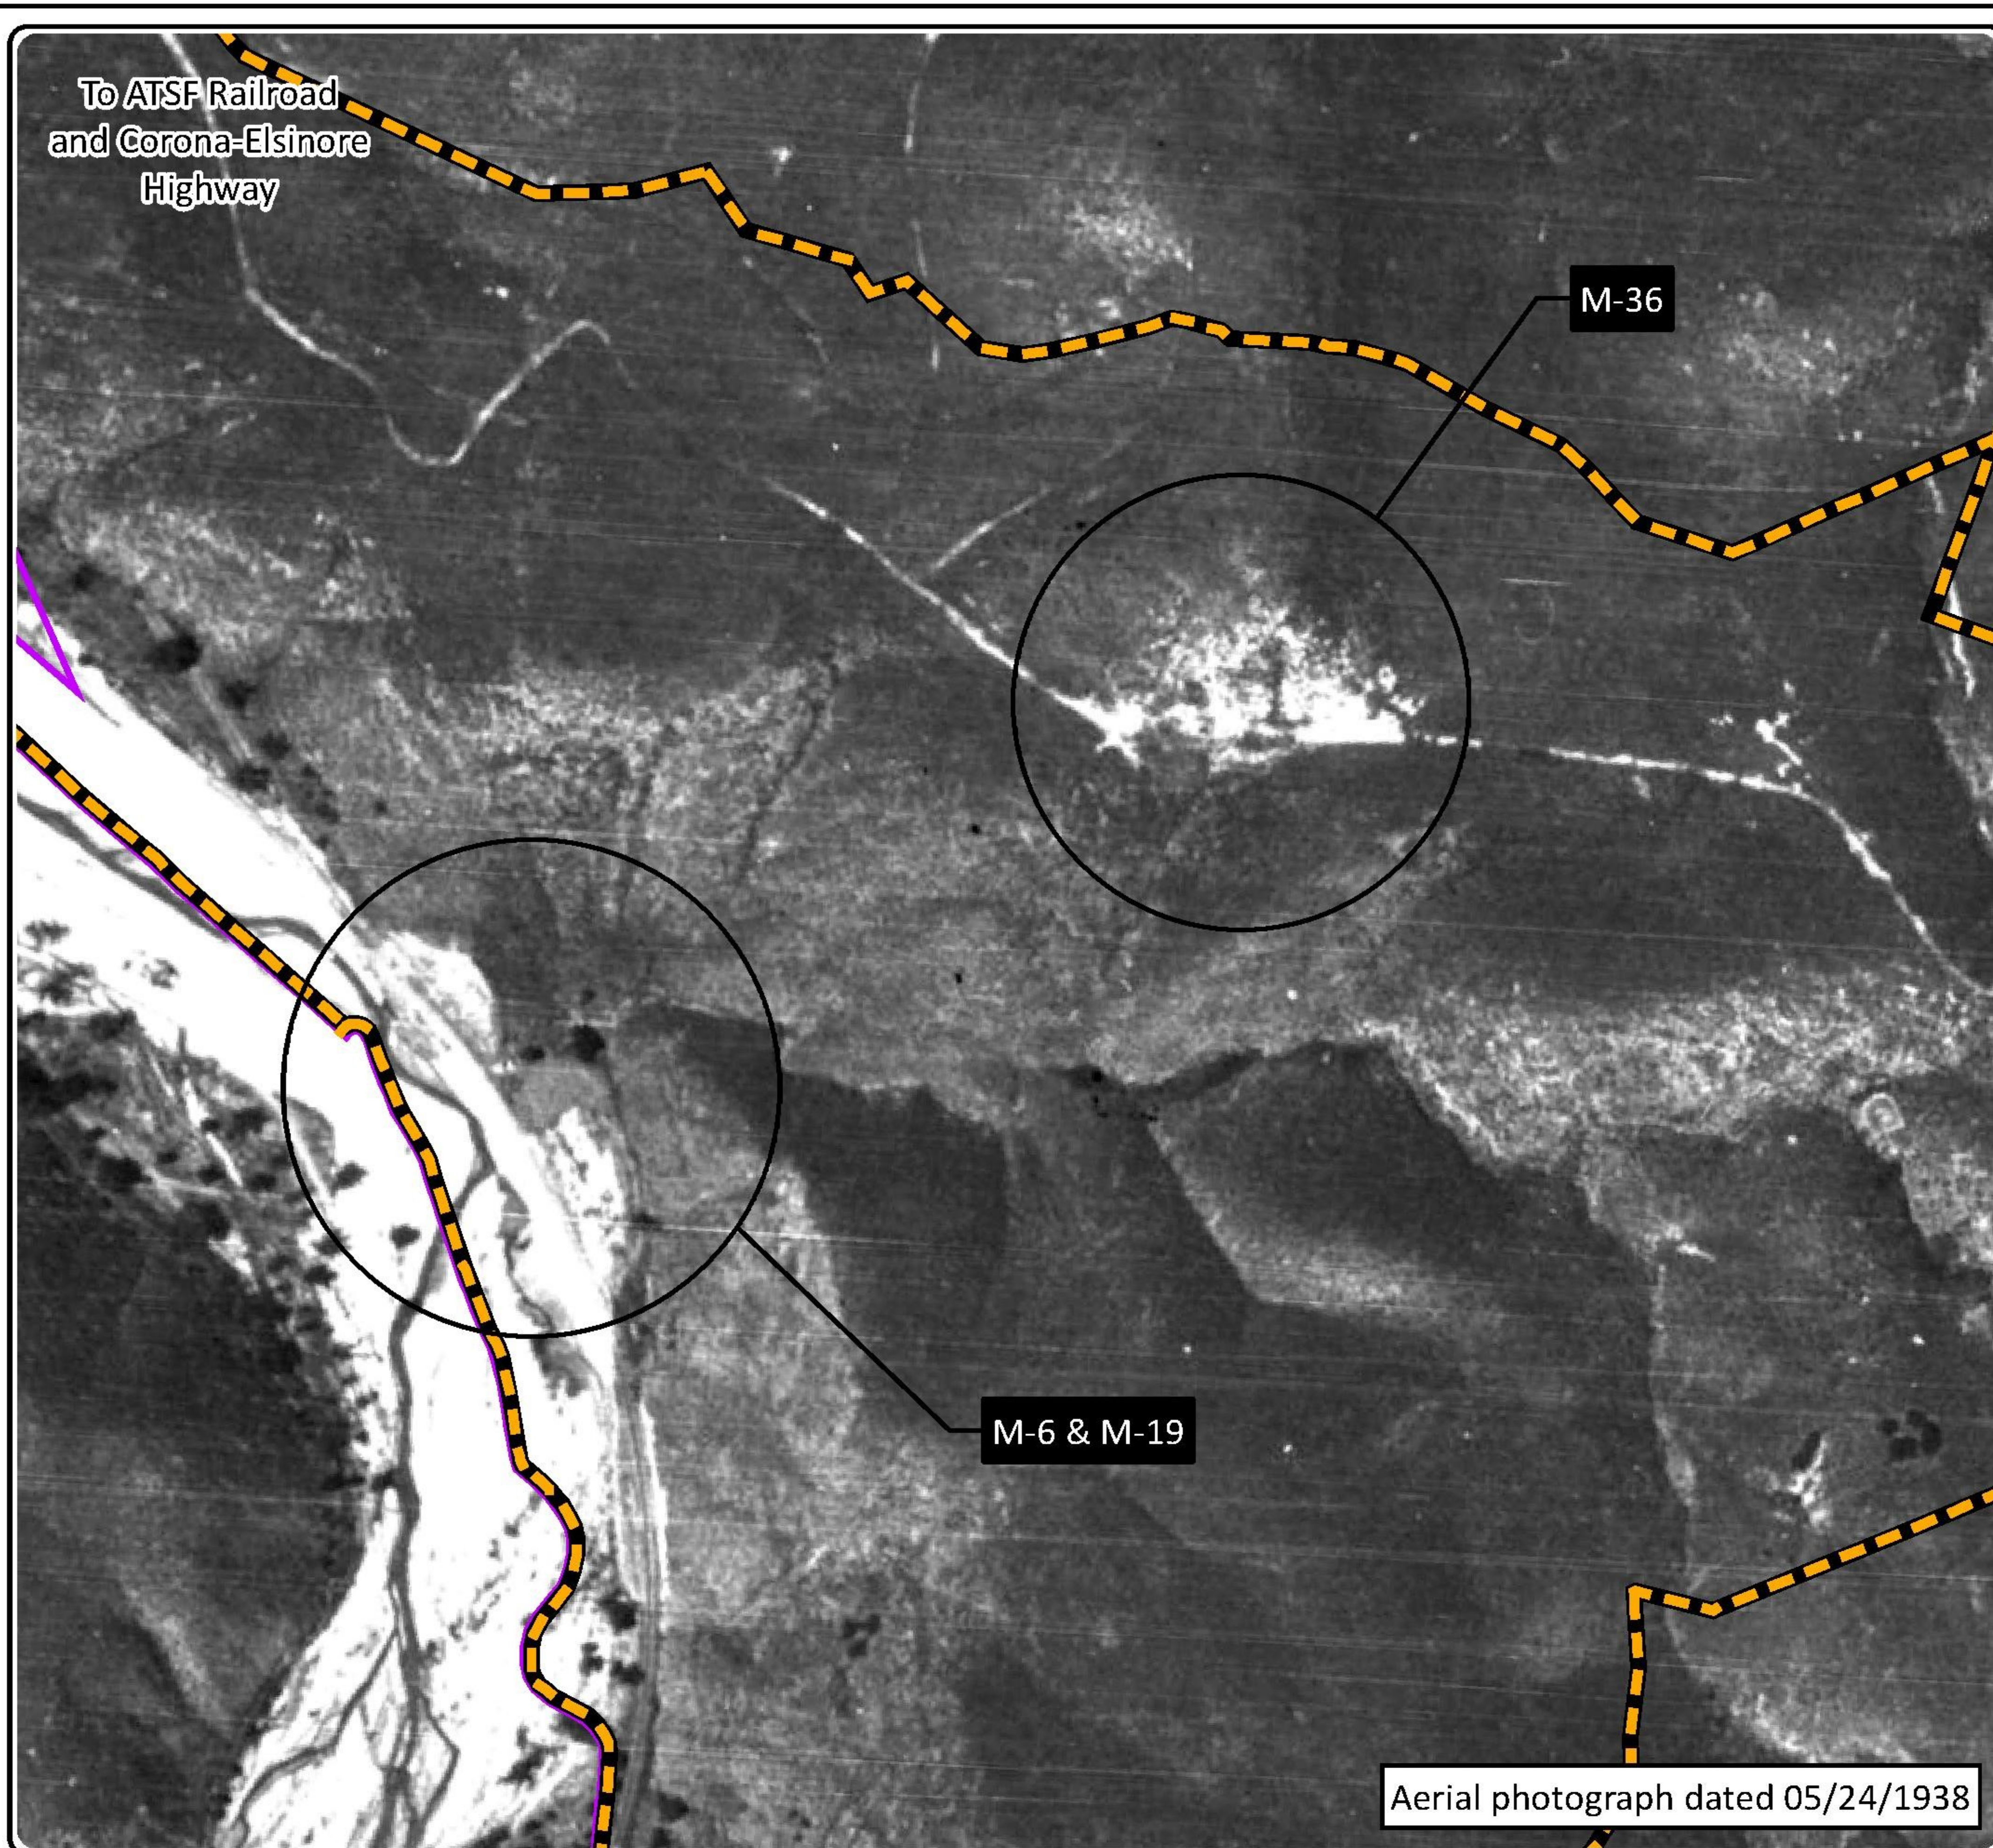
Disturbance Description:

M-36: Early stages (1938) of Blarney Stone operation prior to increased production for construction of Prado Dam.

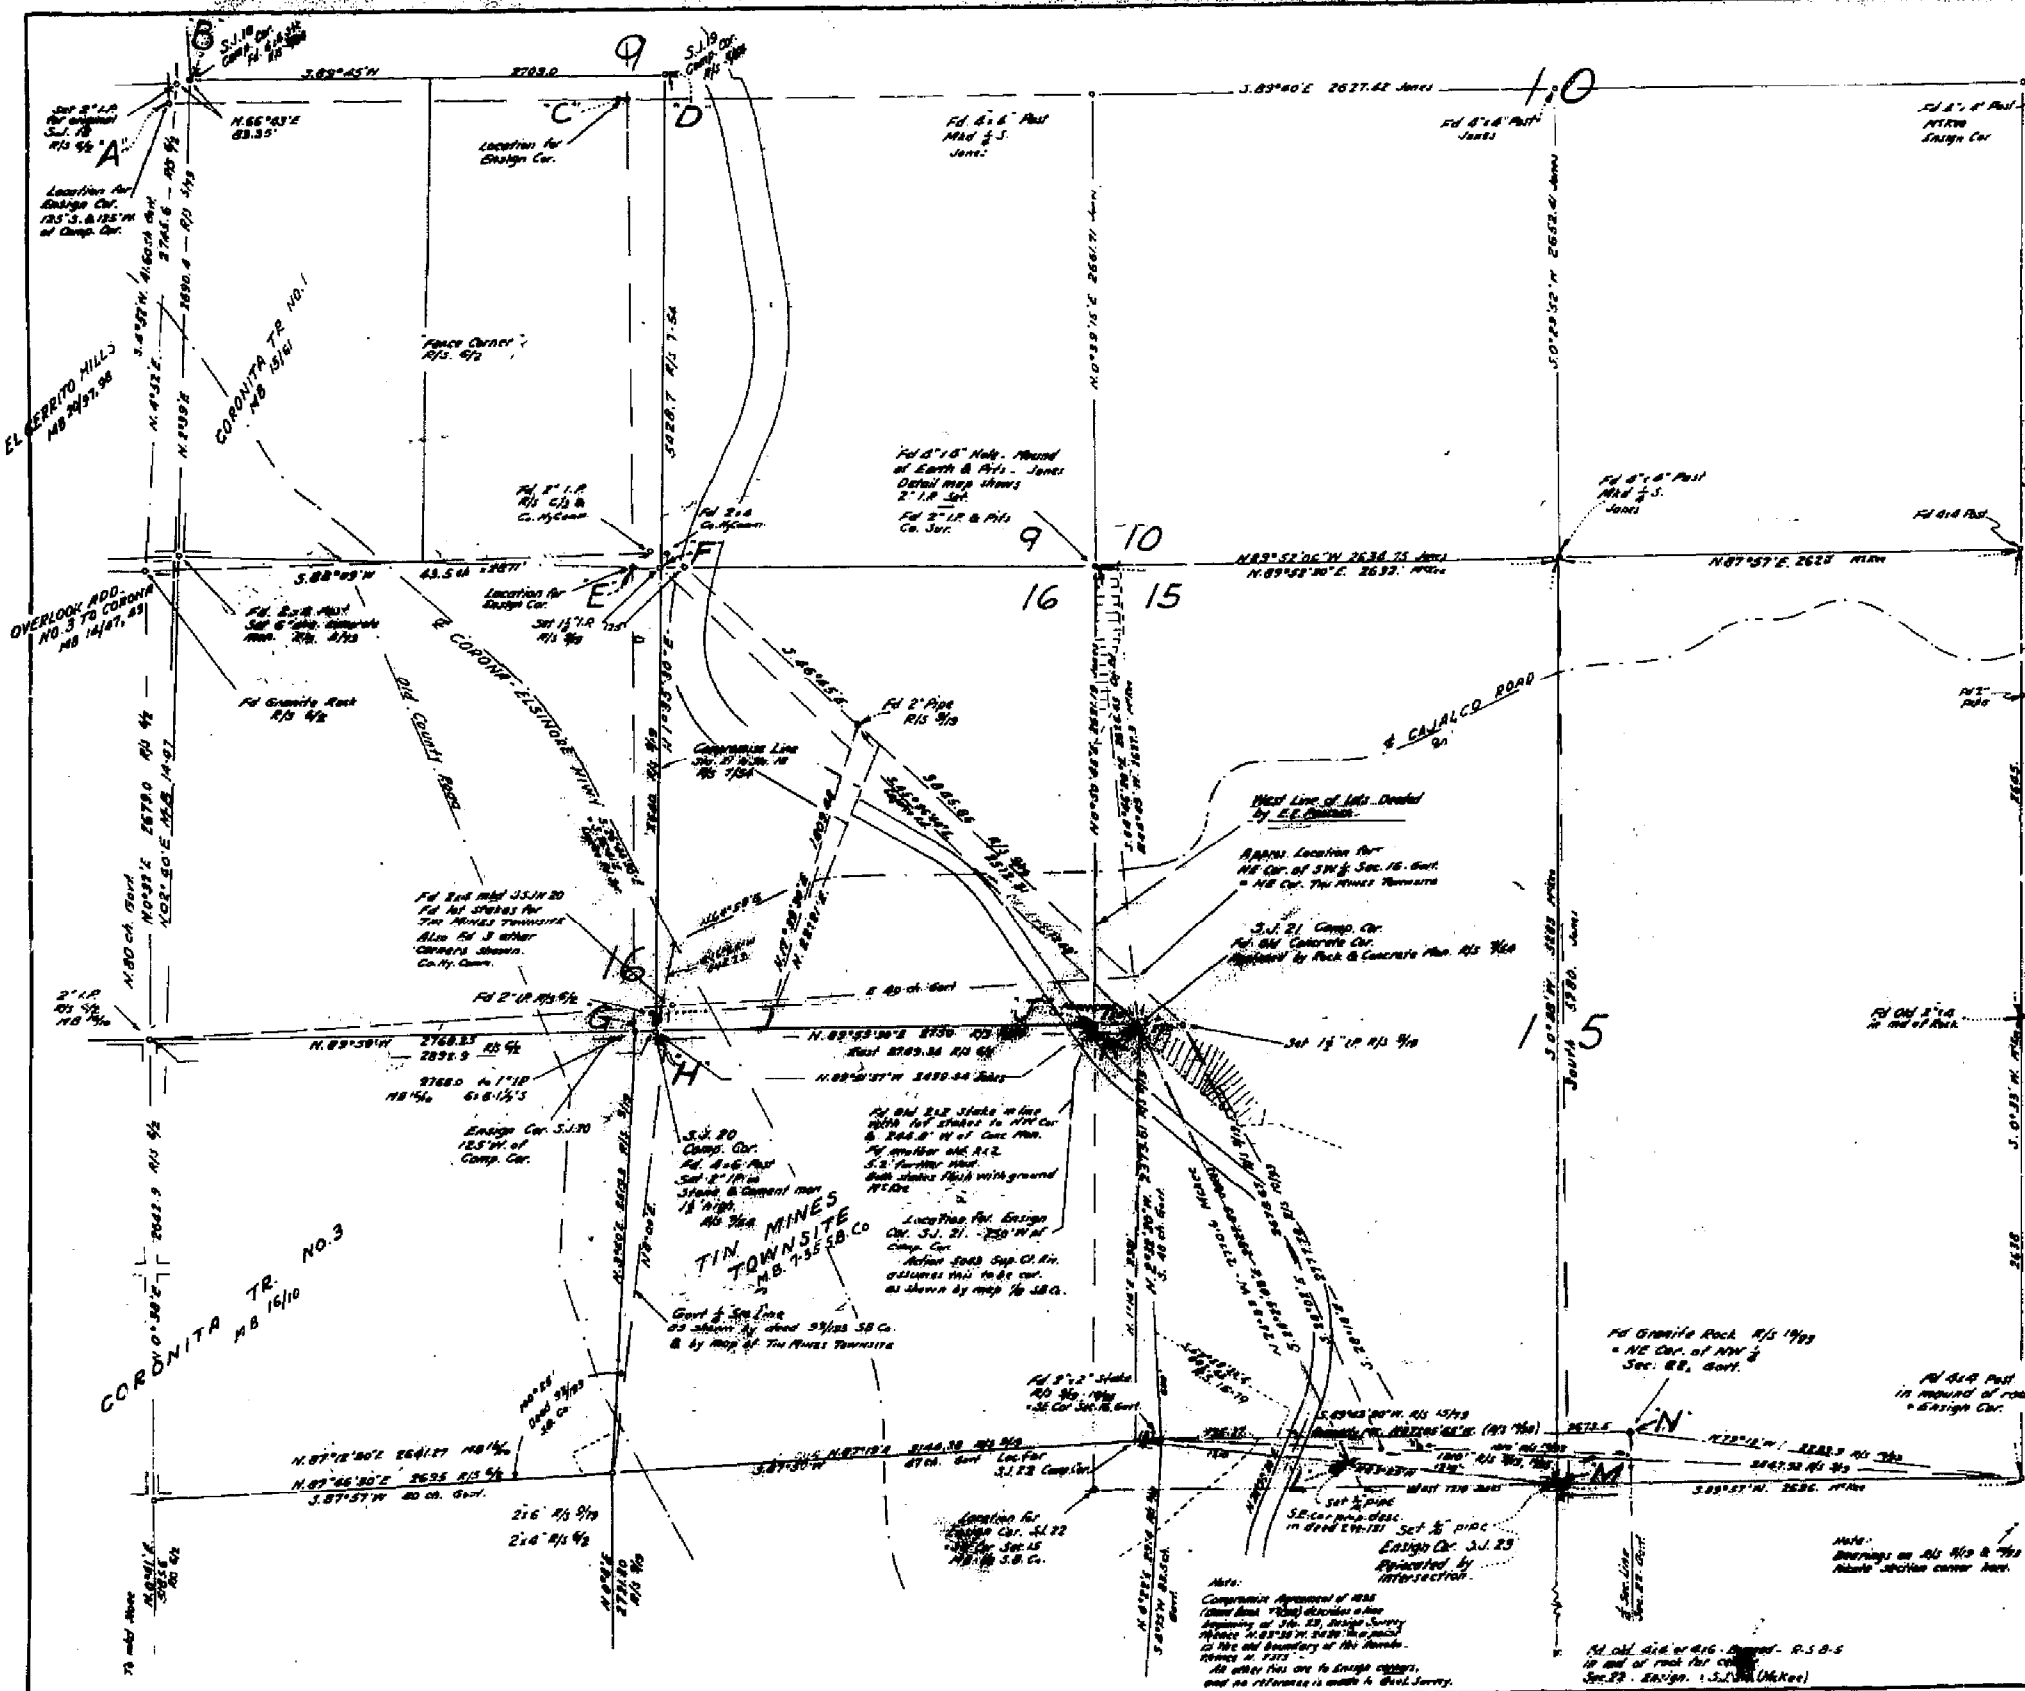
Figure B-5.8:
1948 Record of Survey

Harlow commission an ambitious Record of Survey of the entire HH VRA site and adjoining mineral property to define and fully exploit the mineral resources, spurred on by failed effort to acquire nearby mineral lands, coupled with rapidly expanding mineral operations, demonstrating an intent to appropriate the entire HH VRA as a mine site.

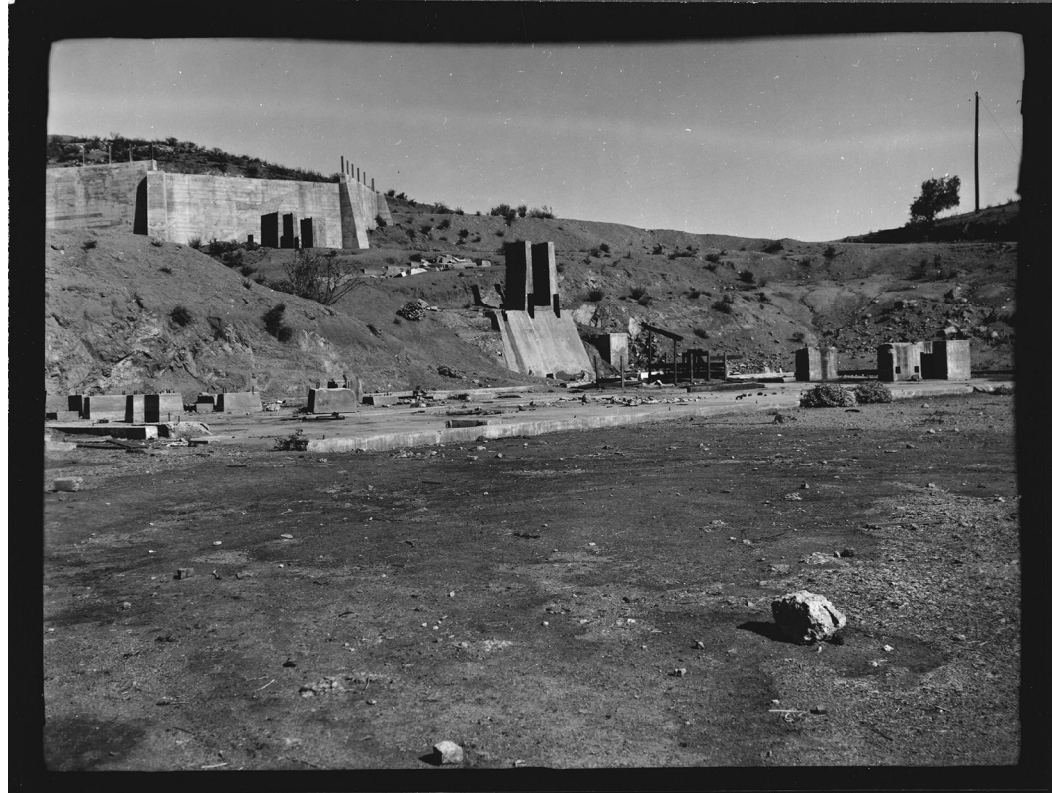
Photo #1: Temescal Tin Mine – Smelting Plant

Remnants of Tim Mine production facilities and surface excavations of tourmaline veins, which required tin mine haul road through HH VRA to move produced materials to market.

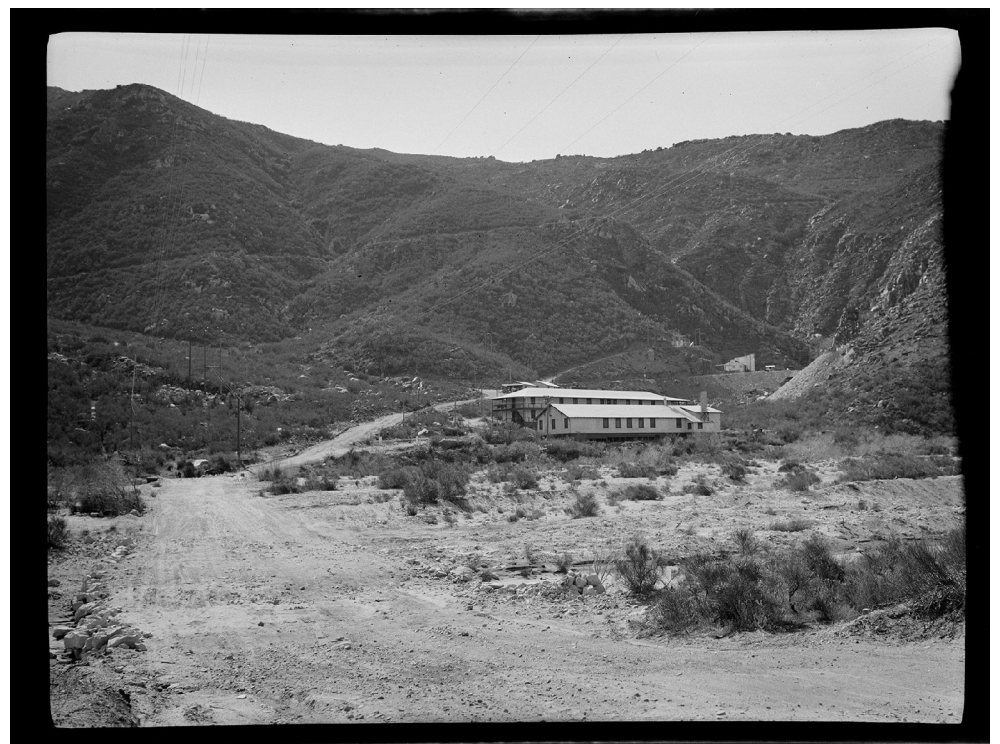
Aerial photograph dated 1949. The accuracy of the base map is limited as it is not a part of any field survey on the ground.

Tin mine facilities likely erected in conjunction with tin mine efforts during World War II (1942-1945), located along Tin Mine Haul Road (visible in foreground), which ran through the HH VRA.

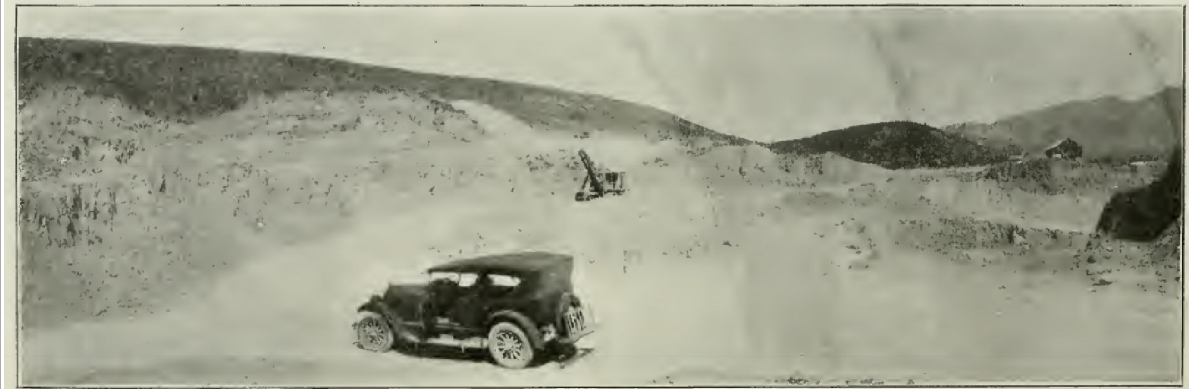
PHOTO No. 45. Emsco Clay Co. Harrington pit, facing east, 8 miles SE. from Corona, Riverside County. The shovel is standing on top of the 'Harrington No. 5' fireclay (sample No. 70) and is digging pink mottled clay (sample No. 71).

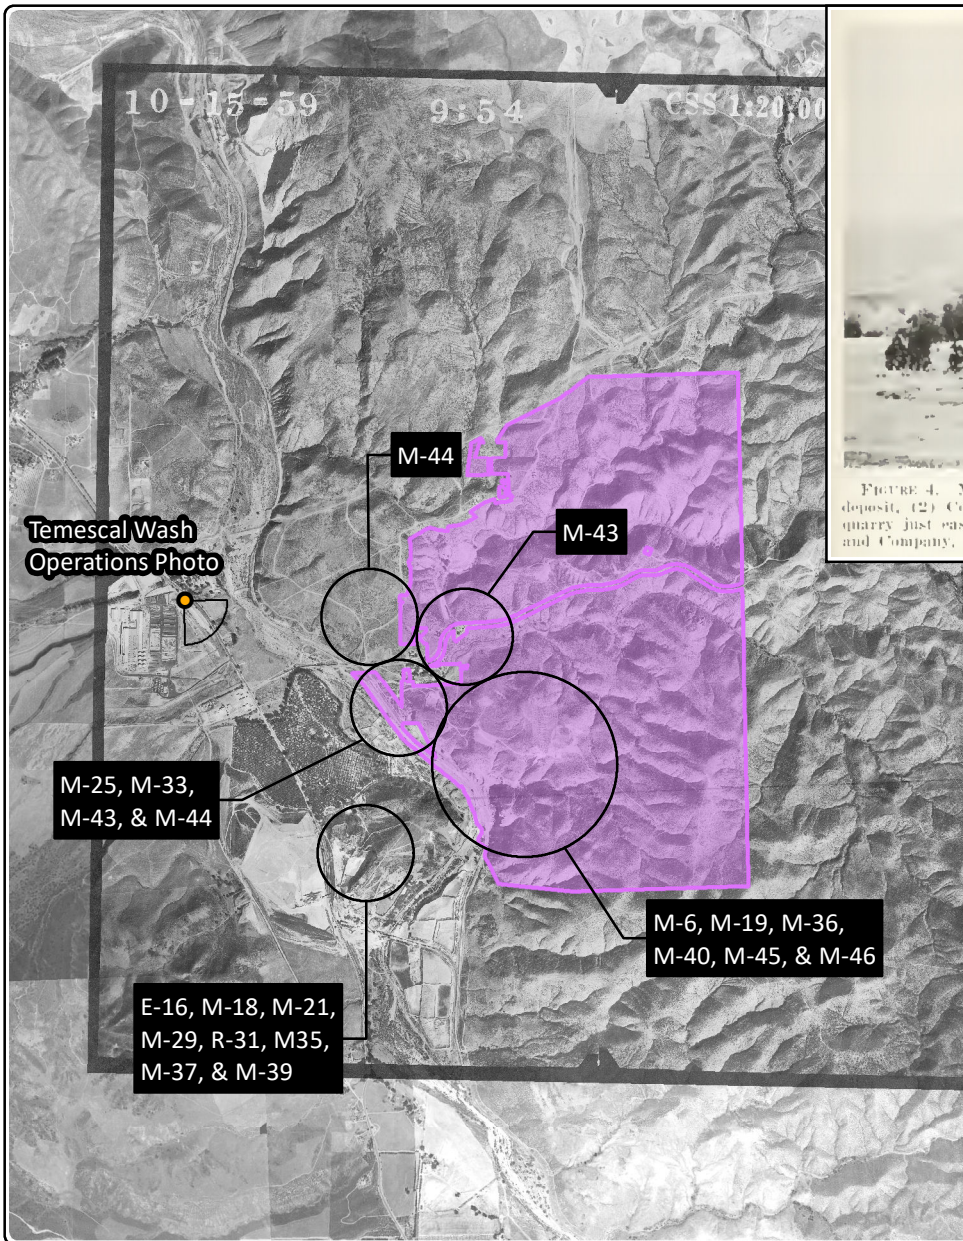
FIGURE 4. Mineral deposits and mineral processing plants in Corona-Elsinore trough near Bedford Wash, (1) Coronita Ranch sand deposit, (2) Corona silica sand deposit (Owens-Illinois Glass Co.), (3) Blarneystone rock quarry (metavolcanic rock used for riprap, quarry just east of Corona South quadrangle), (4) **Cajalco** clay pit, (5) Liston Brick Company, (6) Corona plant, Gladding, McBean and Company, quarry at left behind trees, Observer faces southeast.

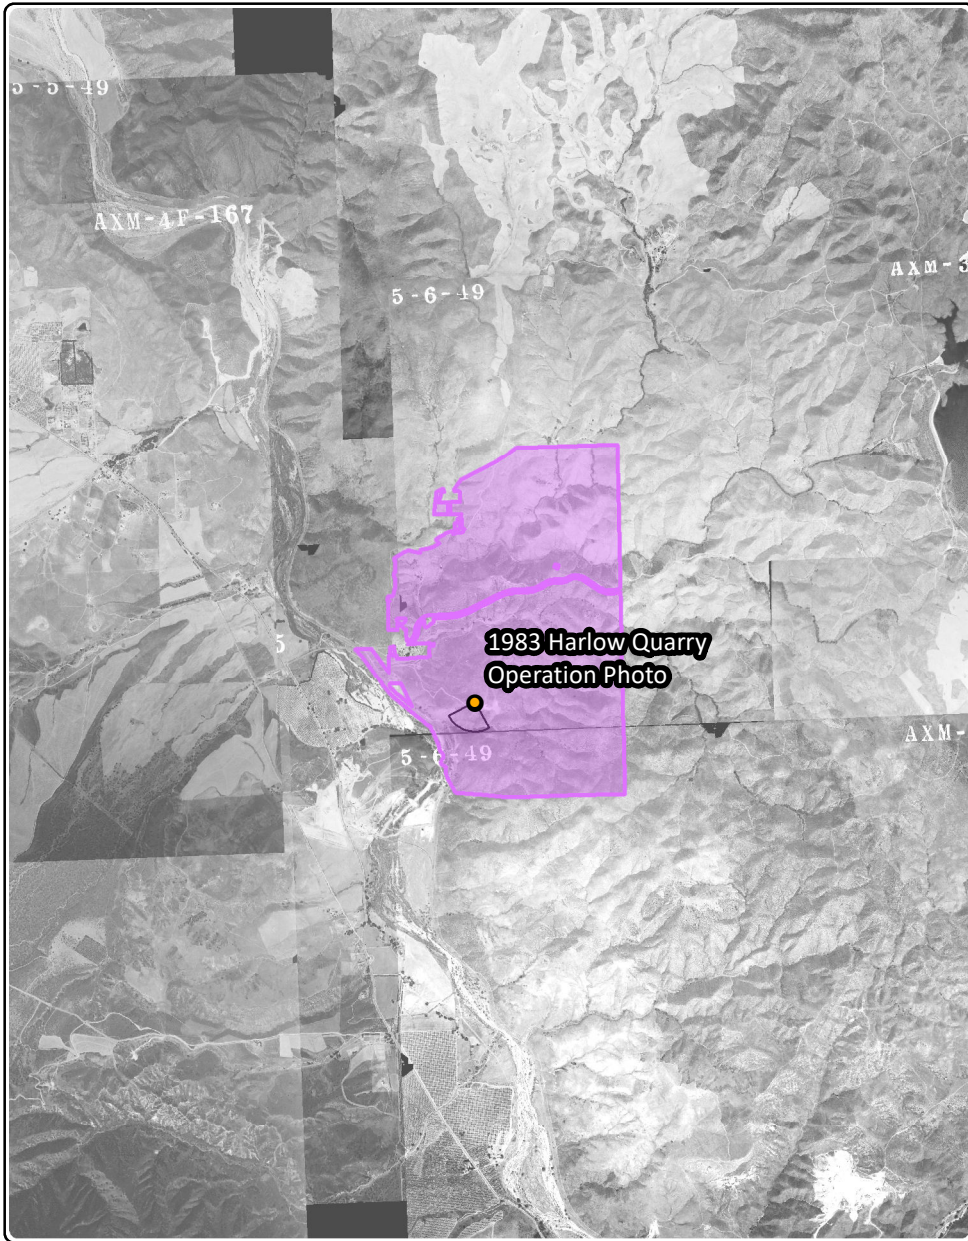
Aerial perspective of multiple surface mining operations located at mouth of Cajalco Canyon, as described by the California Division of Mines, in their 1961 report on the geology and mining in the Temescal region (Exh. C-2.3). These operations include Blarney Stone Quarry and the Cajalco and Harlow Clay Pits.

- Item 1 corresponds with surface mining activities: E-16, M-18, M-21, M-29, R-31, M-35, M-37, and M-39
- Item 3 corresponds with surface mining activity: M-43
- Item 4 corresponds with surface mining activity: M-44

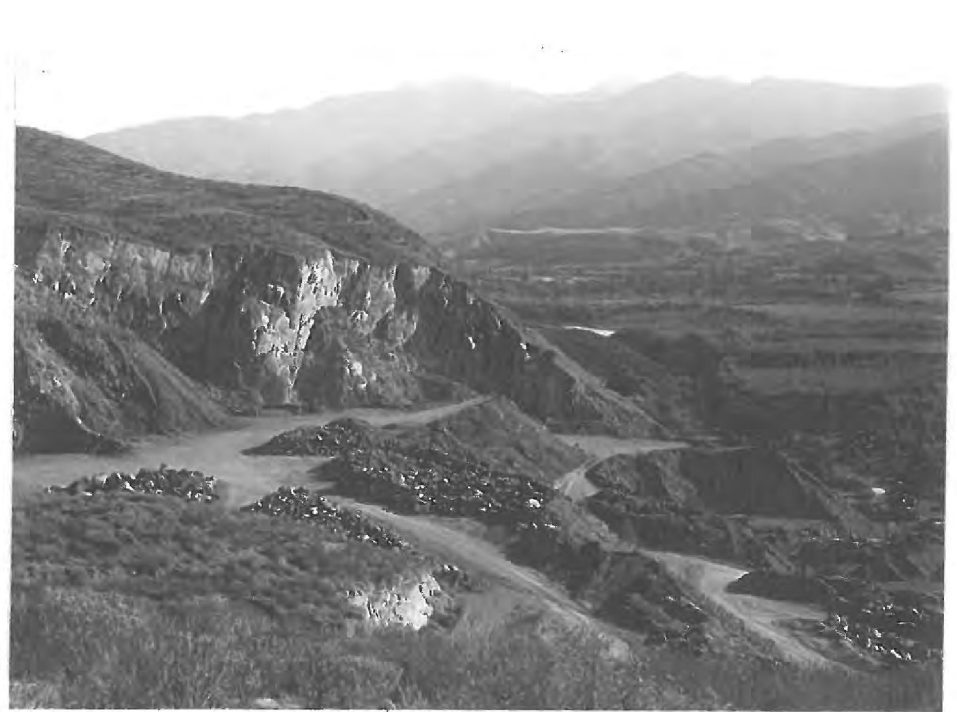
Aerial photograph dated 1949. The accuracy of the base map is limited as it is not a part of any field survey on the ground.

Demonstrates historic surface mining operations, including outside the S-4 VRA, of quarrying and stockpiling within the HH VRA, consistent with the exercise of a vested right.

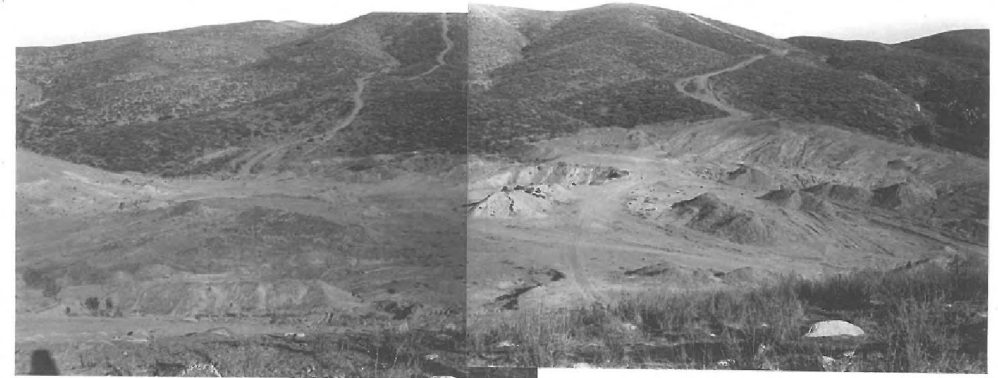
Photo 7 Panorama of clay resource area. The zone of highly-weathered metamorphic rock is probably at least 3 m thick over much of the disrupted area shown in this photograph. Total volume would therefore be about 130,000 m³ (176,000 yd³). Volume verification would require test borings or pits and additional surface measurements.
