SUBJECT: 11th Street Jail Demolition – In-Principle

Reference: Seismic Evaluation Report
County of Riverside Probation and Jail Facilities
Riverside, California

SEISMIC EVALUATION

COUNTY OF RIVERSIDE PROBATION AND JAIL FACILITIES Riverside, California L06-48

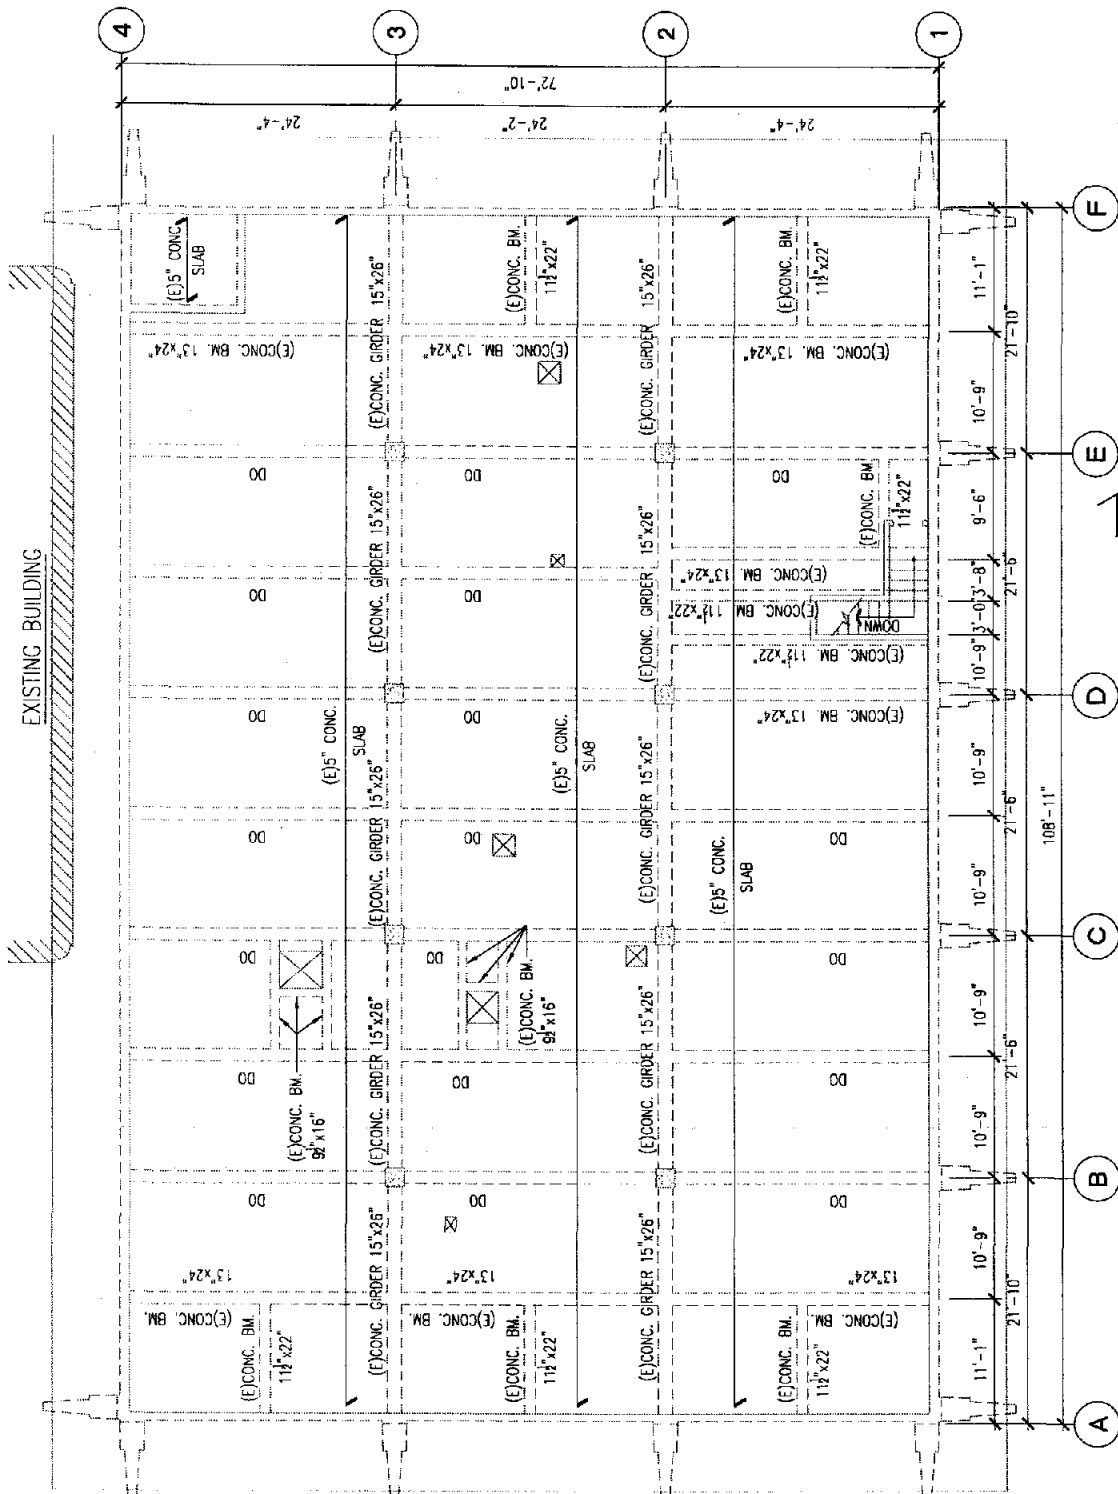
FIGURE 5

PROBATION AND JAIL FACILITIES
ROOF FRAMING PLAN

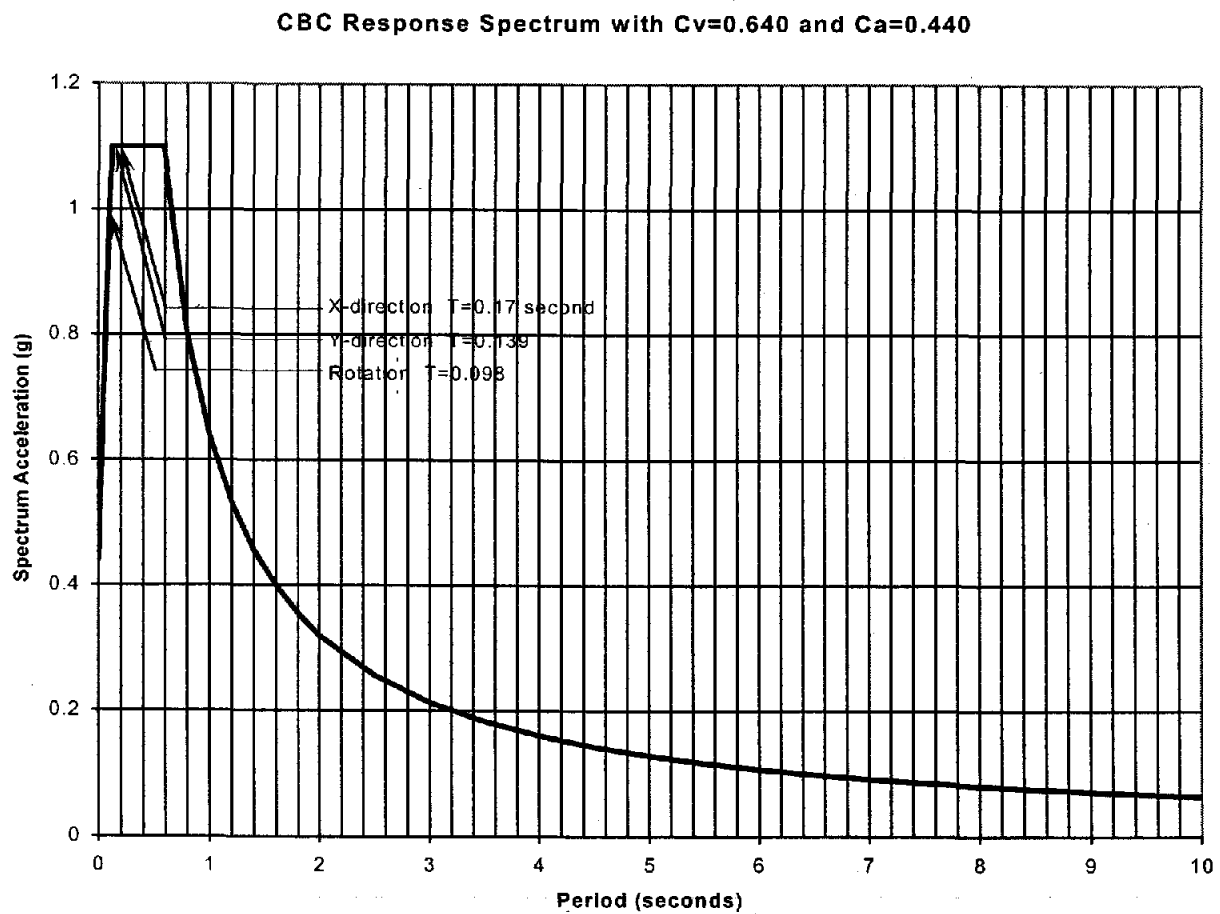
The evaluation of this building is based on the criteria contained in the 2001 CBC Chapter 16A, Division VI-R. Both static force procedure and CBC response spectrum analysis with 5% damping were used. See Figure 6 for the plot of the response spectrum curve used. Demands placed on the structure by earthquake ground motion and the ultimate capacity of the structure system were compared using load combination equations 44A-5 and 44A-6 of 2001 CBC.

In addition to static force analysis, a linear response spectrum analysis was performed using the standard CBC spectrum curve with $C_a = 0.44$ and $C_v = 0.64$. The first twelve modes of vibration were included resulting in a participation of 100% of the building mass. The modes were combined using the complete quadratic combination (CQC) method. The three fundamental modes (two translational modes and one rotational mode) of buildings with uncracked stiffness are shown on Figure 9. As expected, it was observed that the north-south direction translation had the longest period of 0.138 second, given the narrow width of the shear wall in that direction. The second translation mode of 0.114 second was primarily on the east-west direction. Lastly, the third mode of 0.079-second vibration is rotational translation. Numerous iterations were required before a model can realistically represent the existing structure. Much of the modeling complexity is the result of the presence of high parapet, perimeter cantilever slab and interior gunite partition that occurred at the third and fourth floors. Mass of these elements were assumed lumped at the respective floor and roof diaphragms.

Figure 6 - Response Spectrum used for this Project

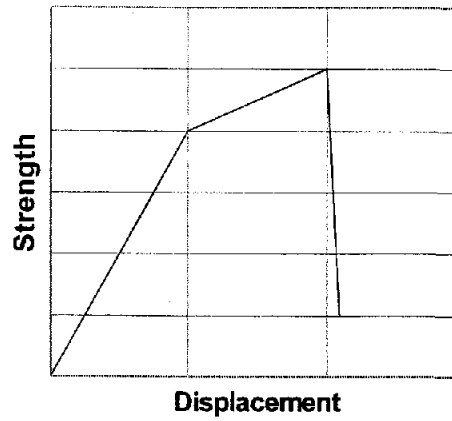
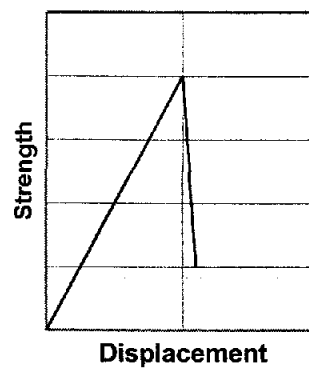
Generally, most structural elements constructed according to the current building code will have sufficient ductility to allow demands greater than their calculated capacity with $\beta=1.0$. Please refer to Figure 7 for comparison of material behavior with or without ductility. Concrete buildings built before 1976 are considered limited or non-ductile. Clear indication of lack of ductility of this building can be found from typical reinforcing details of construction documents which only provides 28-diameter splice of reinforcing steel. Under current code requirements, the same rebar splice will require 38 to 64-diameter lap splice. Due to lack of ductility of this building, the β factor ranging from 2.5 to 3.5 were used in the above equations for shear wall stress check. For the evaluation of this existing structure, the following β value was used:

Figure 7 - Comparison of Material Behavior

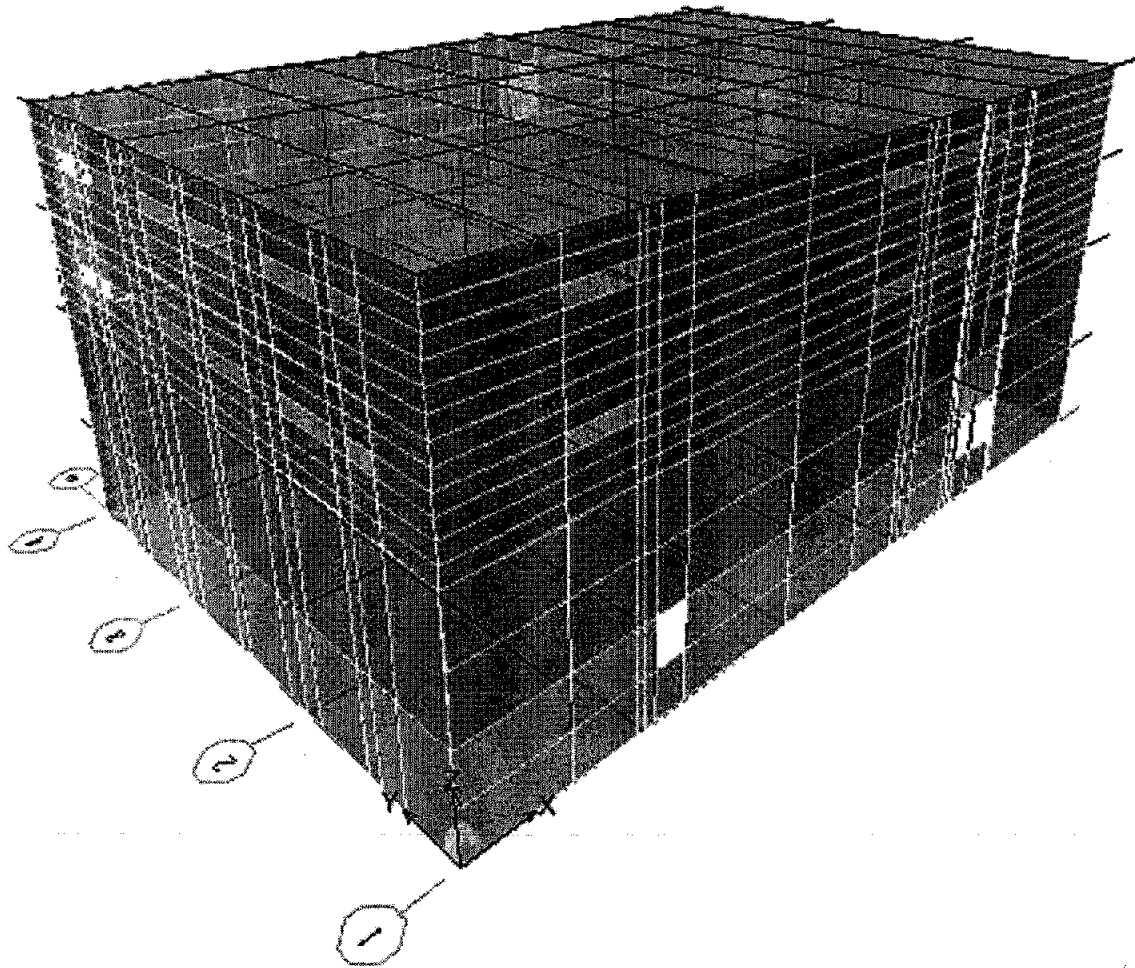
Three-dimensional finite element computer model of the building was developed using the program ETABS. Rigid diaphragms were modeled for both the roof and all floors. This assumption significantly reduces the computational complexity of analyzing the building's lateral load resisting system and also improves computational accuracy for shear wall analysis. Wall, column, and beam elements were used to model the building. An isometric representation of the computer model is shown on Figure 8. Besides performing evaluation of the strength of members of the building, the drift of the building under the design load was also determined. The evaluation was compared to the drift limit stated in CBC, Section 1630.9.

Figure 8 – three-Dimensional Computer Model

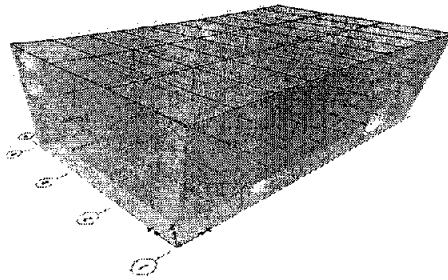
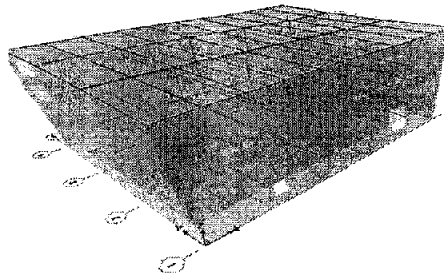
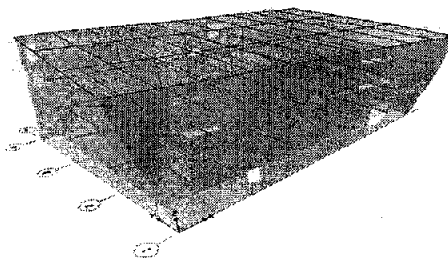
Figure 9 - Fundamental Mode Shapes
